POWER SYSTEM INCIDENT REPORT TRIP OF THE SNUGGERY – BLANCHE AND SNUGGERY – SOUTH EAST / MAYURRA 132 KV LINES ON 12 MAY 2010

PREPARED BY: Electricity System Operations Planning and Performance

FINAL

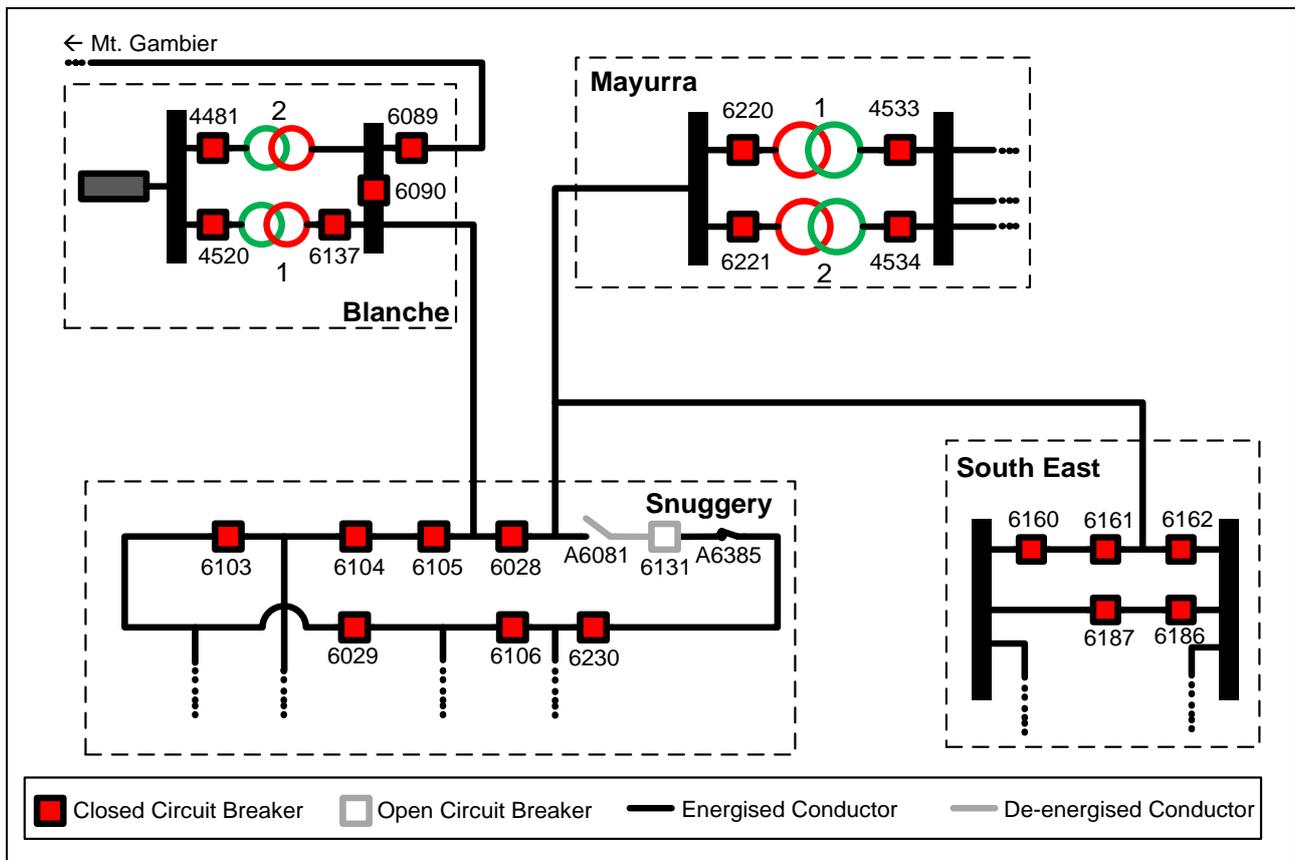
Figure 1 - Status of relevant circuit breakers and conductors prior to the event

The Snuggery substation has a 132 kV ring busbar configuration. The ring busbar configuration had been opened at circuit breaker 6131 prior to the incident to permit servicing and current transformer (CT) oil sampling of the circuit breaker. The Snuggery gas turbines were not in service at the time.

Figure 1 shows the status of the relevant circuit breakers and isolators prior to the event.

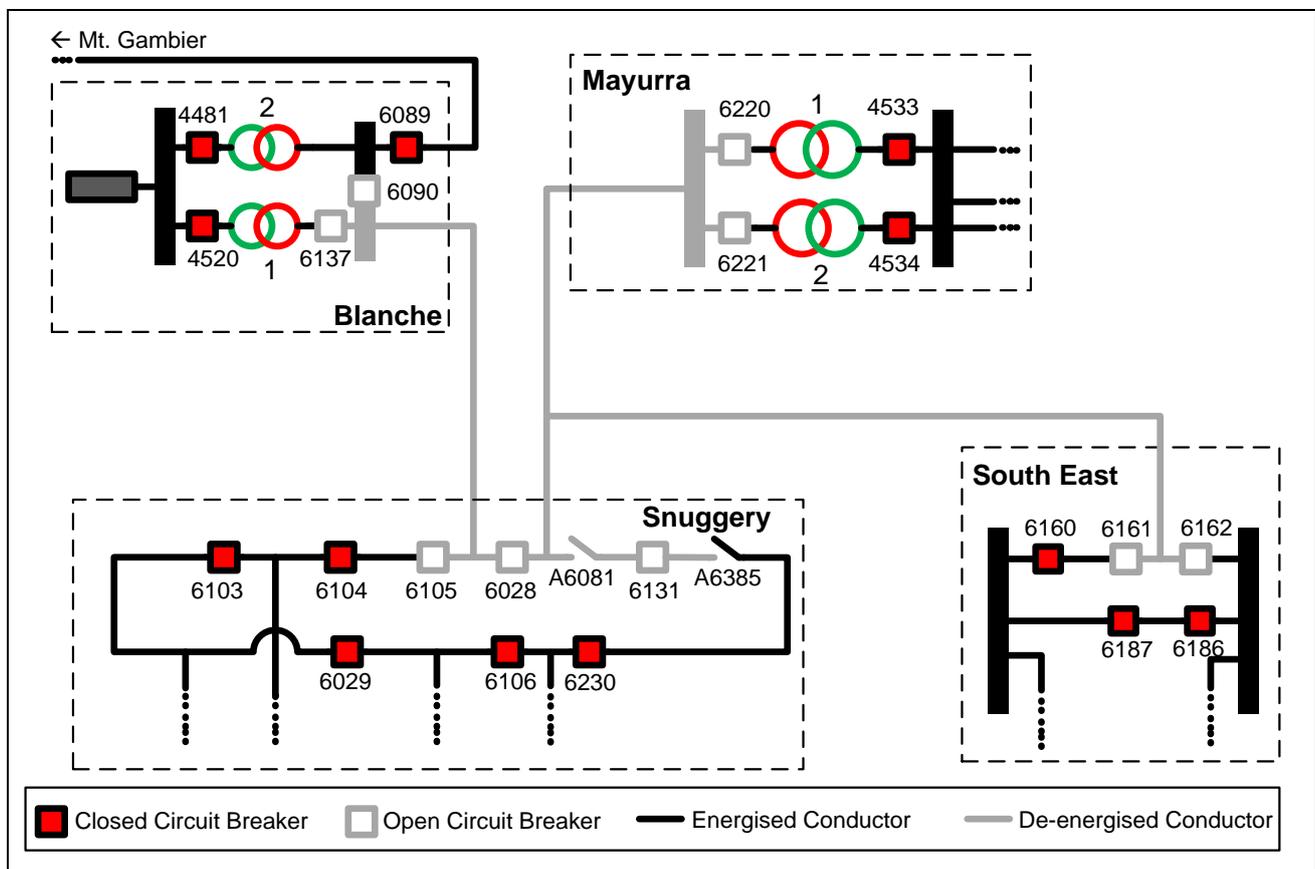
Figure 2 - Status of relevant circuit breakers and conductors after the event

At 09:21 hrs on 12 May 2010, the Snuggery 6131 circuit breaker was opened. At 09:26 A6081 isolator was opened to begin the isolation of the circuit breaker 6131 for routine servicing and CT sampling. At 09:28 the A6385 isolator was opened to complete the isolation. This action caused a spurious 'Circuit breaker fail initiate' signal for circuit breaker 6028. The following circuit breakers correctly operated in response to the spurious signal:

- Snuggery busbar section circuit breakers 6105 and 6028
- Blanche No. 1 Transformer 132 kV circuit breaker 6137
- Blanche 132 kV busbar coupler circuit breaker 6090
- Mayurra No. 1 Transformer 132 kV circuit breaker 6220
- Mayurra No. 2 Transformer 132 kV circuit breaker 6221
- South East to Snuggery/Mayurra circuit breakers 6161 and 6162 at South East

The operation of these circuit breakers left the following lines de-energised:

- Snuggery to South East / Mayurra 132 kV line
- Snuggery to Blanche 132 kV line

Figure 2 shows the status of the relevant 132 kV circuit breakers and transmission lines after the circuit breakers tripped.

When isolator A6385 was opened, a spurious circuit breaker fail initiate signal (as described above) for Snuggery 132 kV circuit breaker 6028 caused the surrounding circuit breakers to trip. There were no high voltage power system faults identified at the time of this incident.

Further investigation into the programming of the management/CBF relay for CB 6028 revealed it was issuing the Circuit Breaker Fail (CBF) trips for the condition when both isolators A6081 and A6385 were open. Modifying the programming logic of the relay will correct the design issue and ensure the CBF relay does not issue a CBF trip for the identical condition. ElectraNet plan to complete all necessary design changes by the end of October 2010.
