# POWER SYSTEM INCIDENT REPORT

## TRIP OF NO.1 AND NO.3 BUSBARS AT 500 KV LOY YANG POWER STATION SWITCHYARD ON 06 APRIL 2010

PREPARED BY: Electricity System Operations Planning and Performance

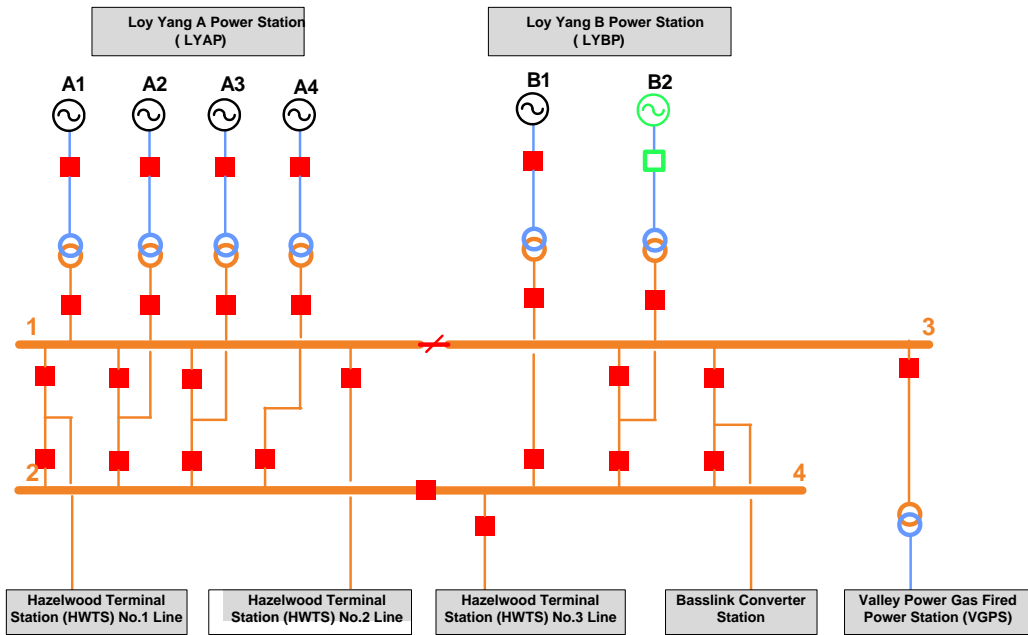
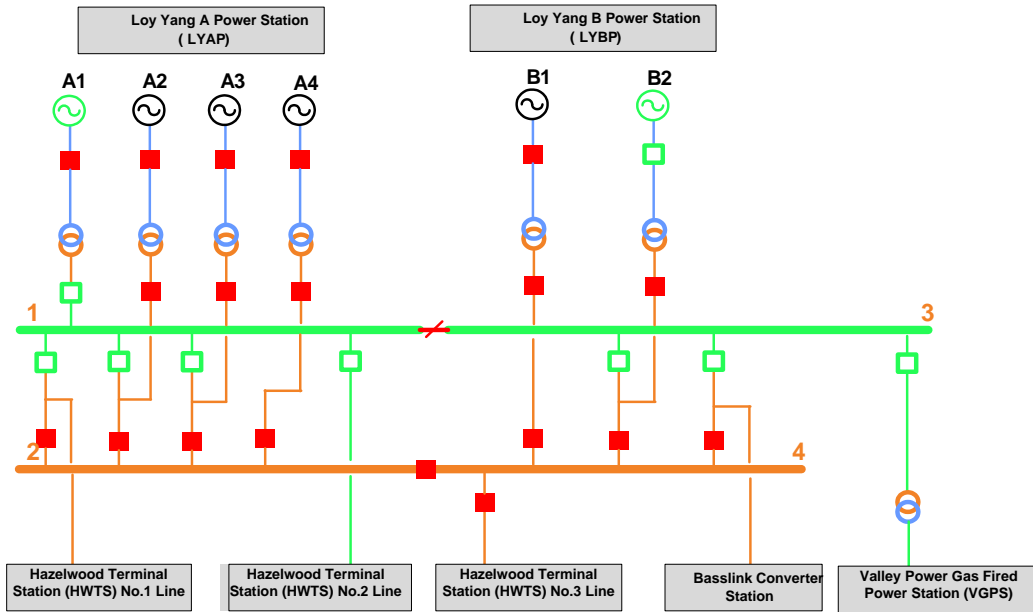
FIGURE 1: TRANSMISSION NETWORK ARRANGEMENTS AT LYPS SWITCHTARD BEFORE AND AFTER THE TRIP OF NO.1 AND NO.3 500 kV BUSBARS

Transmission network arrangements at LYPS switchyard before and after the event are shown in Figure 1.

LYPS A Generating Unit 1 has only a single transmission connection to the LYPS switchyard via the LYPS No.1 500 kV busbar. Similarly Valley Power gas fired power station (VPGS) also has a single transmission connection to the LYPS via LYPS No.3 500 kV busbar. Hence the loss of No.1 and No.3 500 kV busbars resulted in the loss of LYPS A Generating Unit 1 and VPGS. VPGS was not generating at the time.

The No.2 LYPS to HWTS 500 kV transmission line is connected to LYPS No.1 500 kV busbar. As a consequence of the incident, this transmission line was off-loaded at LYPS.
