POWER SYSTEM INCIDENT REPORT TRIP OF 275 KV NORTH BUSBAR AT SOUTH EAST SUBSTATION – 18 SEPTEMBER 2010

PREPARED BY: ESOPP
VERSION: 1.0
DATE: 10 January 2011
FINAL

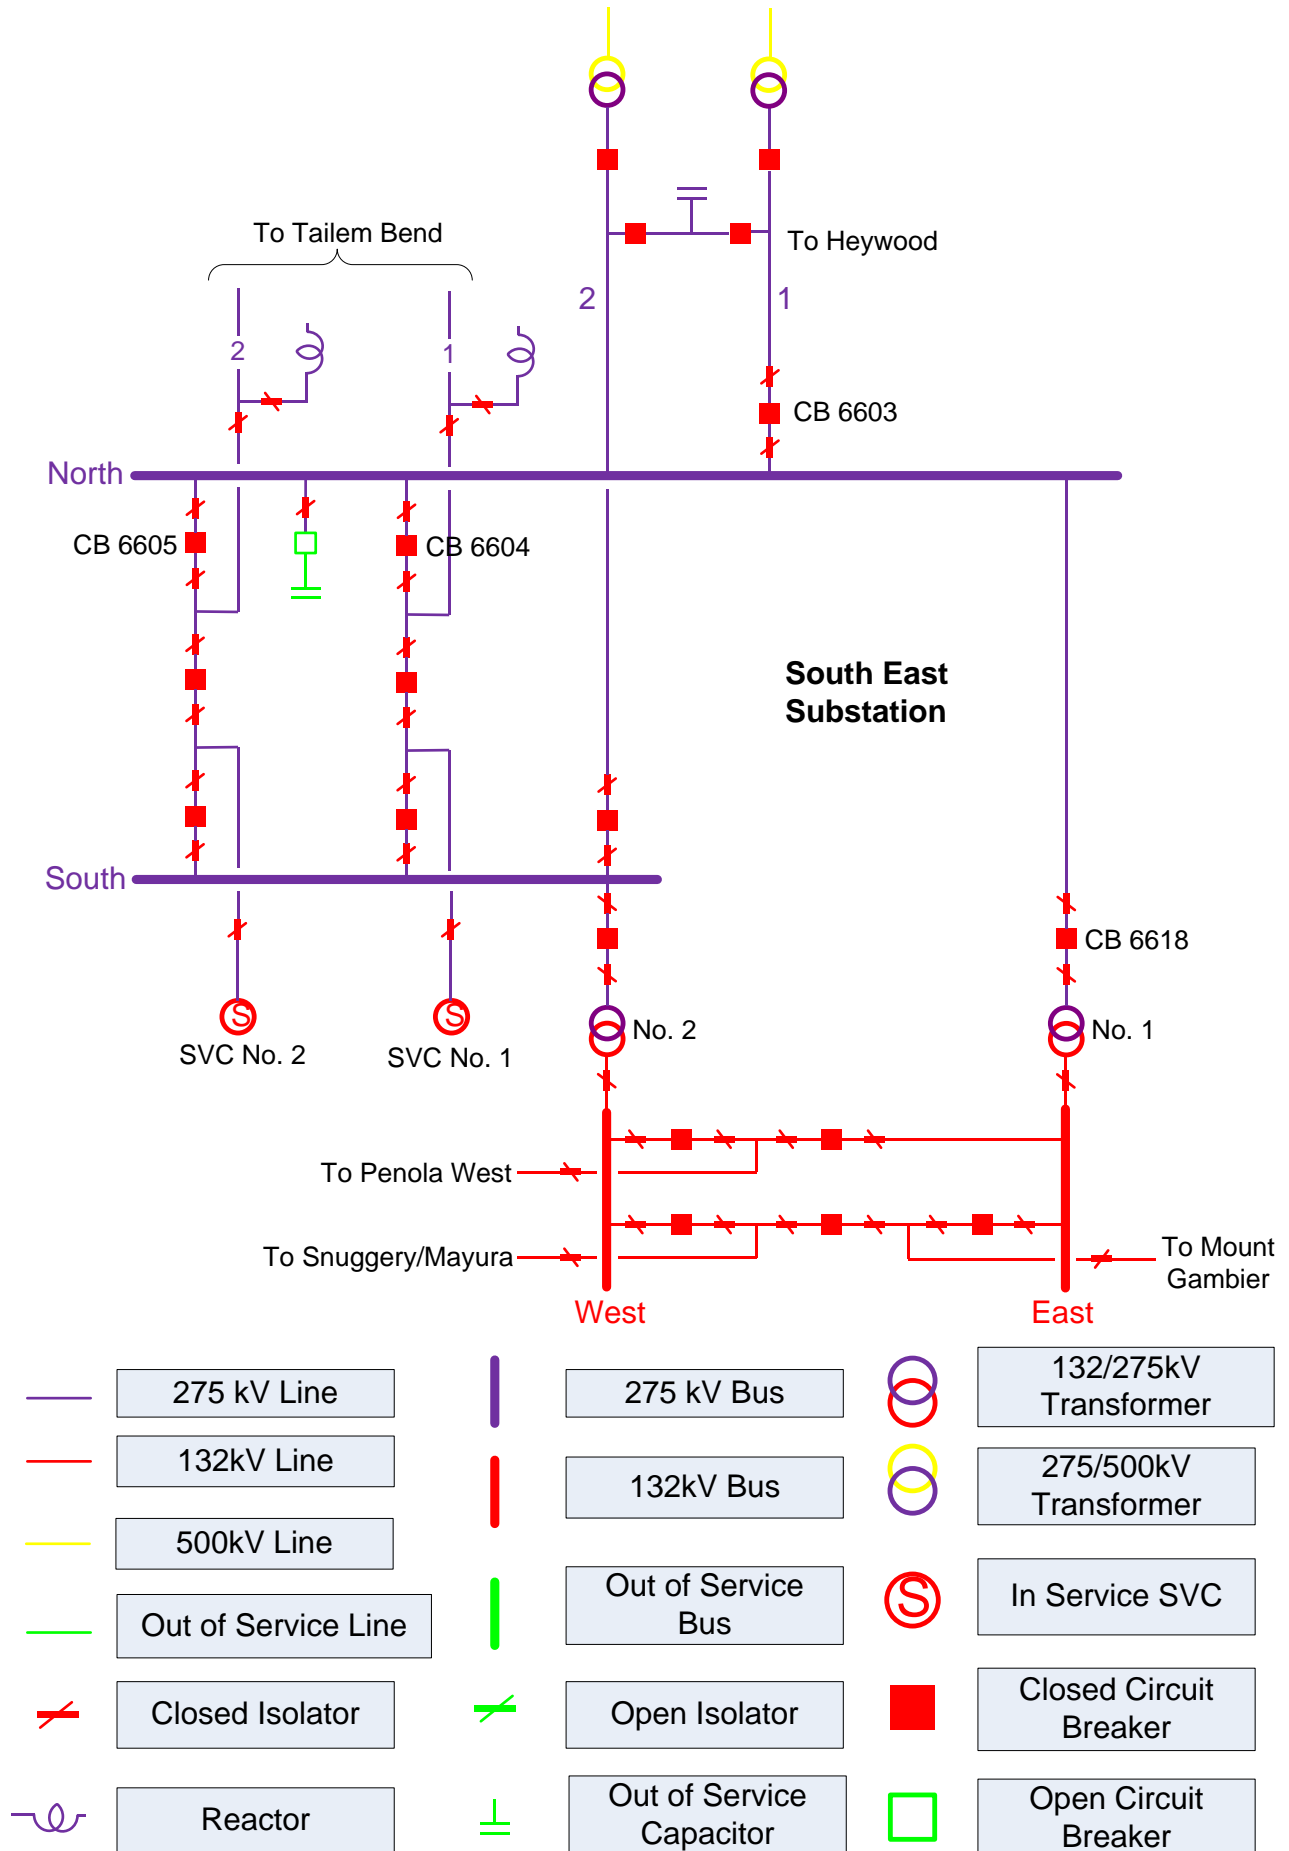
Figure 1 – South East substation switchyard before the event

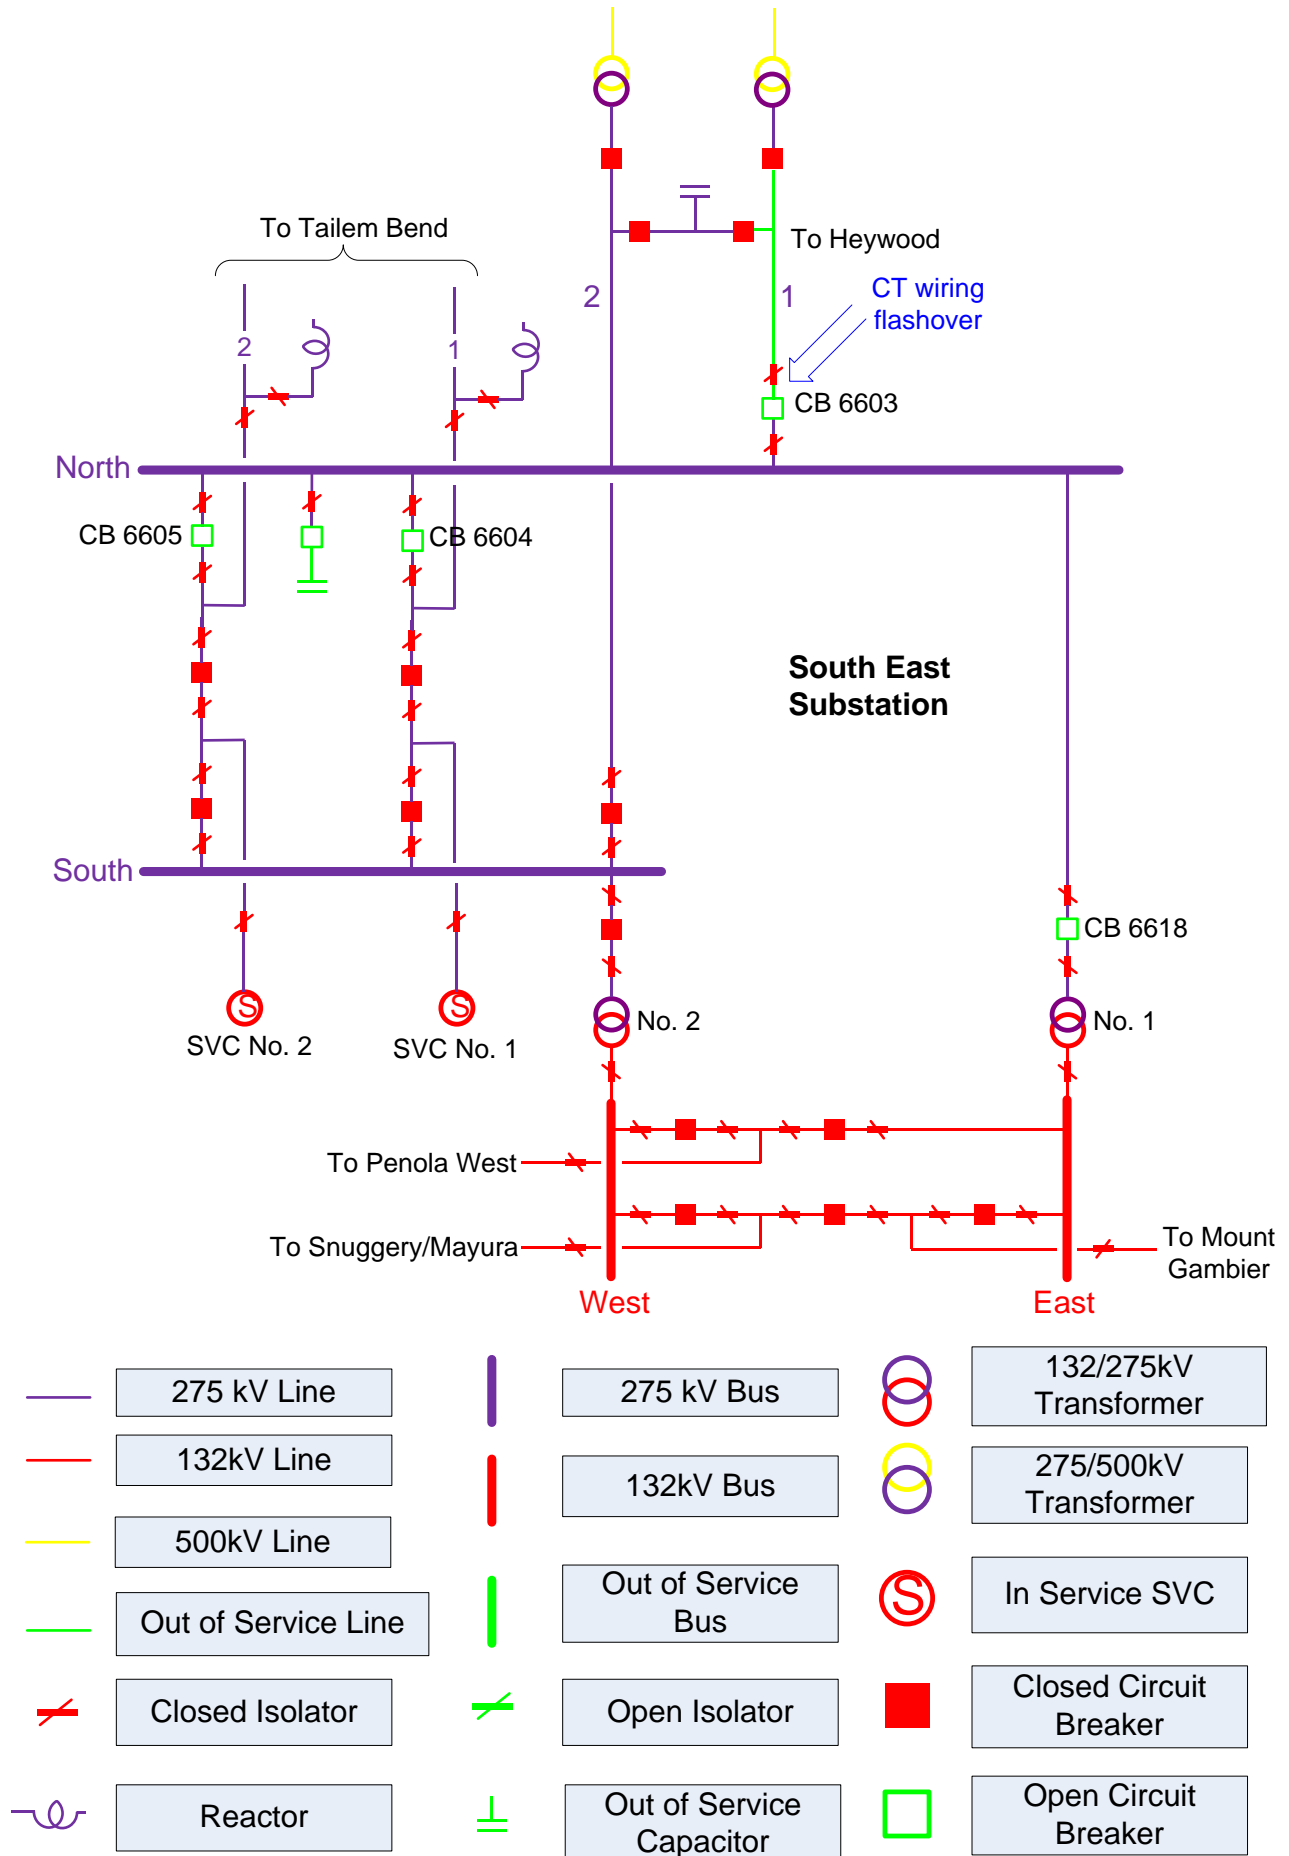
At 2236 hrs on the same day, the 275 kV North busbar at SESS tripped on the operation of the North Bus Zone Set 2 auxiliary relay. This trip resulted in the off-loading of the No.1 SESS_HYTS 275 kV line, leaving South Australia transmission network connected to HYTS via a single circuit. The No.1 275/132 kV transformer at SESS was also offloaded. The circuit breakers 6603, 6604, 6605, and 6618 at SESS tripped during the incident. Weather conditions with light mist, rain and fog were recorded in the vicinity at the time of the event.

Figure 2 – South East substation switchyard immediately after the event
