POWER SYSTEM INCIDENT REPORT

TRIP OF MORWELL TERMINAL STATION 66 KV NO. 1 BUSBAR AND MORWELL POWER STATION ON 28 NOVEMBER 2010

PREPARED BY: ESOPP

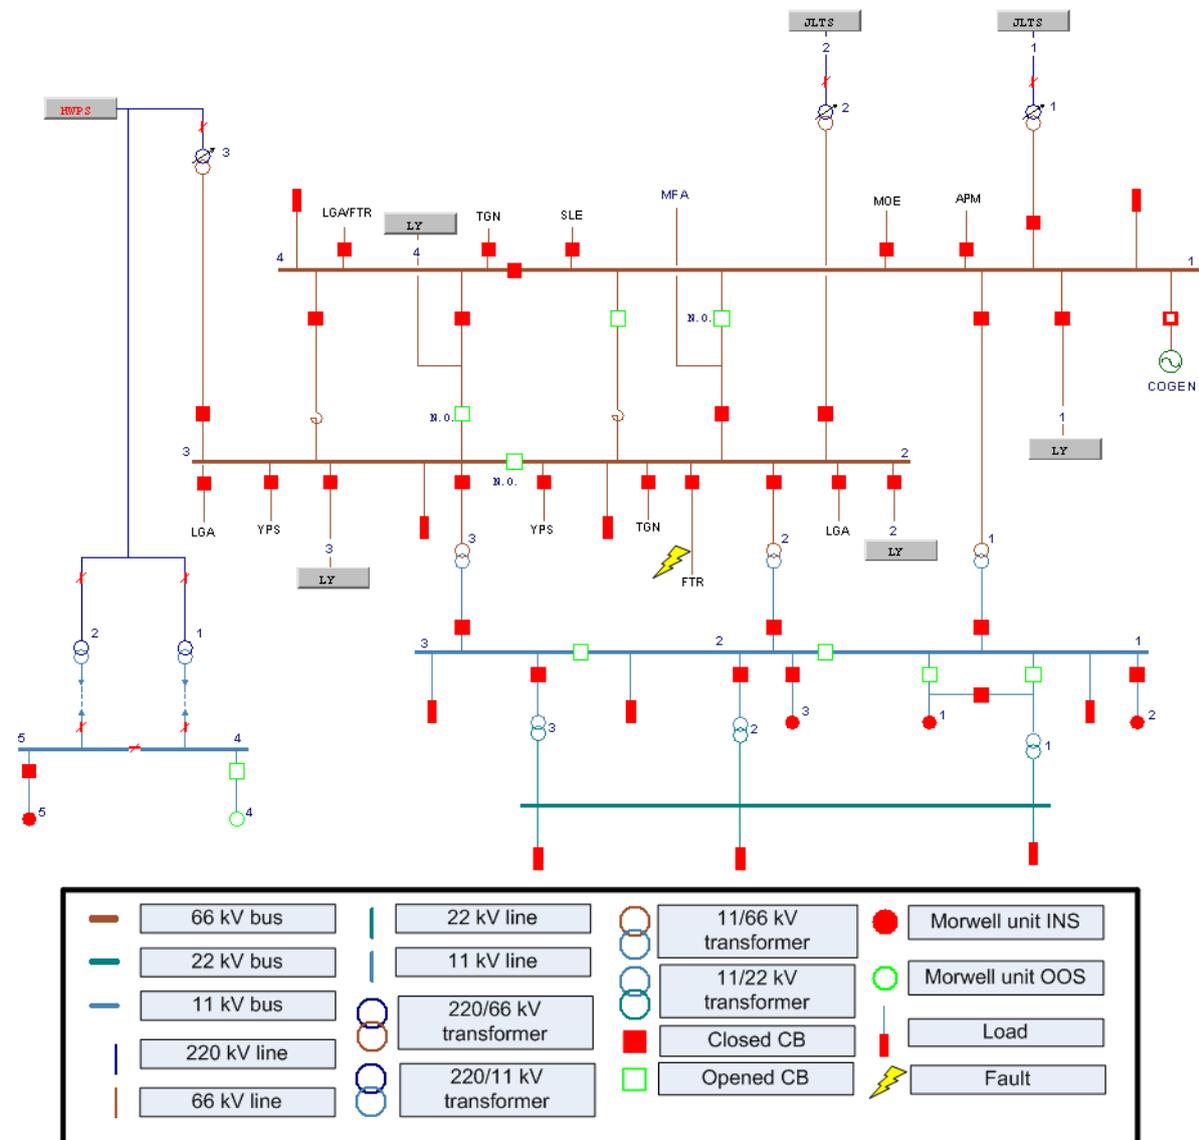
During the line fault, the 'X' protection of the MWTS 66 kV No. 1 busbar operated and tripped the busbar. As a result, several transmission elements opened at MWTS. Figure 1 and Figure 2 show the statuses of network elements at MWTS immediately before and after the incident. The following is a list of affected equipment during the event:

FIGURE 1. OVERVIEW OF MORWELL TERMINAL STATION AND MORWELL PS BEFORE THE INCIDENT.

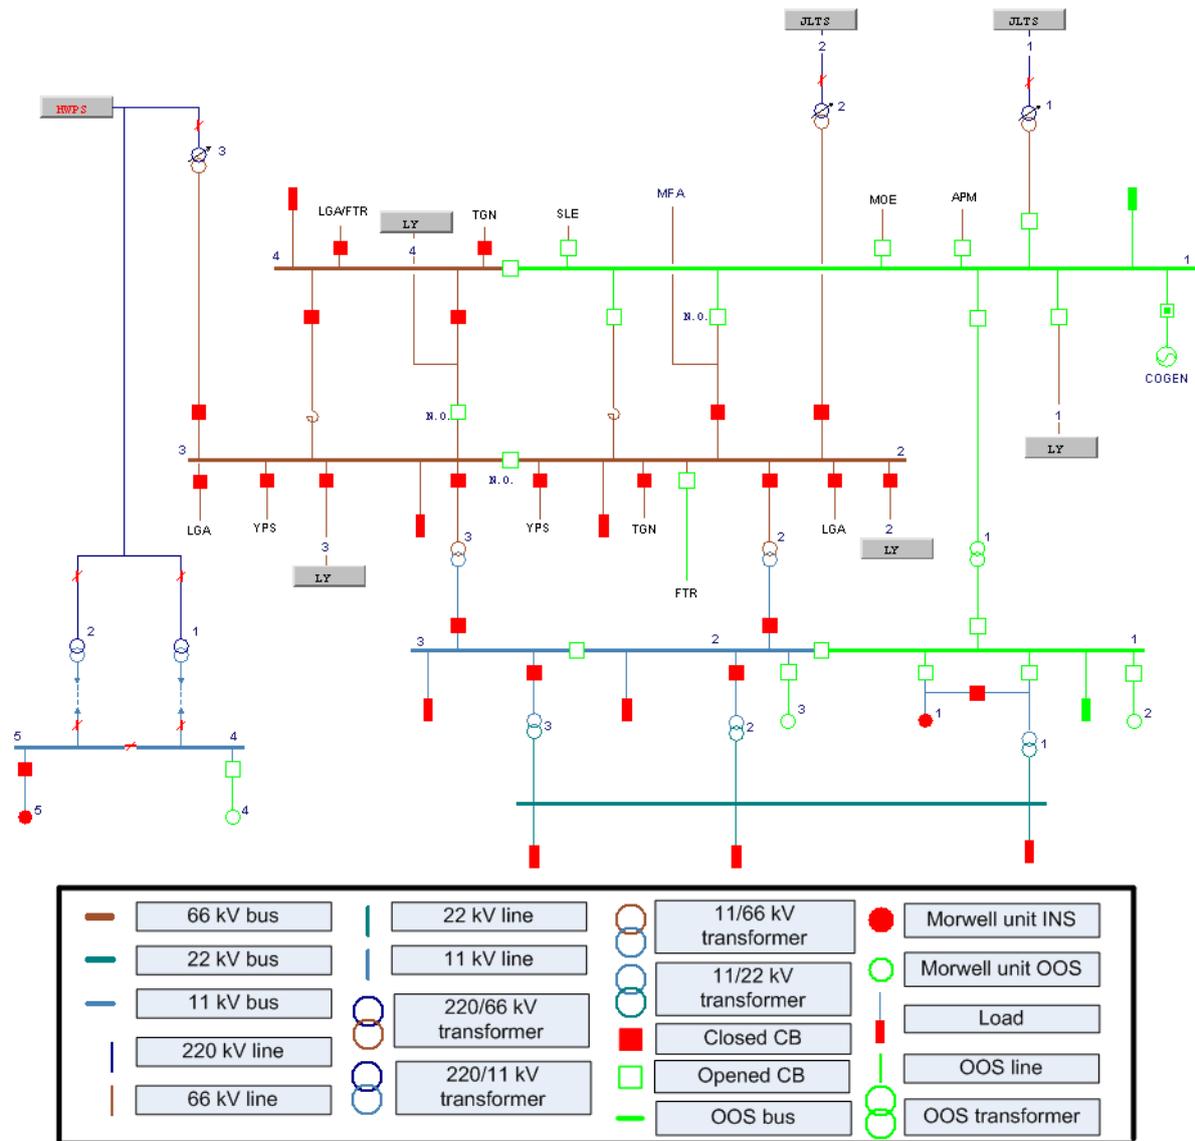
- 66 kV line between MWTS and Australian Paper Mill (APM)
- 66 kV line between MWTS and Moe (MOE)
- 66 kV line between MWTS and Loy Yang substation (LY)
- 66 kV line between MWTS and Sale (SLE)
- 220/66 kV No. 1 transformer between MWTS and Jeeralang Terminal Station (JLTS)
- Morwell PS

FIGURE 2. OVERVIEW OF MORWELL TERMINAL STATION AND MORWELL PS IMMEDIATELY AFTER THE LINE FAULT AND BUSBAR TRIP.
