POWER SYSTEM INCIDENT REPORT TRIP OF BOTH TARONG – BLACKWALL 275 KV LINES ON 21 FEBRUARY

PREPARED BY: Electricity System Operations Planning and Performance

DATE: 3 June 2011

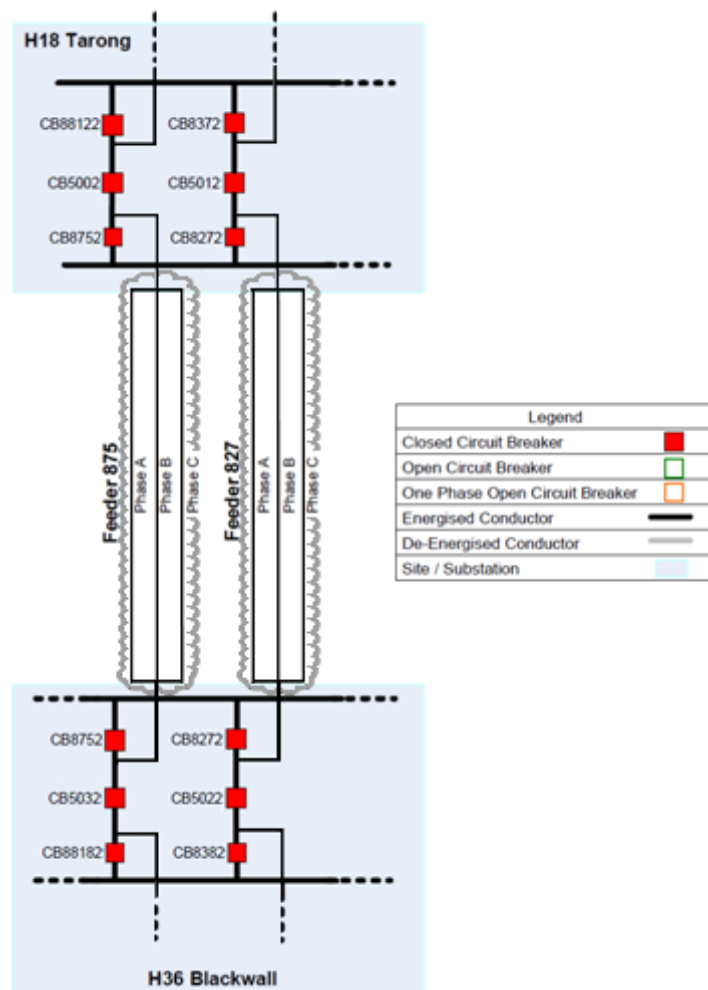
Prior to the incident all circuit breakers and transmission elements connecting the Tarong and Blackwall 275 kV substations were in service, as shown in Figure 1 below.

Figure 1 – Transmission line and circuit breaker status prior to the incident

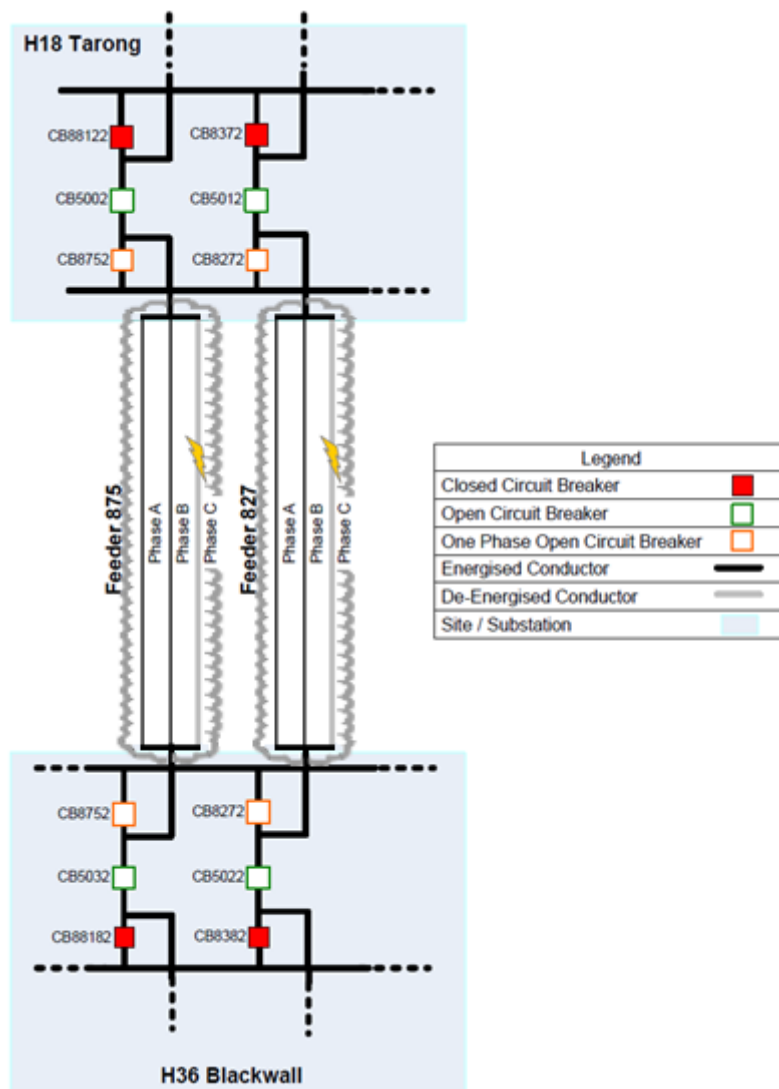
At 14:40:05 on 21 February 2011, the phase C circuit breakers of both 827 and 875 Tarong – Blackwall 275 kV lines tripped at both ends due to the presence of a high voltage fault on those phases due to a lightning strike.

The phase C circuit breakers at both ends of the lines opened to isolate the fault from the power system. The circuit breakers connecting the transmission lines immediately to the busbars only opened on the faulted phase while all three phases of the centre circuit breakers correctly opened. These operations resulted in the two transmission lines remaining in service on two phases only. Figure 2 below shows the status of the relevant circuit breakers after the lightning strike.

Figure 2 – Transmission line and circuit breaker status after the lightning strike

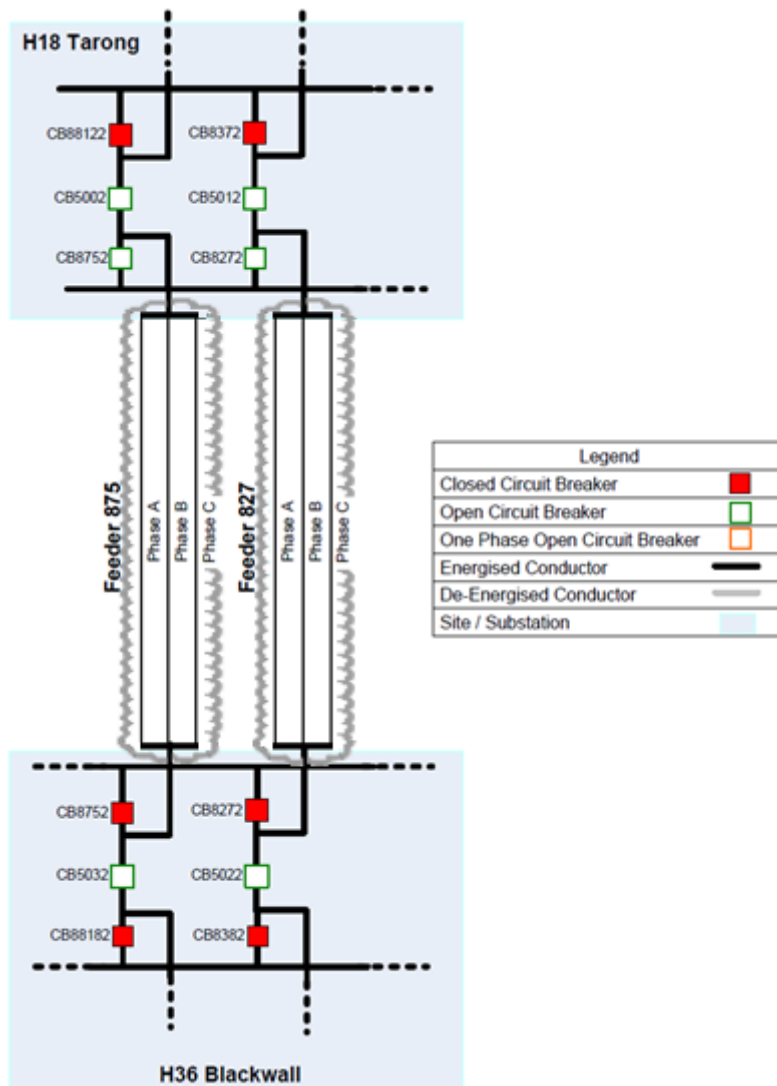
At 14:40:08, the two closed phases of circuit breaker 8272 at the Tarong 275 kV substation tripped on operation of pole discrepancy protection, resulting in the 827 Tarong – Blackwall 275 kV line being off-loaded but still energised from the Blackwall end. The operation of the pole discrepancy protection was unexpected.

At 14:40:09, the two closed phases of circuit breaker 8752 at the Tarong 275 kV substation tripped on operation of pole discrepancy protection, resulting in the 875 Tarong – Blackwall 275 kV line being off-loaded but still energised from the Blackwall end. Again, the operation of the pole discrepancy protection was unexpected.

At 14:40:14, the open phase C of circuit breaker 8752 at the Blackwall 275 kV substation successfully auto-reclosed, resulting in all three phases of the 875 Tarong – Blackwall 275 kV line being energised from the Blackwall end but remaining off-loaded. Figure 3 below shows the status of the equipment at this time.

Figure 3 – Transmission line and circuit breaker status after the protection system operations

As shown in Figure 3, at this time both transmission lines were off-loaded but energised from the Blackwall end.

Following the incident, Powerlink investigated the circuit breaker auto-reclose performance. The investigation identified that, for a coincident single phase trip of the 827 and 875 275 kV transmission lines, there was a timing coordination issue between the auto-reclose dead time and the circuit breaker pole discrepancy time for circuit breakers 8272 and 8752 at Tarong 275 kV substation. This timing coordination issue caused the unexpected operation of the pole discrepancy protection systems, which resulted in the transmission lines being opened on all phases. Powerlink has since successfully tested and implemented new protection system settings.
