# POWER SYSTEM INCIDENT REPORT TRIP OF COWRA 132 KV BUSBAR ON 5 FEBRUARY 2011

PREPARED BY: Electricity System Operations Planning and Performance

DATE: 2 June 2011

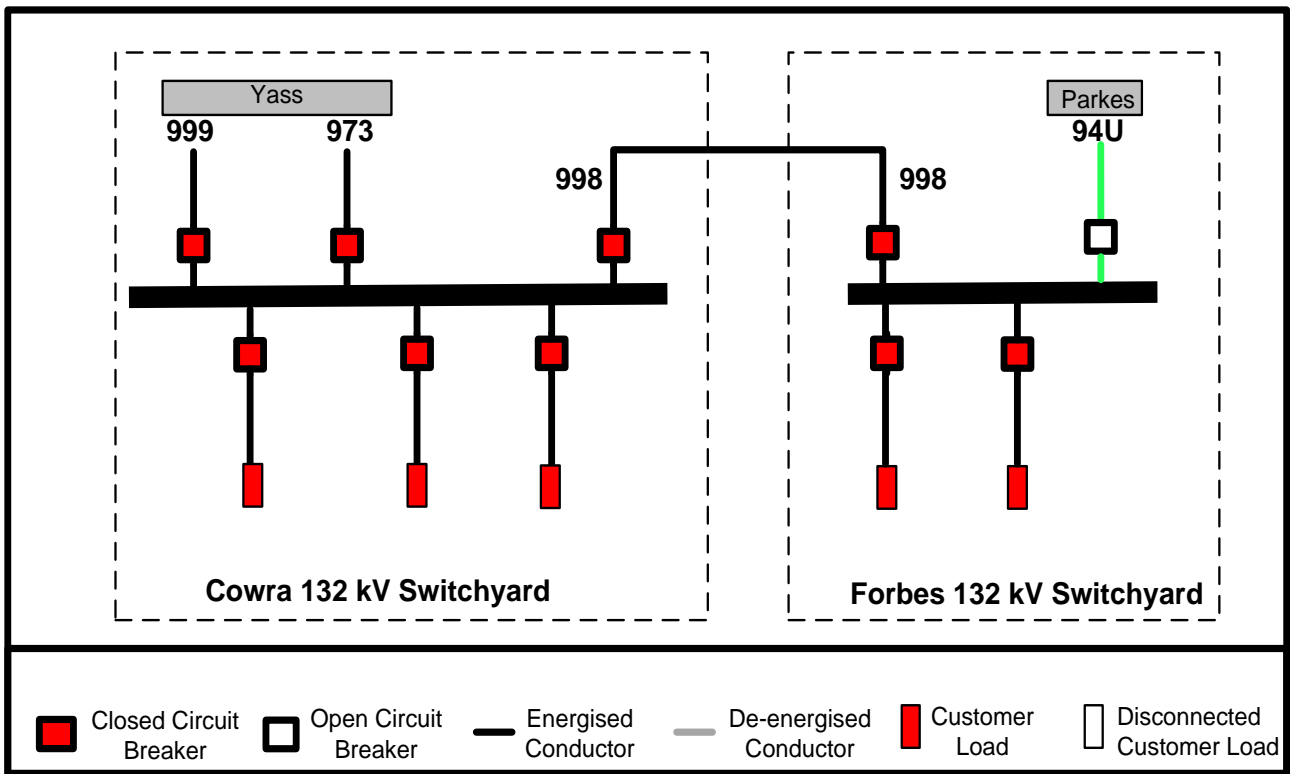
The status of the relevant power system equipment before the incident is shown in Figure 1. Prior to the incident, the 94U Forbes–Parkes 132 kV line was open and Forbes was supplied from Cowra via the 998 Cowra–Forbes 132 kV line as shown in Figure 1.

Figure 1 - Status of relevant circuit breakers lines and customer loads prior to the event

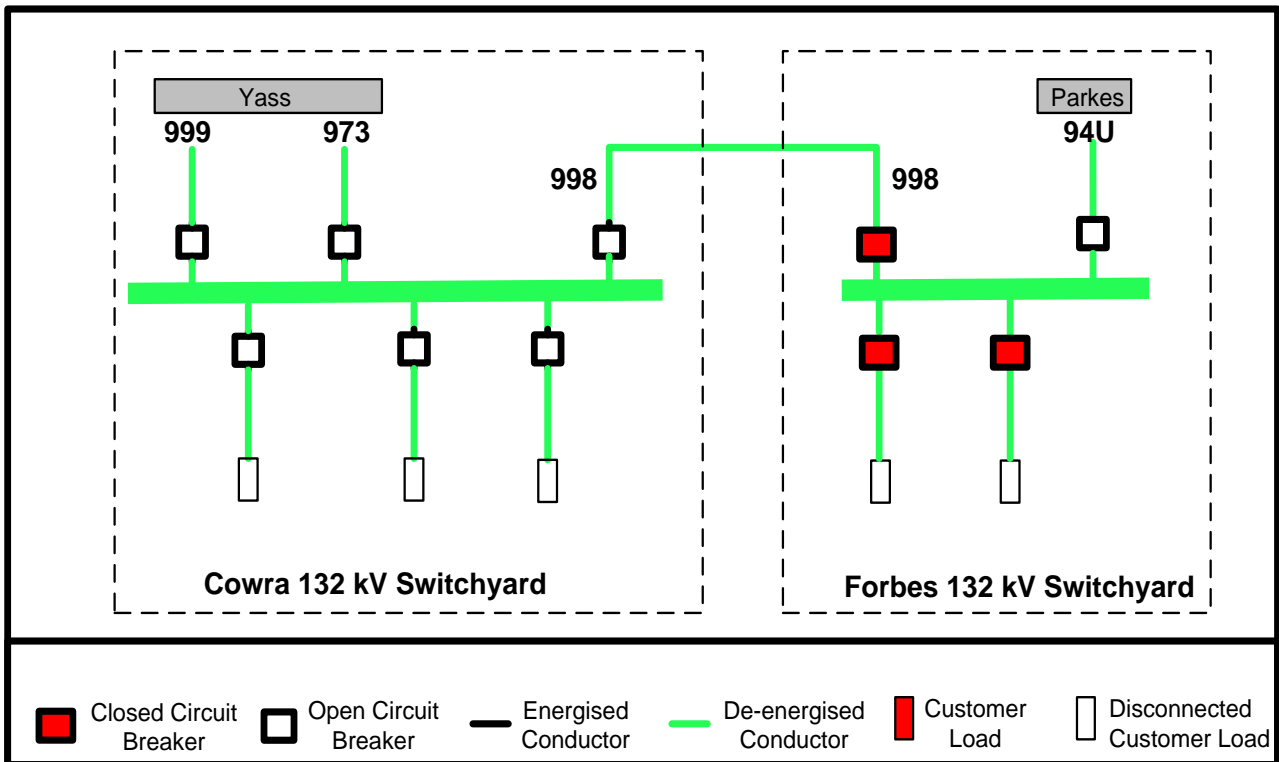
Approximately 50 MW of customer load supplied from Cowra and Forbes was interrupted as a result of the incident. All customer loads were restored by 2115 hrs. Figure 2 shows the status of relevant circuit breakers, lines and customer loads following the operation of protection systems at Cowra 132 kV substation.

Figure 2 - Status of relevant circuit breakers, lines and customer loads after the event
