POWER SYSTEM OPERATING INCIDENT REPORT REDBANK 132KV BUSBAR TRIP ON 25 APRIL 2011

PREPARED BY: Electricity System Operations Planning and Performance

DATE: 28 July 2011

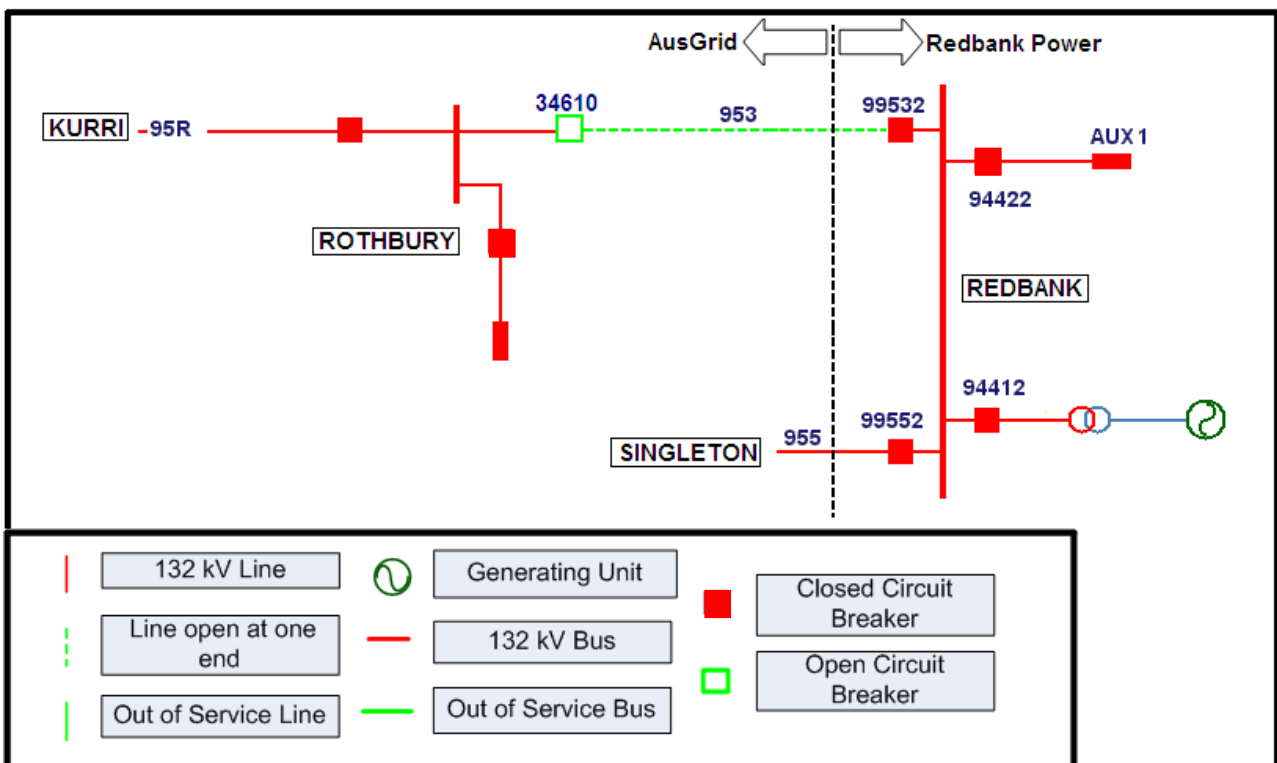
Figure 1 – Status of the power system prior to the incident

The Redbank generating unit was generating 71 MW at the time and the 953 Redbank—Rothbury line was open at Rothbury, which is the normal operating arrangement.

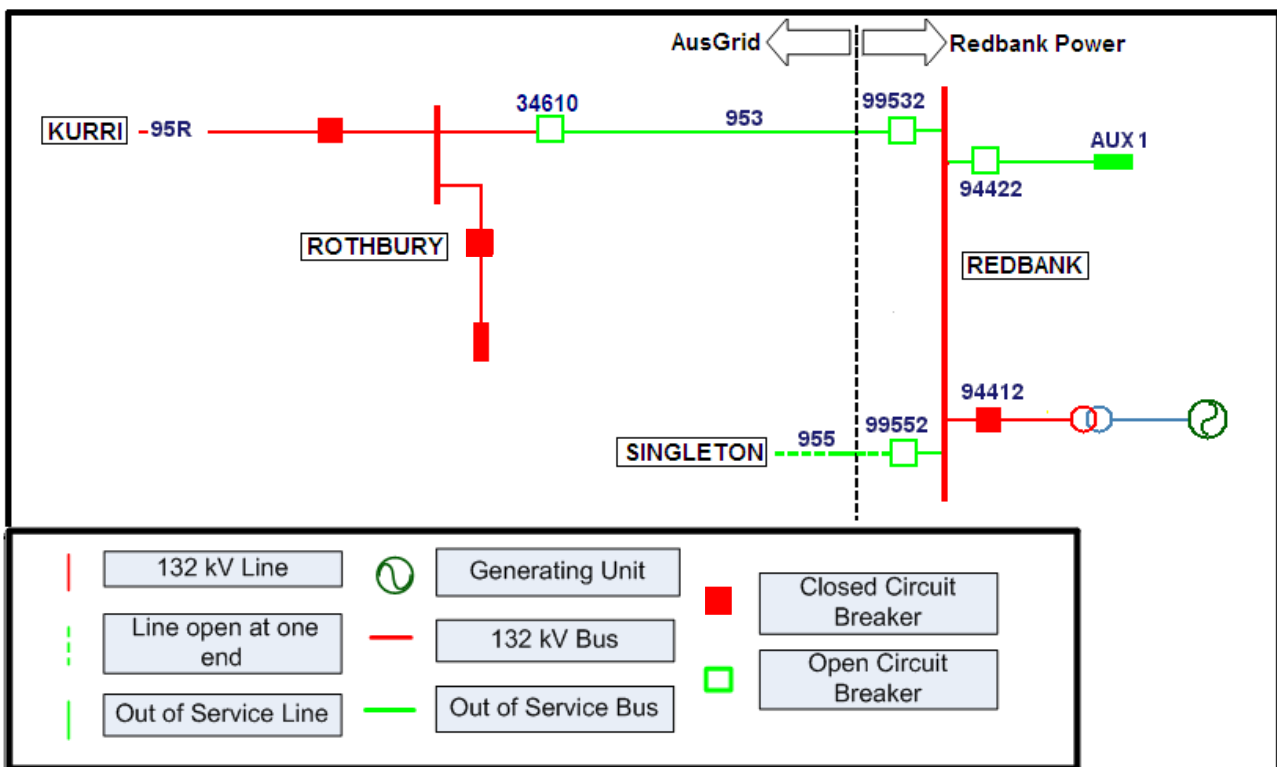
Figure 2 - Status of the power system immediately after the incident

At 1723 hrs on 25 April 2011, the Redbank generating unit protection system operated after detecting a fault in the generator excitation system. An excitation fault alarm was recorded at Redbank Power Station when the protection system operated. The operation of protections should have opened the generator transformer CB 94412 but this CB failed to open.

After 253 milliseconds, the CB failure protection operated as designed to trip the Redbank 132 kV busbar by opening CBs 99552, 94422, and 99532. As a consequence the following events took place:

- the Redbank generating unit tripped from 71 MW
- the auxiliary supplies to Redbank Power Station were interrupted
- the 955 Redbank—Singleton 132 kV line was off-loaded at Redbank
- the 953 Redbank—Rothbury 132 kV line was de-energised

A trip signal was also sent to generator transformer CB 94412 when CB failure protection operated but the CB failed to operate again.

Redbank Power will investigate the reason for failure of the generator transformer CB 94412 to operate on 25 April 2011 during the next scheduled outage of the generating unit. Redbank Power will inform the progress of this investigation to AEMO by the end of April 2012.
