POWER SYSTEM OPERATING INCIDENT REPORT

TRIP OF TORRENS ISLAND 'A' 275 KV WEST BUSBAR ON 20 MAY 2011

PREPARED BY: Electricity System Operations Planning and Performance

DATE: 2/09/2011

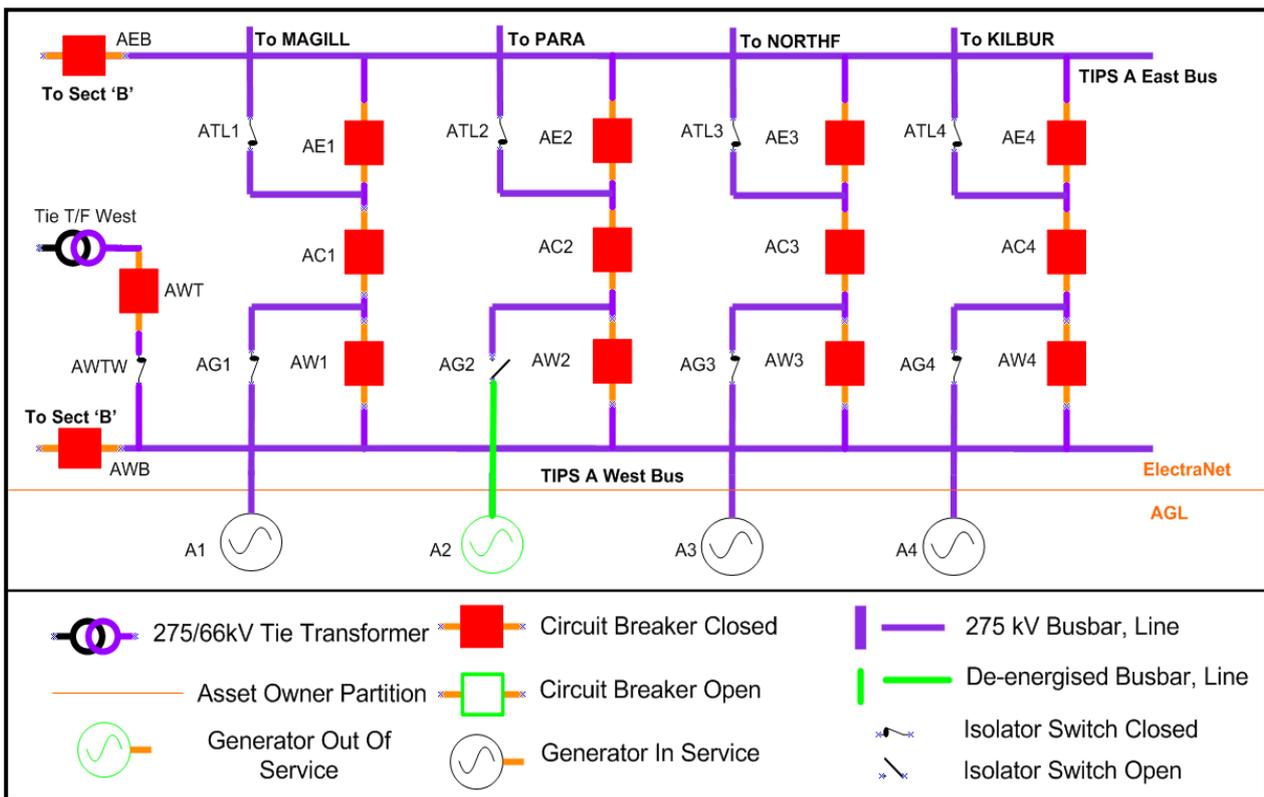
Figure 1 – Status of the power system prior to the incident

The status of the relevant power system equipment prior to the incident is shown in Figure 1. For clarity only equipment relevant to this incident has been included in the diagram.

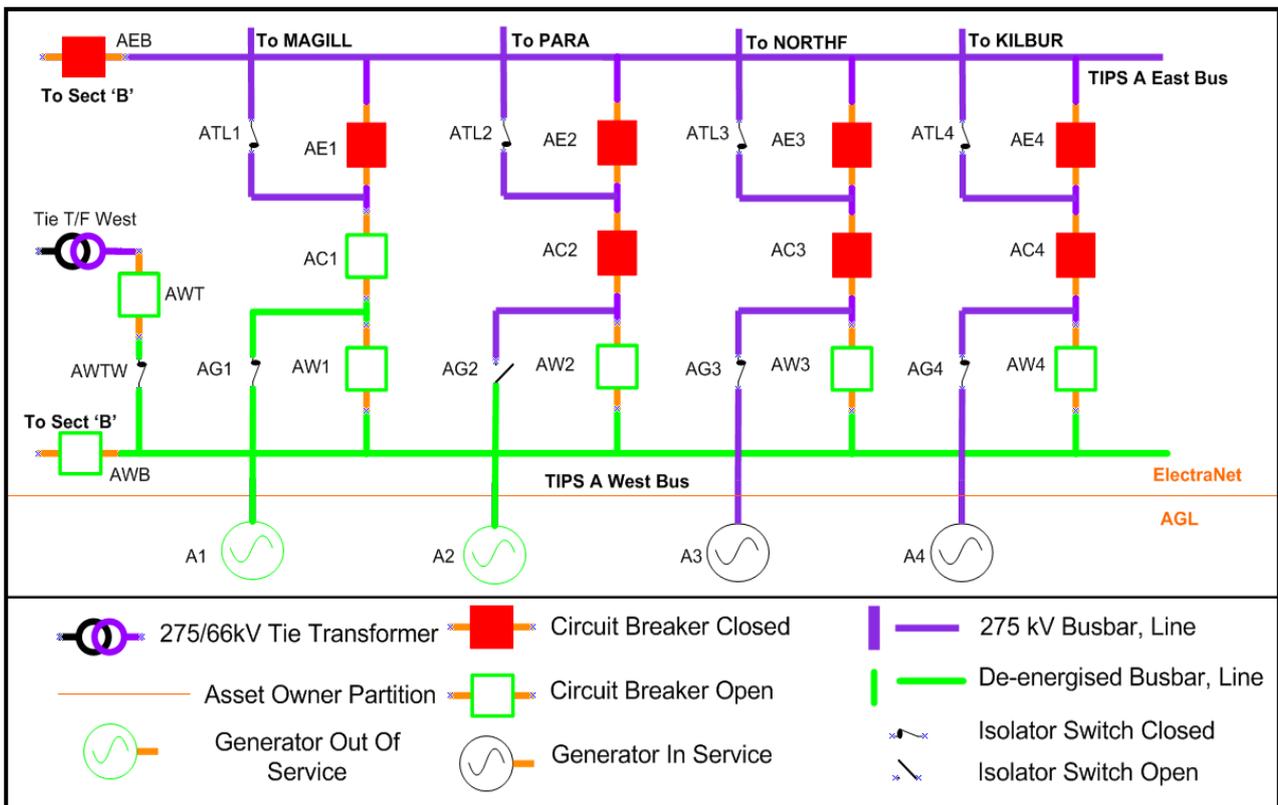
Figure 2 - Status of the power system immediately after the incident

A trip signals were sent to circuit breakers (CB) AW1 & AC1 as part of the normal shutdown sequence of the TIPS A1 generating unit. CB AC1 tripped immediately, but CB AW1 failed to open within the required time. After a time delay of 250 ms the circuit breaker fail protection operated to trip CBs AW1, AW2, AW3, AW4, AWT and AWB, disconnecting TIPS A 275 kV West busbar from the power system. The slow to open CB AW1 tripped when this protection operated.

The status of the power system immediately after the incident is shown in Figure 2.

The main cause of this incident was the failure of CB AW1 to open within the required time when it received a trip signal as a part of the planned shutdown of the TIPS A1 generating unit.

At 2202 hrs ElectraNet isolated the slow to open CB AW1. As CB AW1 remained out of service for maintenance AEMO assessed that there was no above normal risk of trip of the TIPS A 275 kV West busbar, and therefore did not reclassify the trip of that busbar as a credible contingency event.

- Carried out maintenance of CB AW1.
- Conducted timing and mechanical tests on CB AW1.
- Conducted trip checks on CB AW1.
