# POWER SYSTEM OPERATING INCIDENT REPORT

## TRIP OF NEWCASTLE 330 KV 'A' BUSBAR SECTION 1 ON 27 JULY 2011

DATE: 10 November 2011

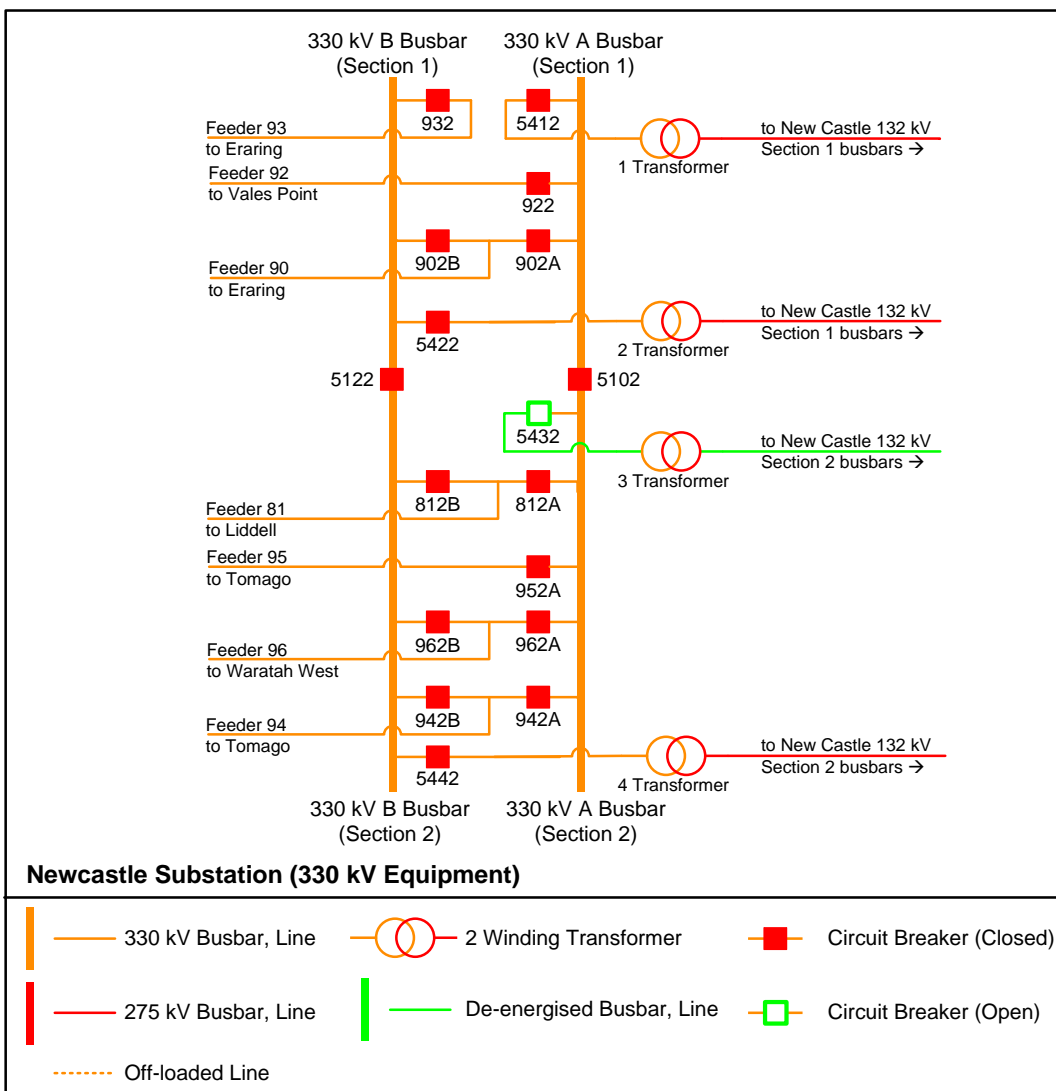
Prior to the incident, the No. 3 330/132 kV transformer was out of service for maintenance. The status of the power system prior to the incident is shown in **Error! Not a valid bookmark self-reference..** For clarity only equipment relevant to this incident has been included in the diagram.

Figure 1 – Status of the power system prior to the incident

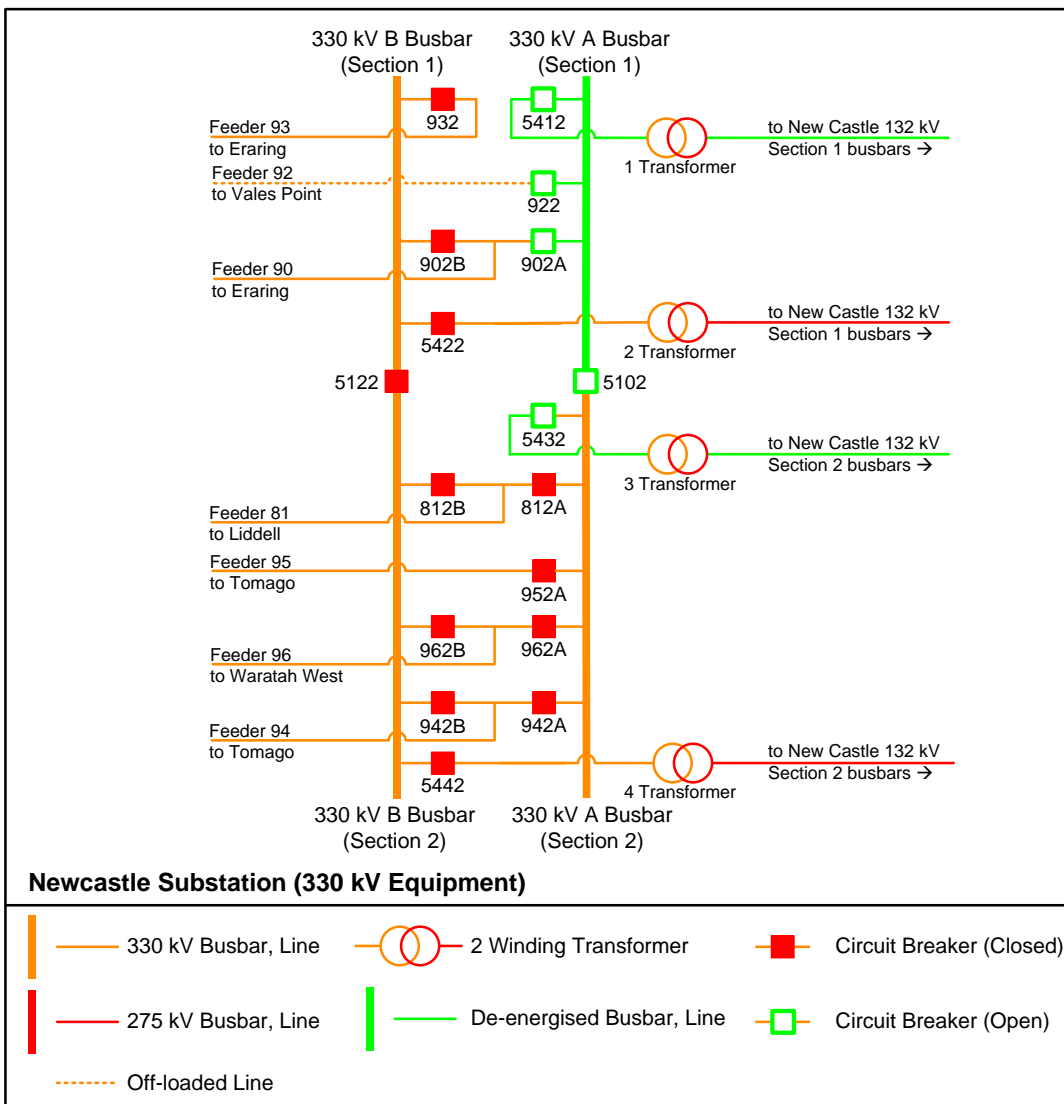
At 1043 hrs on 27 July 2011 the No. 1 330/132 kV transformer at Newcastle substation tripped on the operation of the transformer’s differential protection<sup>1</sup>. The operation of the differential protection was triggered by a fault on a current transformer secondary cable causing a current injection to the differential protection relay. This protection operation opened the circuit breakers directly connected to the No. 1 330/132 kV transformer. Because the fault on the current transformer cabling continued to inject current to the differential protection system after a signal had been given to open the circuit breaker, the circuit breaker fail protection<sup>2</sup> correctly operated to trip the 330 kV ‘A’ busbar section 1. This operation also off-loaded the 92 line because it is single switched to the busbar. The 92 line remained energised from Vales Point.

The status of the Newcastle 330 kV equipment immediately after the incident is shown in Figure 2.

Figure 2 - Status of the power system immediately after the incident

Investigations by TransGrid determined that the cause of the incident was a fault on a current transformer secondary cable associated with the differential protection of the transformer. This fault triggered the operation of the differential protection which tripped the transformer. Because the fault current injection continued to the differential protection, the circuit breaker fail protection operated to trip the busbar and off-load the 92 line. The faulted element was replaced, the protection was tested and the transformer was returned to service at 1808 hrs on 28 July 2011.
