POWER SYSTEM OPERATING INCIDENT REPORT – TRIP OF BALLARAT–BENDIGO 220 KV LINE AND WAUBRA WIND FARM ON 29 NOVEMBER 2011

PREPARED BY: Electricity System Operations Planning and Performance

DATE: 19 March 2012

FINAL

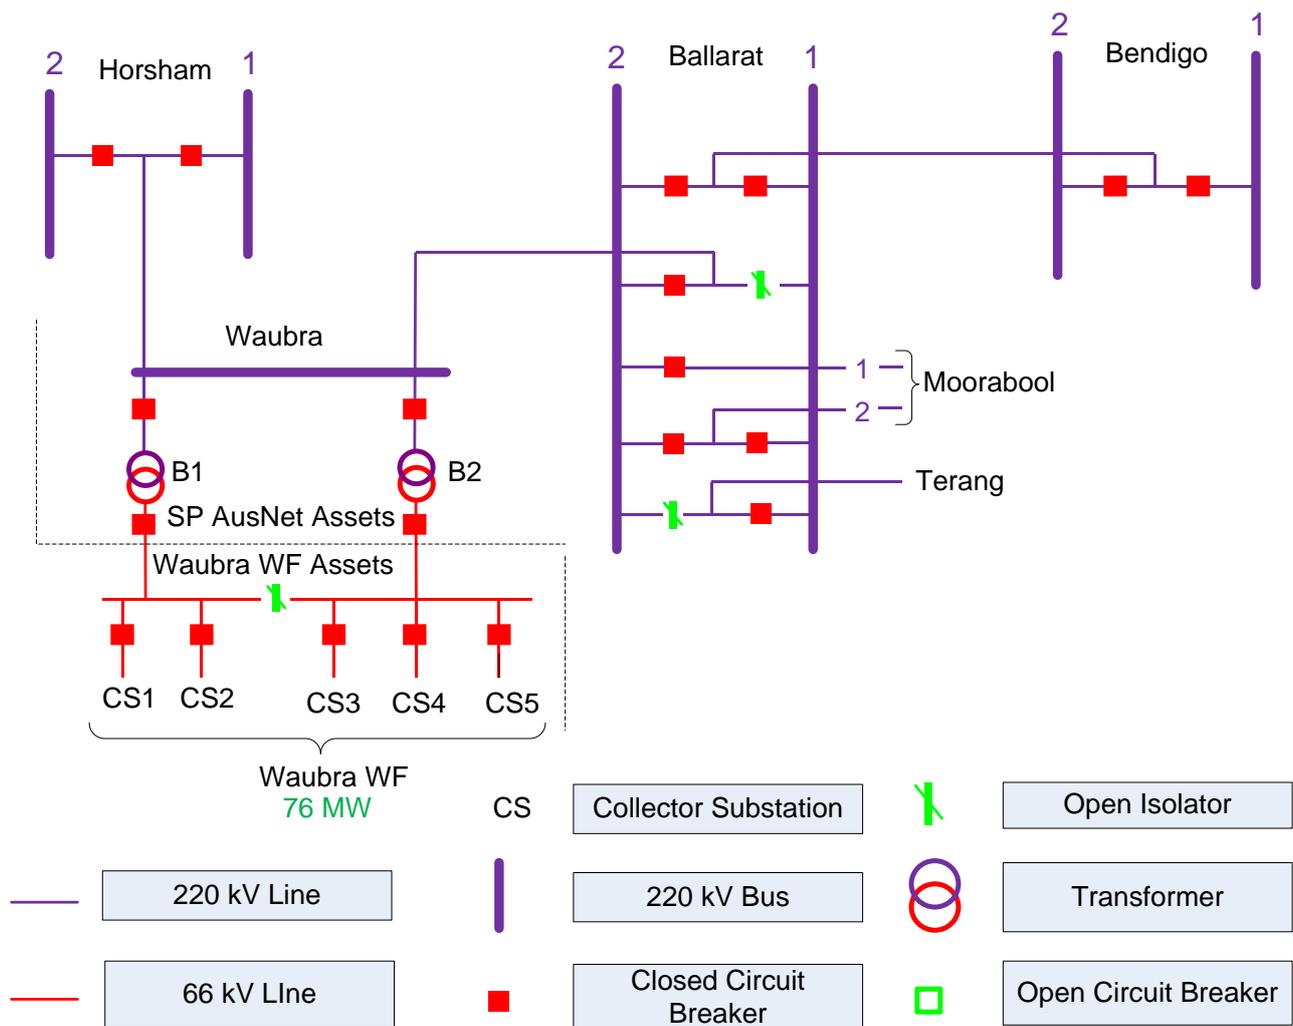
Figure 1 - Status of Waubra, Ballarat and Bendigo prior to the incident

The status of the power system prior to the incident is shown in Figure 1. For clarity only equipment relevant to this incident has been included in the diagram.

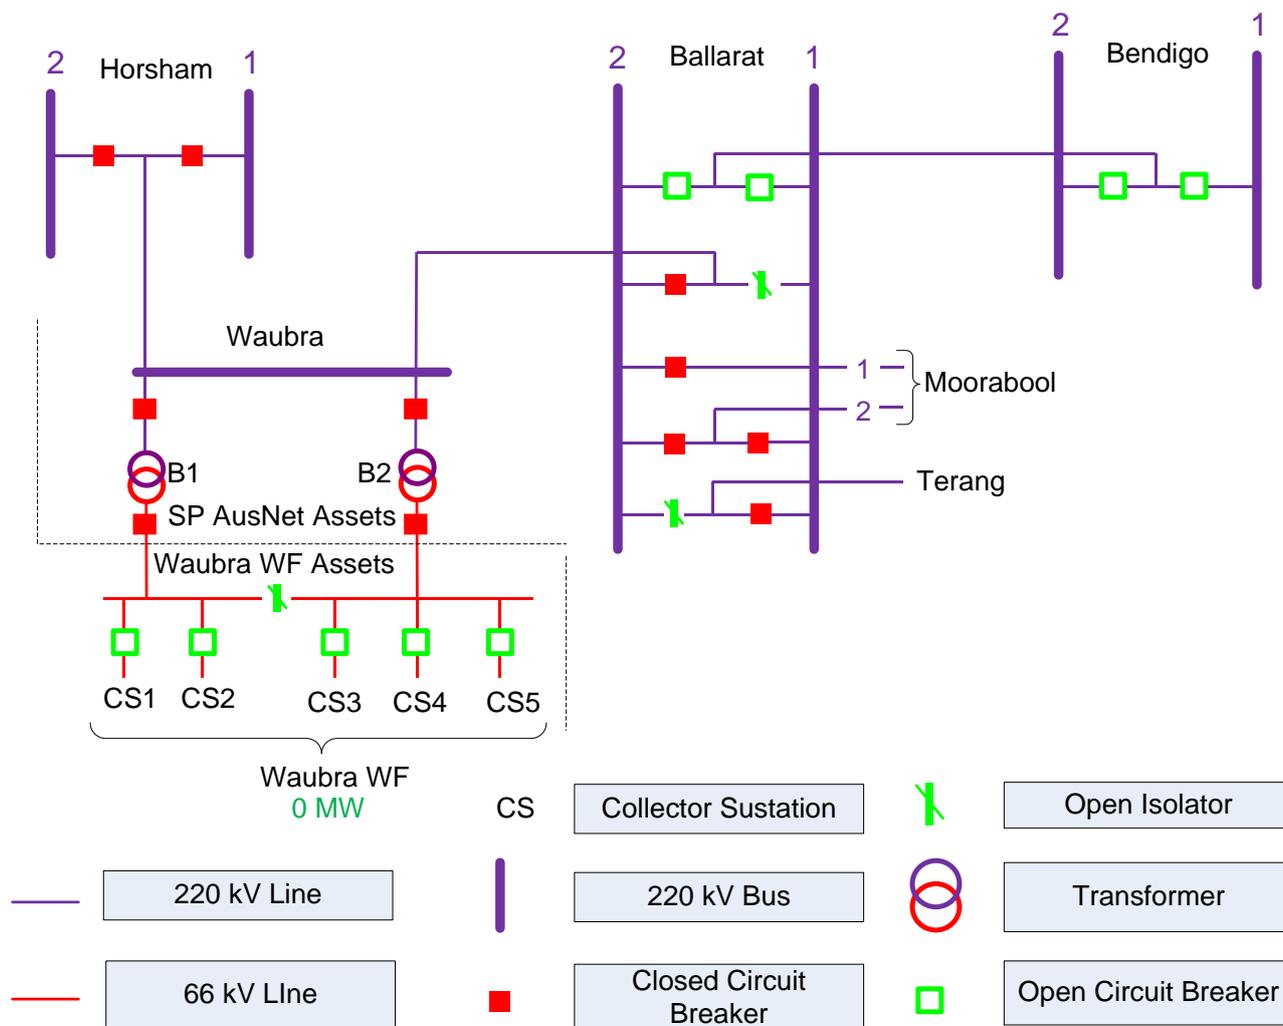
Figure 2 - Status of Waubra, Ballarat and Bendigo immediately after the incident

At 2140 hrs on 29 November 2011, the Ballarat–Bendigo 220 kV transmission line and Waubra WF tripped. Auto-reclose of the line was expected by the design but auto-reclose did not work. Heavy rain and lightning were reported in the Ballarat area at the time of this incident.

The status of the power system immediately after the incident is shown in Figure 2.
