POWER SYSTEM OPERATING INCIDENT REPORT – TRIP OF 132 KV BUSBAR AT WATERLOO ON 17 DECEMBER 2011

PREPARED BY: Electricity System Operations Planning and Performance

DATE: 11 April 2012

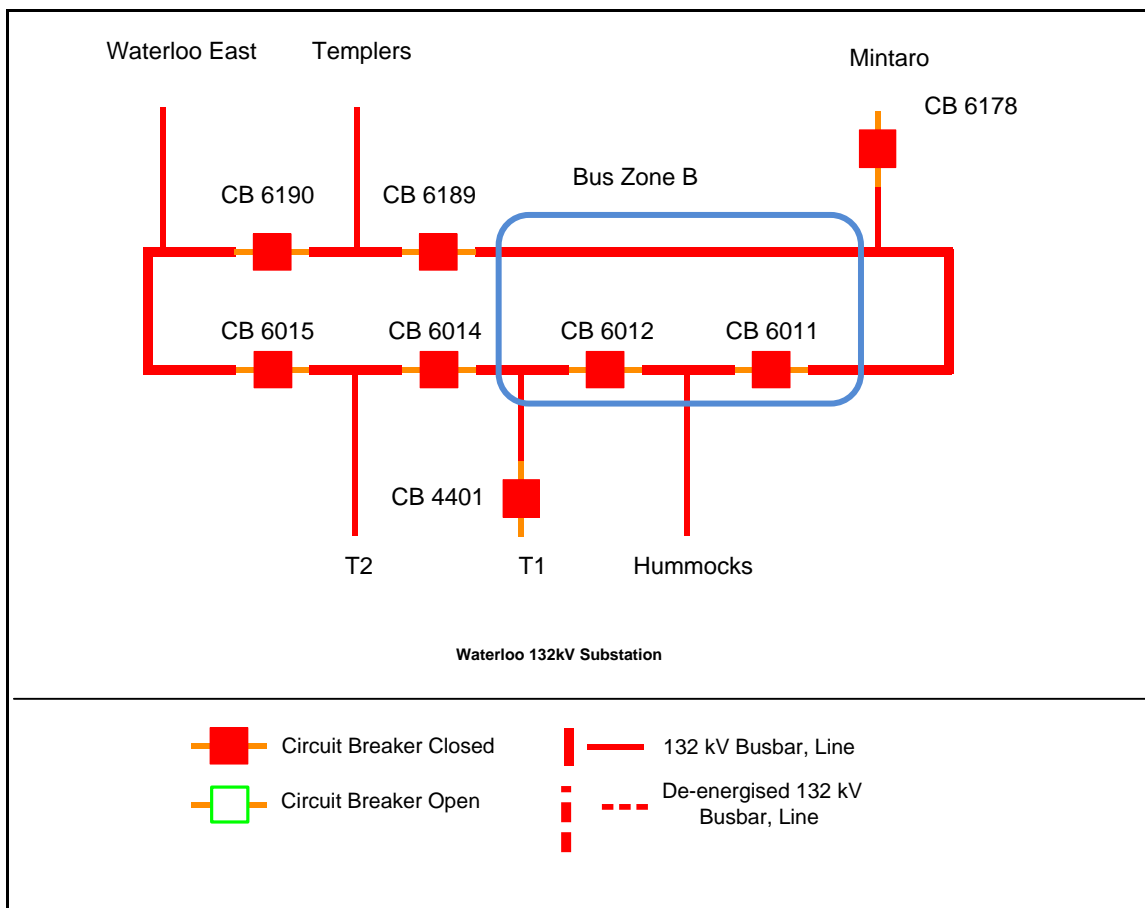
Figure 1 - Status of the power system prior to the incident

Prior to the incident, a lightning strike caused the Bungama – Hummocks – Snowtown 132kV line to trip and this line remained out of service. This prior incident removed generation from Snowtown and Wattle Point wind farms.

The status of the power system prior to the incident is shown in Figure 1. For clarity, only equipment relevant to this incident has been included in the diagram.

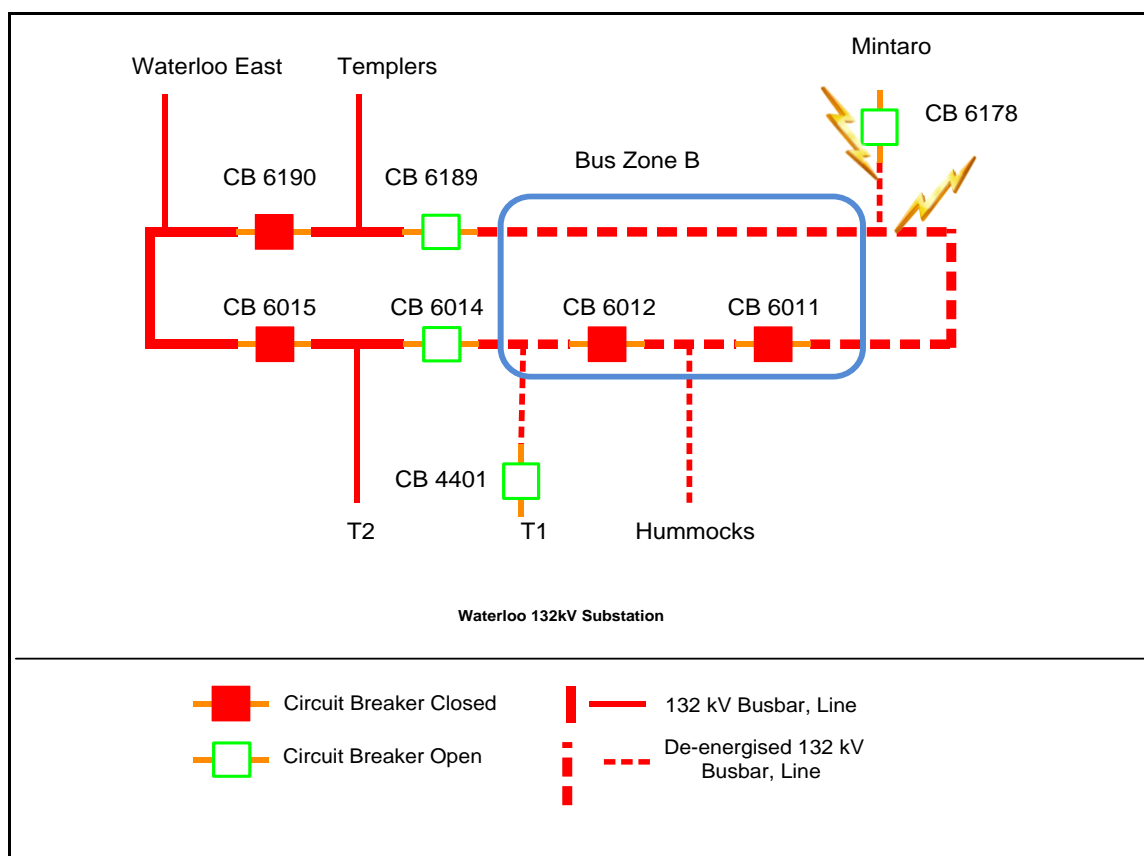
Figure 2 - Status of the power system immediately after the incident

The status of the power system immediately after the incident is shown in Figure 2.

As a consequence of the line fault, the Mintaro – Waterloo line was offloaded at Mintaro. The operation of the Bus Zone B protection scheme resulted in the loss of approximately 19 MW of load from Hummocks (Ardrossan West, Kadina East and Hummocks T1 load).
