POWER SYSTEM OPERATING INCIDENT REPORT - TORRENS ISLAND B POWER STATION ON 12 DECEMBER 2012

PREPARED BY: System Performance & Commercial

DATE: 14 February 2013

FINAL

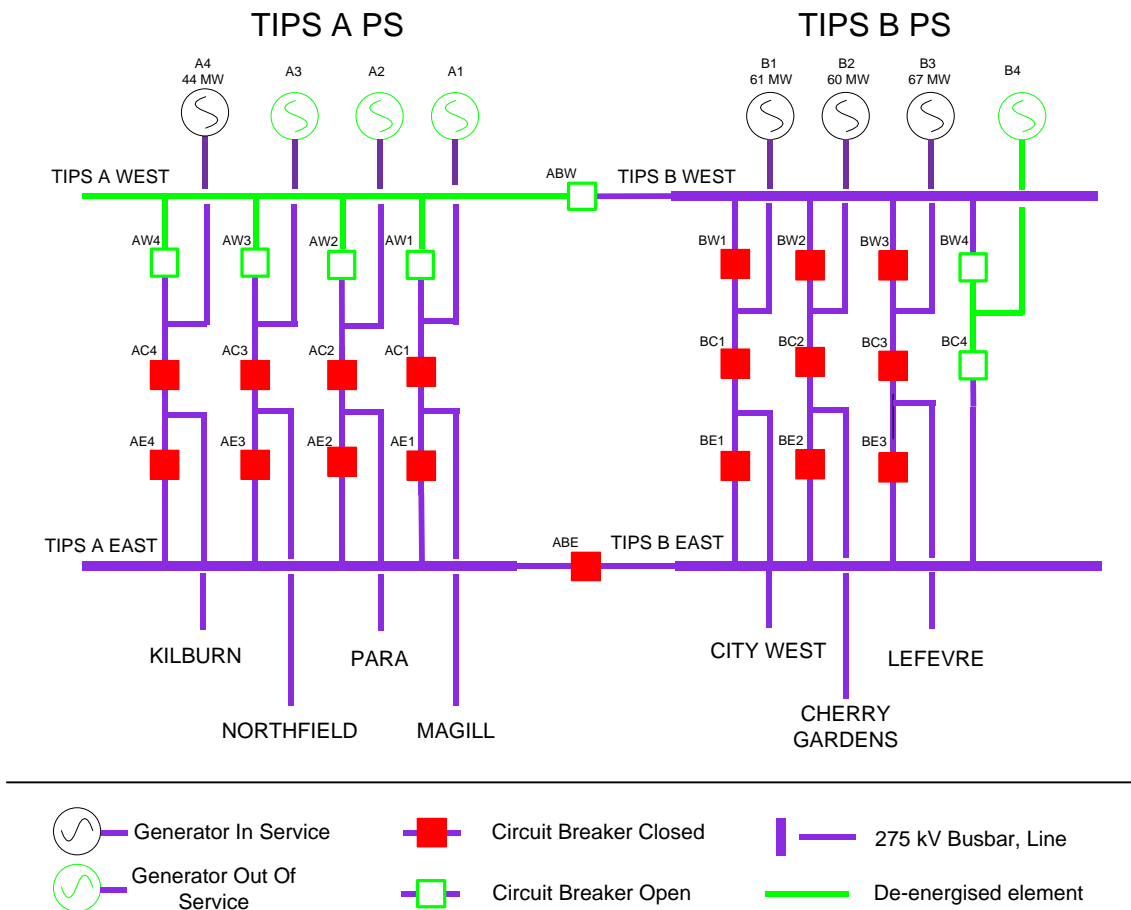
Figure 1 - Status of the power system prior to the incident, 06:25 hrs 12 December 2012.

The status of the power system prior to the incident is shown in Figure 1. The West 275 kV busbar at Torrens Island A Power Station was out of service for planned work. For clarity only equipment relevant to this incident has been included in the diagram.

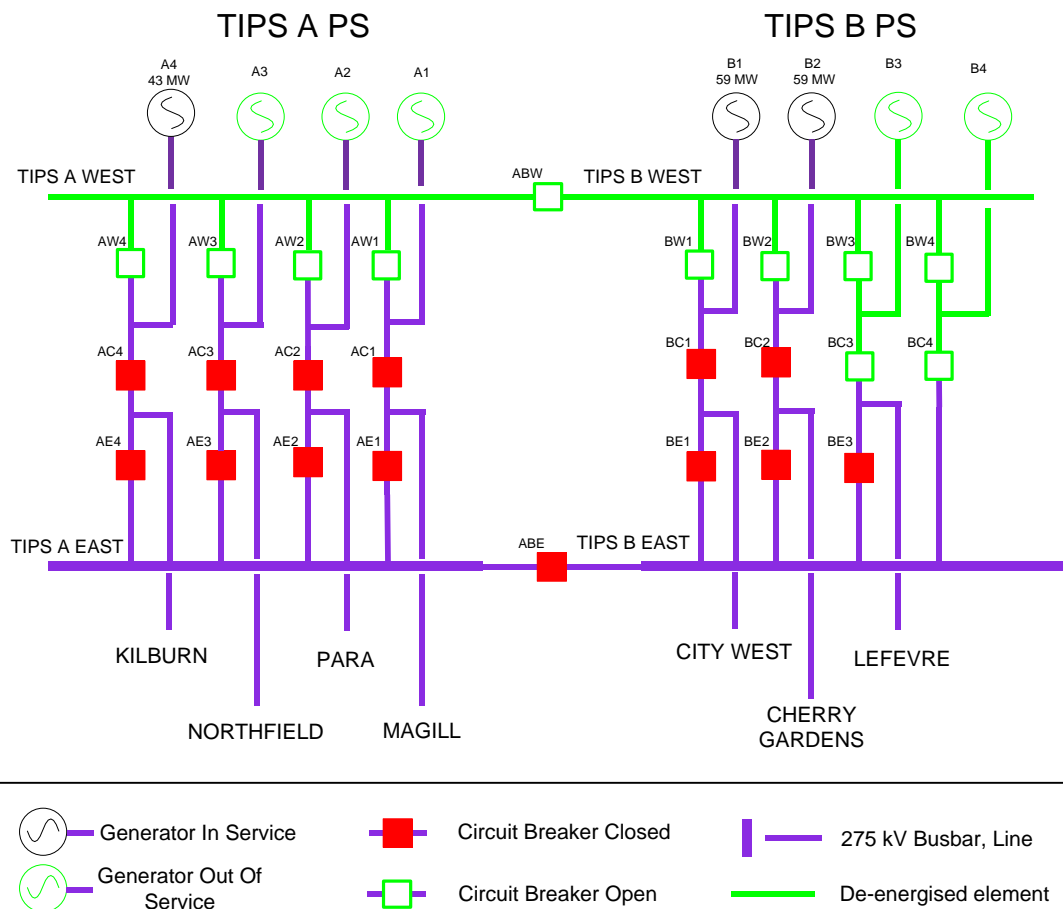
Figure 2 - Status of the power system immediately after the incident – at 06:35 hrs 12 December 2012.

At 06:27 hrs 12 December 2012, Torrens Island unit B3 and West 275 kV busbar at Torrens Island B Power Station tripped out of service, on the operation of open pole flashover protection for 275 kV CB BW3 at Torrens Island B Power Station. A generation reduction of 67 MW occurred on the trip of Torrens Island unit B3.

The status of the power system immediately after the incident is shown in Figure 2.

The incident at 06:27 hrs 12 December 2012 was due to an incorrect indication from an auxiliary switch on 275 kV CB BW3 at Torrens Island B Power Station, which caused operation of open pole flashover protection.

Subsequently on 12 December 2012, the faulty auxiliary switch on 275 kV CB BW3 at Torrens Island B Power Station was replaced. The 275 kV CB BW3 at Torrens Island B Power Station returned to service 13 December 2012.
