Power System Operating Incident Report – Trip of Ringwood-Rowville 220 kV Transmission Line and Multiple Generators on 29 September 2013

PREPARED BY: AEMO Systems Capability

DATE: 27 December 2013

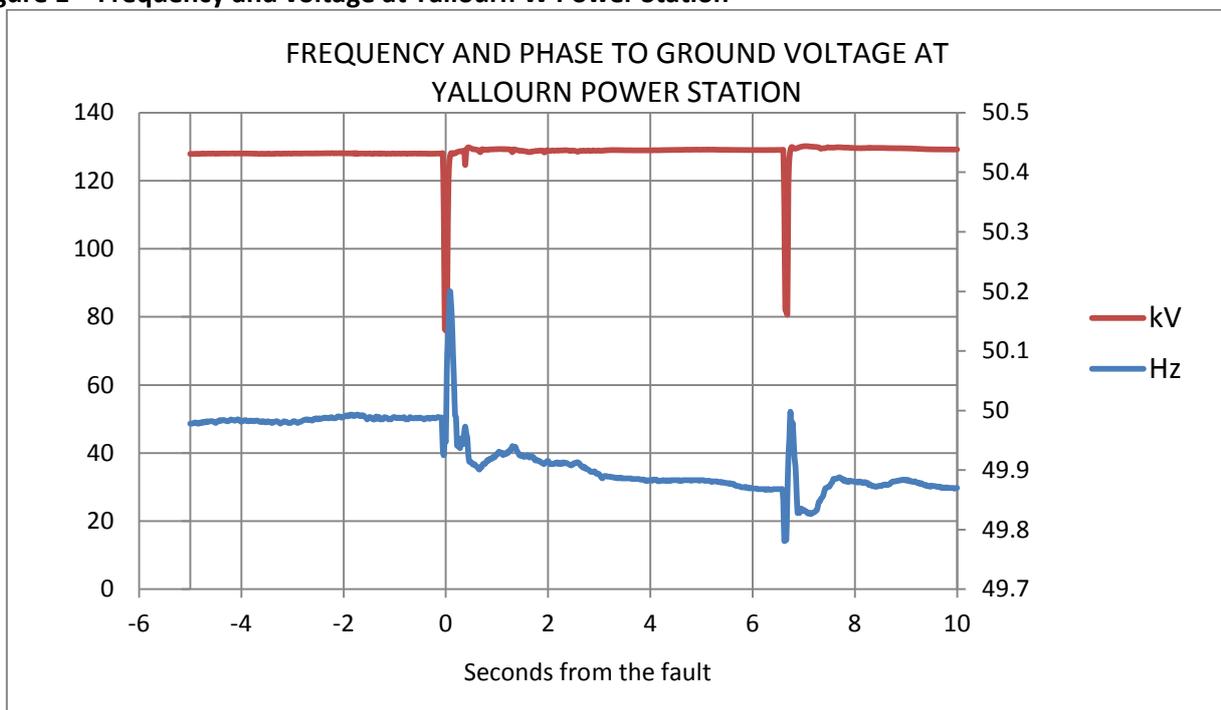
Figure 1 – Frequency and voltage at Yallourn W Power Station

Figure 1 shows the voltage and frequency disturbances caused by the two faults - measured on the 220 kV system at Yallourn Power Station. The graph shows frequency (blue) and average phase to ground voltage (red). The voltage fell to a low of 76.4 kV_{Ph-G} for the first fault and to 81.56 kV_{Ph-G} for the second fault. The frequency remained within operational bands during the two events.

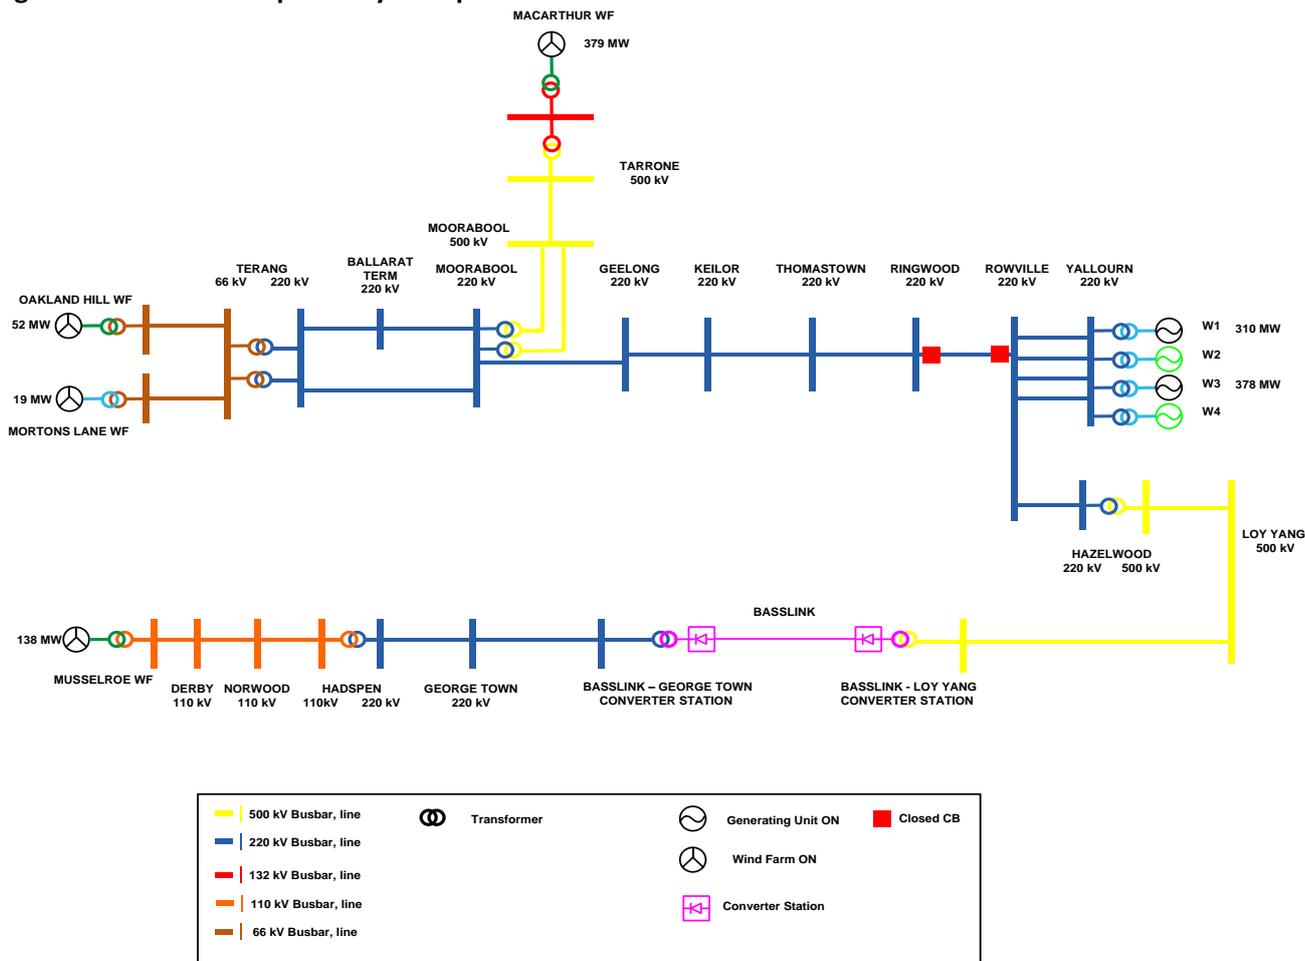
Figure 2 - Status of the power system prior to the incident

The status of the power system prior to the incident is shown in Figure 2. For clarity only equipment relevant to this incident has been included in the diagram. The diagram shows the interconnected sections of the Victoria and Tasmania networks where the affected plant is located.

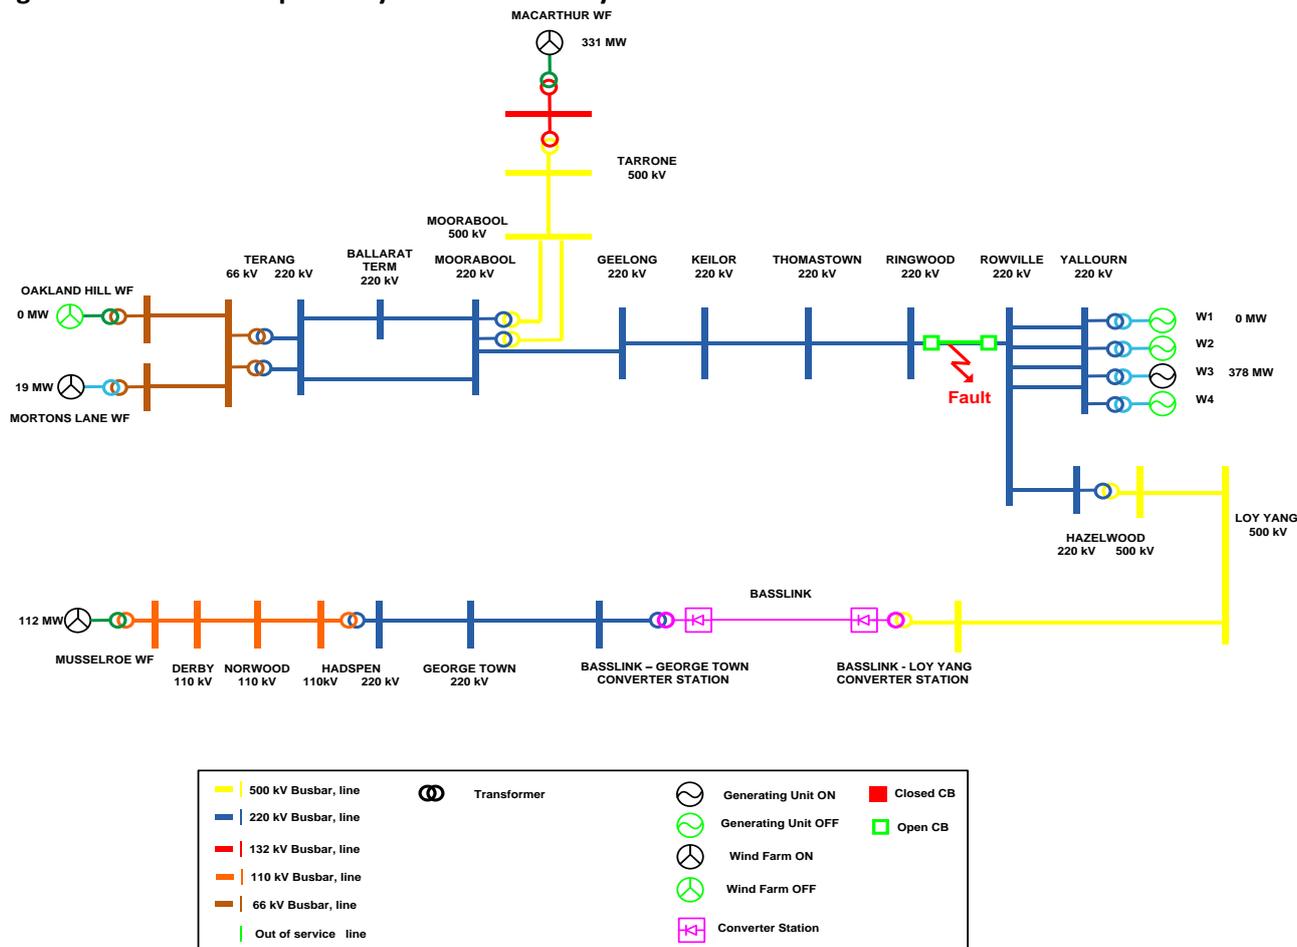
Figure 3 - Status of the power system immediately after the incident

The status of the power system immediately after the incident is shown in Figure 3. For clarity only equipment relevant to this incident has been included in the diagram. The diagram shows transmission line and generating units affected by the event.
