# Power System Operating Incident Report - Trip of Bayswater-Mt Piper 500 kV Transmission Line and Wallerawang Unit 7 on 13 October 2013

PREPARED BY: Systems Capability

DATE: 20 December 2013

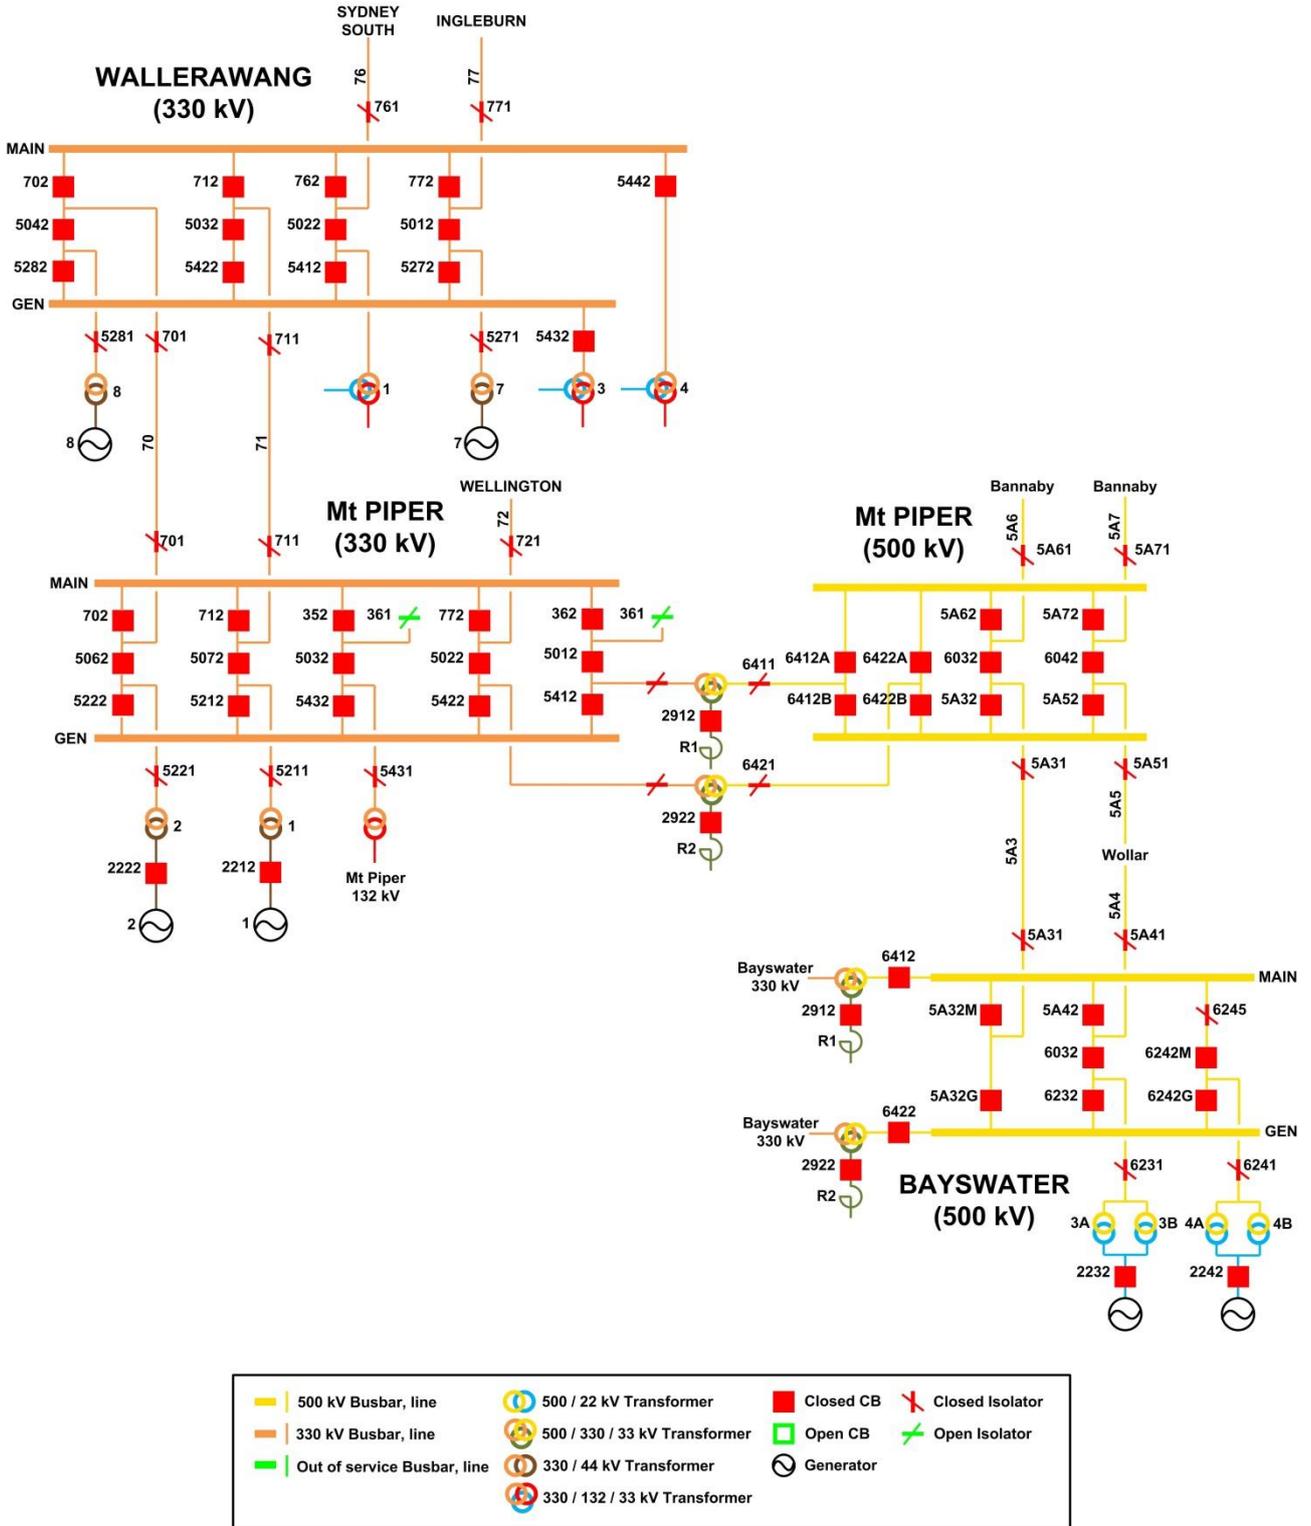
Figure 1 - Status of the power system prior to the incident

The status of the power system prior to the incident is shown in Figure 1. For clarity only equipment relevant to this incident has been included in the diagram. The diagram shows both the Bayswater - Mt Piper (5A3) 500 kV transmission line and Wallerawang Unit 7 in service.

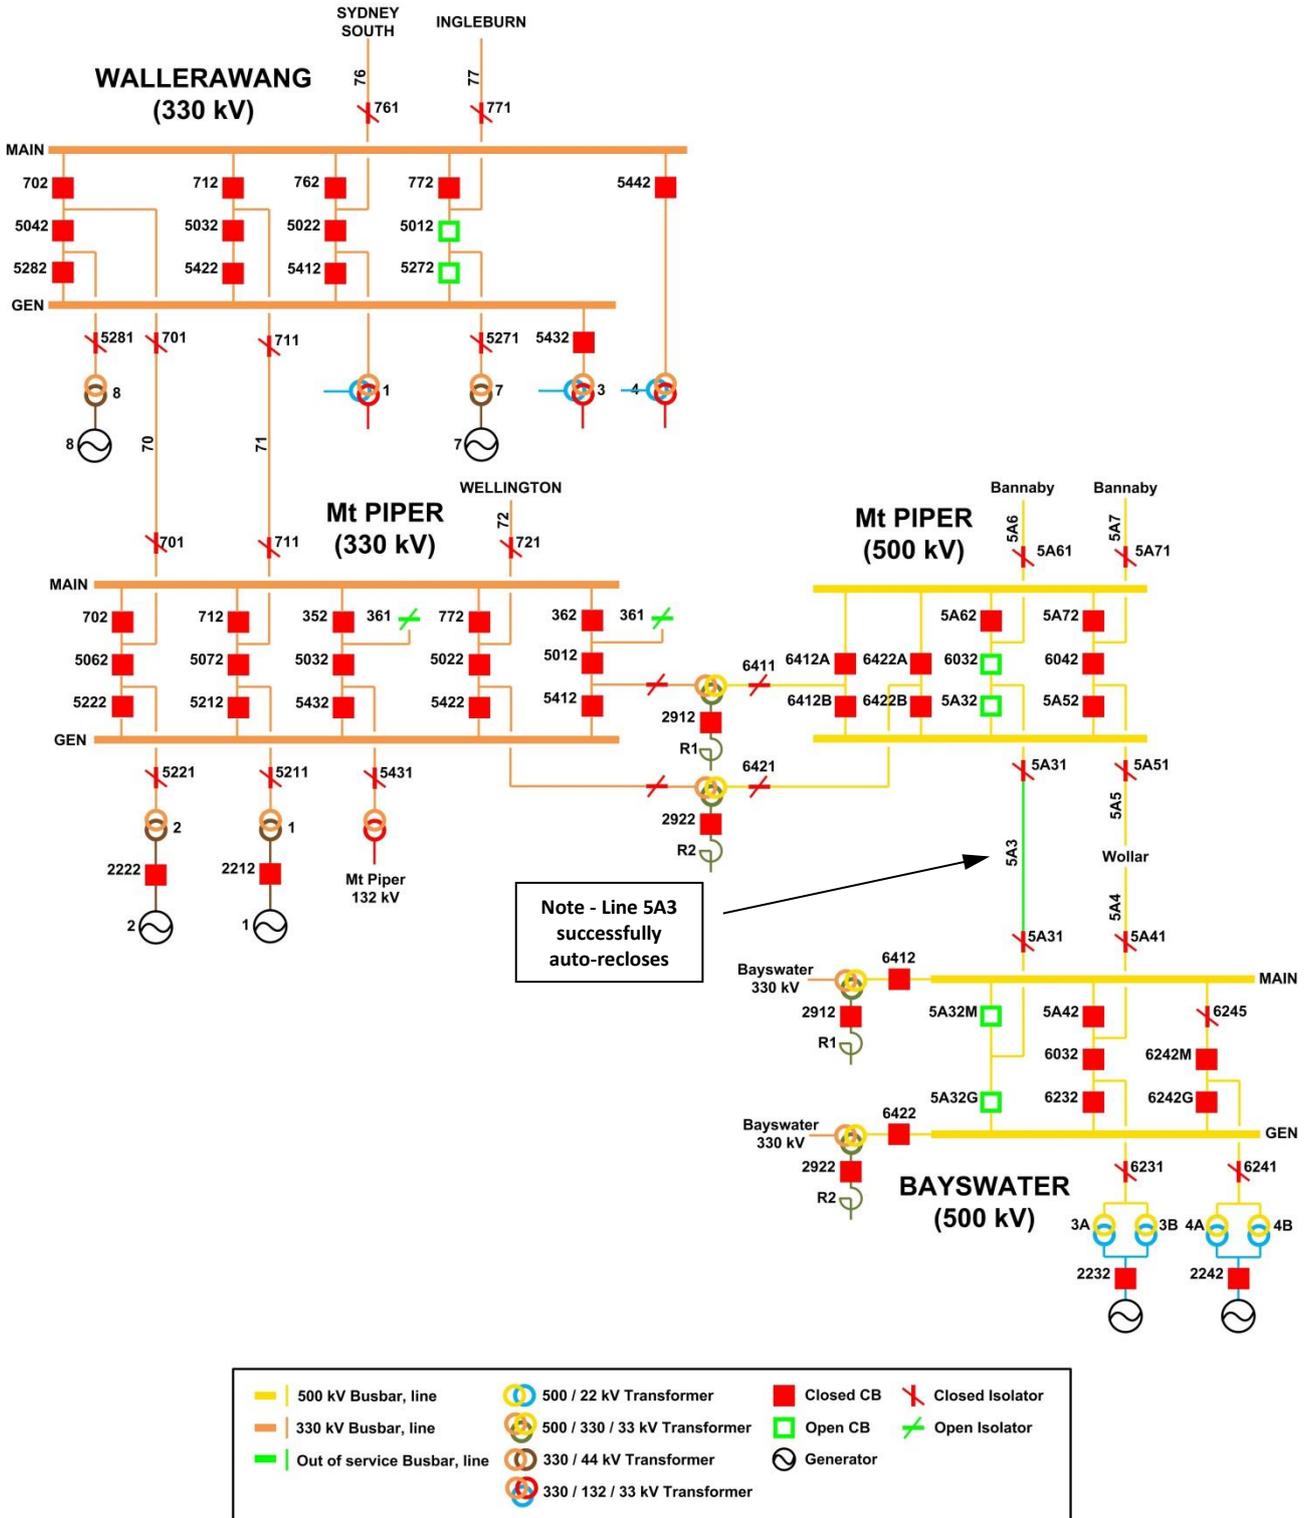
Figure 2 - Status of the power system after the incident

The status of the power system after the incident is shown in Figure 2. The diagram shows the tripped Bayswater to Mt Piper (5A3) 500 kV transmission line and Wallerawang Unit 7 out of service. The Bayswater to Mt Piper (5A3) 500 kV transmission line then successfully auto-reclosed.
