# Power System Operating Incident Report – Trip of Rowville-Thomastown 220 kV Transmission Line and Multiple Wind Farms on 13 October 2013

PREPARED BY: AEMO Systems Capability

DATE: 14 January 2014

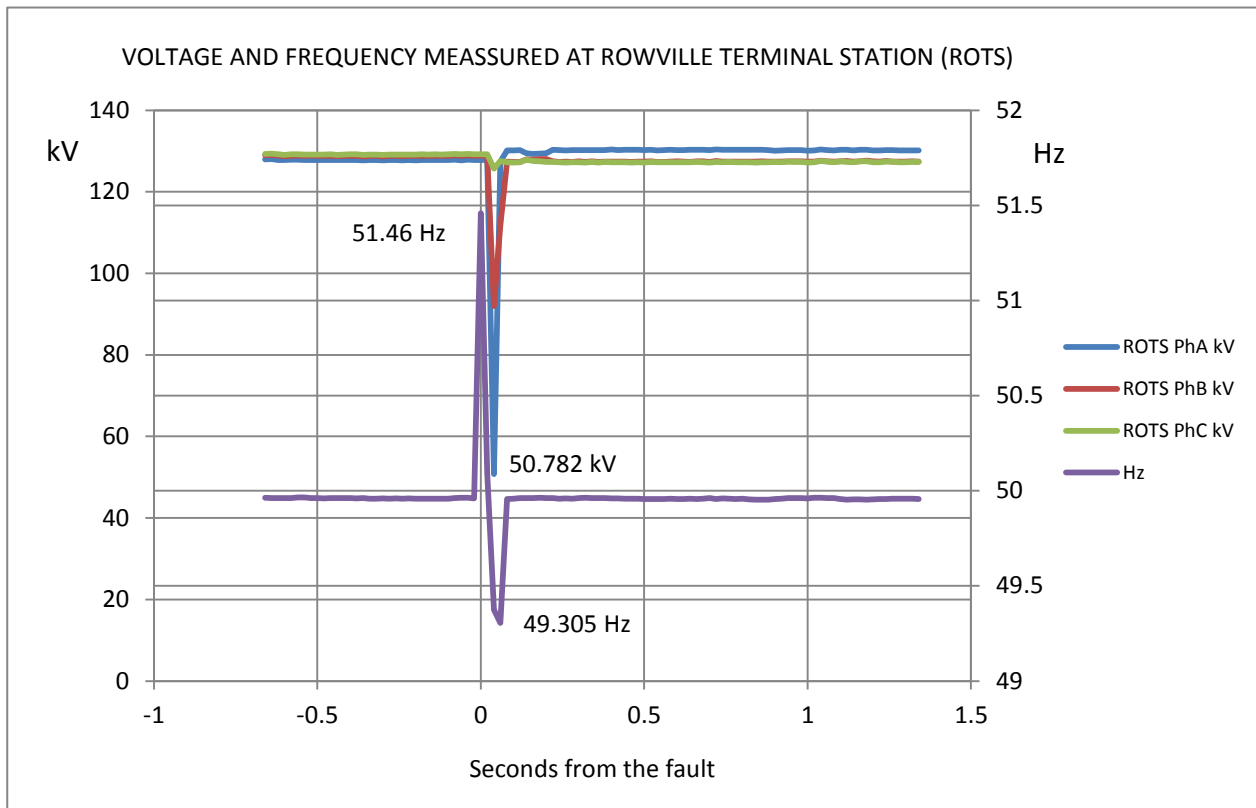
**Figure 1 – Frequency and Voltage at Rowville Terminal Station**

SP AusNet found that a lightning strike on the top of a wooden pole caused the Rowville – Thomastown 220 kV transmission line to trip. The fault was a single phase to earth which was cleared in 78 ms. Heavy rain was reported in the area at the time of this event.

Figure 1 shows the frequency and phase voltages at Rowville Terminal Station (ROTS) during the event.

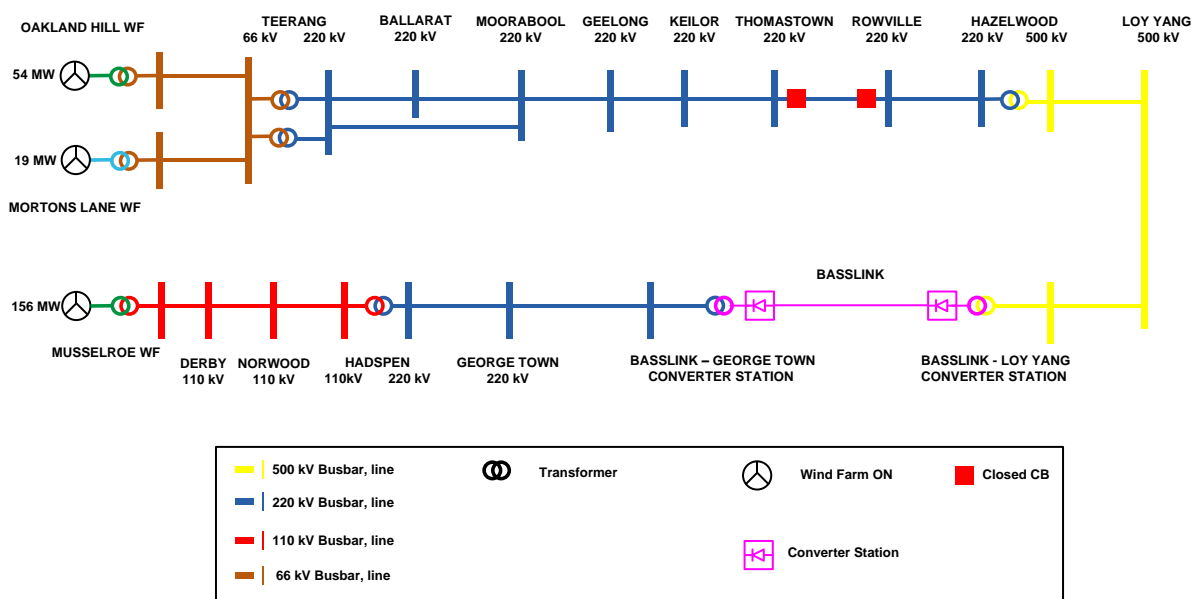
Figure 2 - Status of the power system before the incident

The status of the power system before the incident is shown in Figure 2 and after the incident in Figure 3. For clarity only equipment relevant to this incident has been included in the diagrams. The diagrams shows how the affected generators are linked via the Victoria and Tasmania networks, and the generating units affected by the event.
