POWER SYSTEM OPERATING INCIDENT REPORT – TRIPPING OF NOS.1 AND 2 110 KV BUSBARS AT NERANG ON 9 FEBRUARY 2013

PREPARED BY: Edwin Ong
DATE: 12 March 2013
FINAL

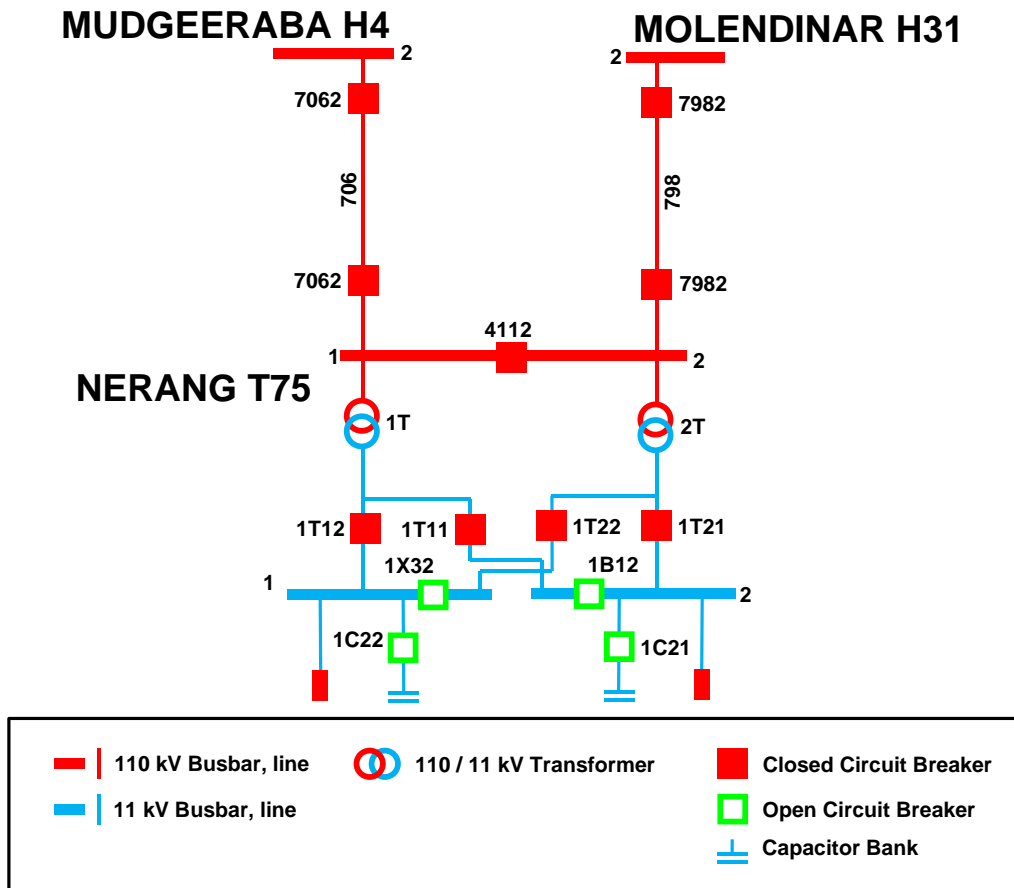
Figure 1 - Status of the power system prior to the incident

The status of the power system prior to the incident is shown in Figure 1. For clarity only equipment relevant to this incident has been included in the diagram.

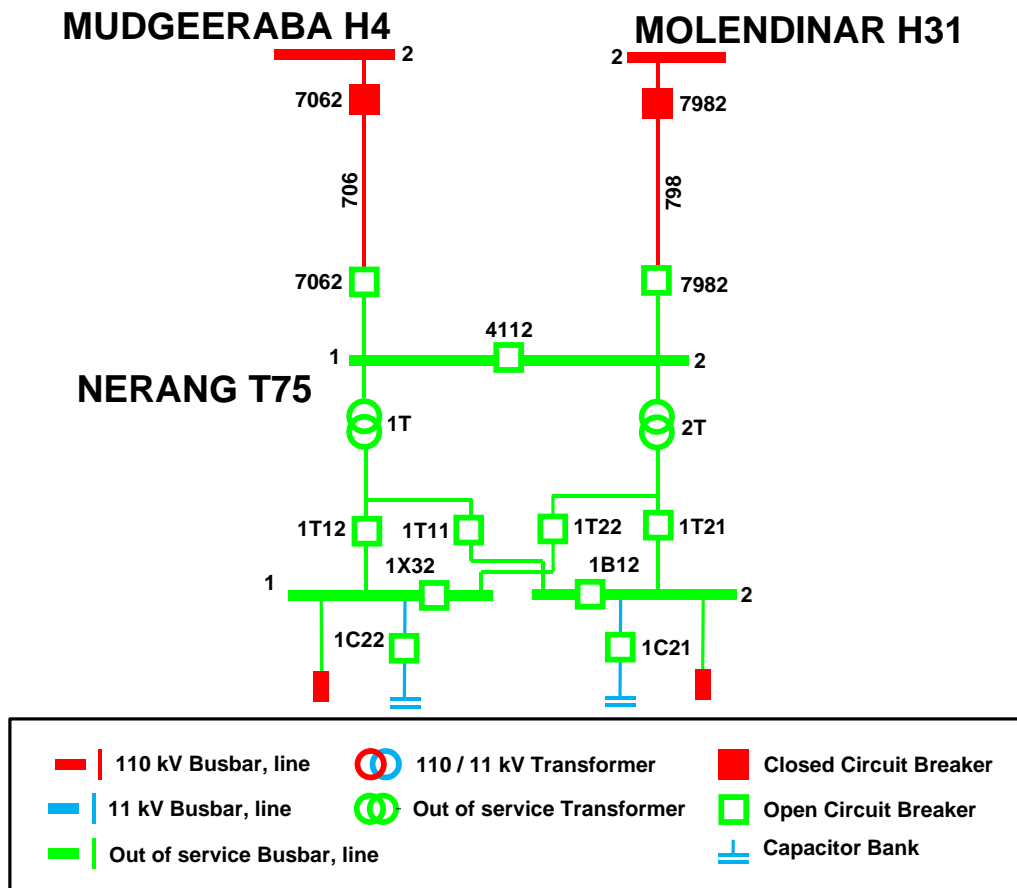
Figure 2 - Status of the power system immediately after the incident

On 9 February 2013, Energex staff were working on the 11 kV network at Nerang Substation. At 1213 hrs, the No.1 and No.2 110 kV busbars at Nerang Substation tripped when Energex attempted to parallel the 11 kV busbars at Nerang Substation. The 110 kV busbar trip was initiated because the neutral sensitive earth fault protection had not been isolated in accordance with procedures.

The status of the power system immediately after the incident is shown in Figure 2.

Energex reviewed its work procedures and determined that it was appropriate. Energex staff were reminded to adhere to work procedures when conducting work on the network.
