Trip of four 220 kV transmission lines at Mt Beauty on 24 November 2014

AN AEMO POWER SYSTEM OPERATING INCIDENT REPORT FOR THE NATIONAL ELECTRICITY MARKET

PUBLISHED MARCH 2015

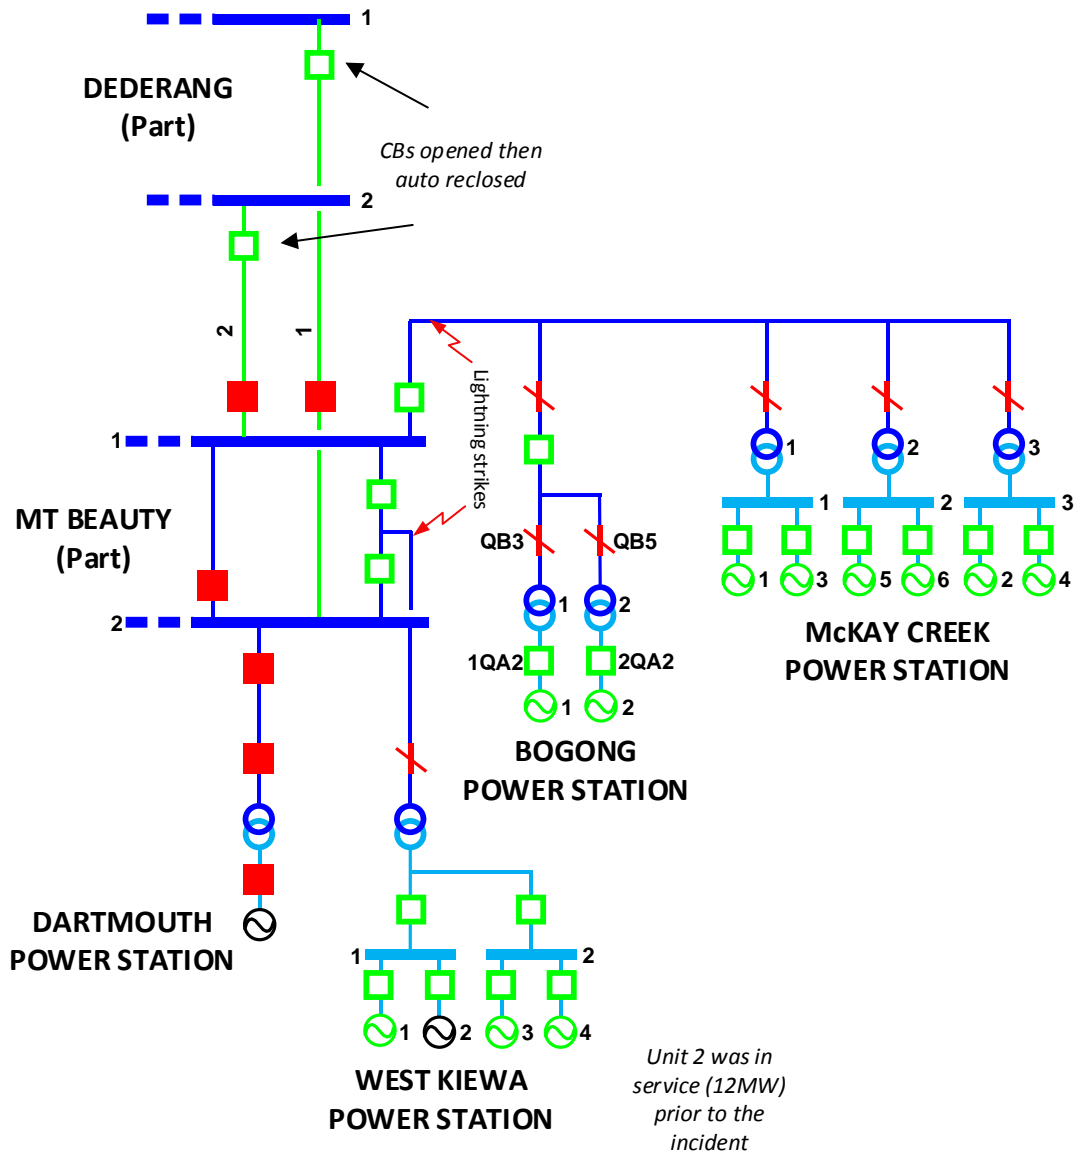
APPENDIX 1 – POWER SYSTEM DIAGRAM

- MBTS-Bogong and McKay Creek Power Stations (MBTS-BOPS/MKPS)
- MBTS-West-Kiewa Power Station (MBTS-WKPS)
- MBTS-Dederang Terminal Station No. 1 (MBTS-DDTS No.1 line)
- MBTS-Dederang Terminal Station No. 2 (MBTS-DDTS No.2 line)

The MBTS-DDTS No.1 and No.2 lines then auto reclosed and returned to service. The MBTS-BOPS/MKPS and MBTS-WKPS lines remained out of service and were returned to service, overnight and the following morning respectively, following line patrols. As a result of this incident 12MW of generation, at West Kiewa Power Station, was disconnected.

Diagram illustrating the incident
