Trip of Dederang-Mount Beauty No.1 and No.2 220 kV transmission lines on 13 Aug 2014

AN AEMO POWER SYSTEM OPERATING INCIDENT REPORT FOR THE
NATIONAL ELECTRICITY MARKET

PUBLISHED SEPTEMBER 2014

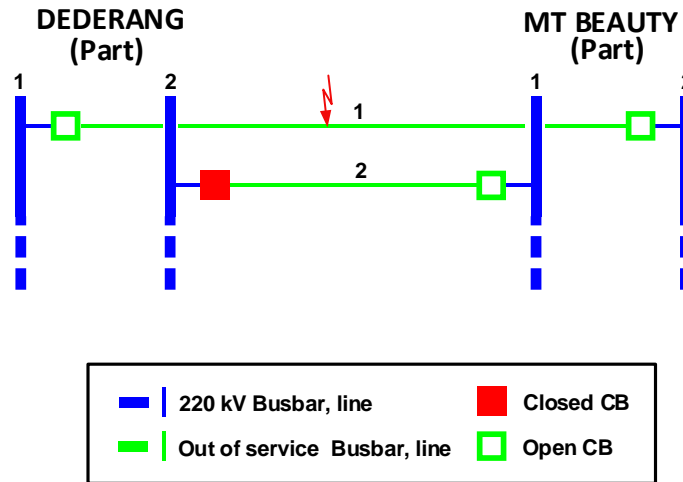
Power System Diagram

On Wednesday 13 August 2014, at 2014 hrs, the Dederang-Mount Beauty No.1 and No.2 transmission lines (No.1 Line and No.2 Line) simultaneously tripped. The No.1 Line tripped at both ends due to a transient single phase to earth fault, then auto-reclosed at both ends and returned to service. The No.2 Line tripped at the Mount Beauty end, as a result of the transient fault on No.1 Line, and then remained open at the Mount Beauty end.

No.2 Line tripped at the Mount Beauty end as a result of a Y directional earth fault (DEF) relay operation (X protection⁷ DEF did not operate). The relay operated due to a change in direction of fault current flow on No.2 Line when the No.1 Line circuit breaker opened at Mount Beauty.

The No.1 Line circuit breaker at Mount Beauty then opened, momentarily, before the No.1 Line circuit breaker at Dederang. This caused the fault current on No.2 Line to change direction and flow from Mount Beauty to Dederang. The Y DEF at Mount Beauty now correctly detected a forward fault current, however the signal from Dederang had not yet dropped off so the trip condition was fulfilled. The Y DEF at Mount Beauty operated to trip No.2 Line at Mount Beauty. This overlap of a forward fault current and the presence of the remote signal (which should have dropped off due to the fault current reversal at Dederang) was incorrect.

The power system immediately after the incident before No.1 Line auto reclosed
