**POWERLINK QUEENSLAND**

**NETWORK OPERATION SERVICES  
INCIDENT SUMMARY REPORT**

**NORTH QUEENSLAND  
POWER SYSTEM EVENTS ON  
21<sup>ST</sup> JANUARY 2015**

**DATE PREPARED**  
24th February 2015

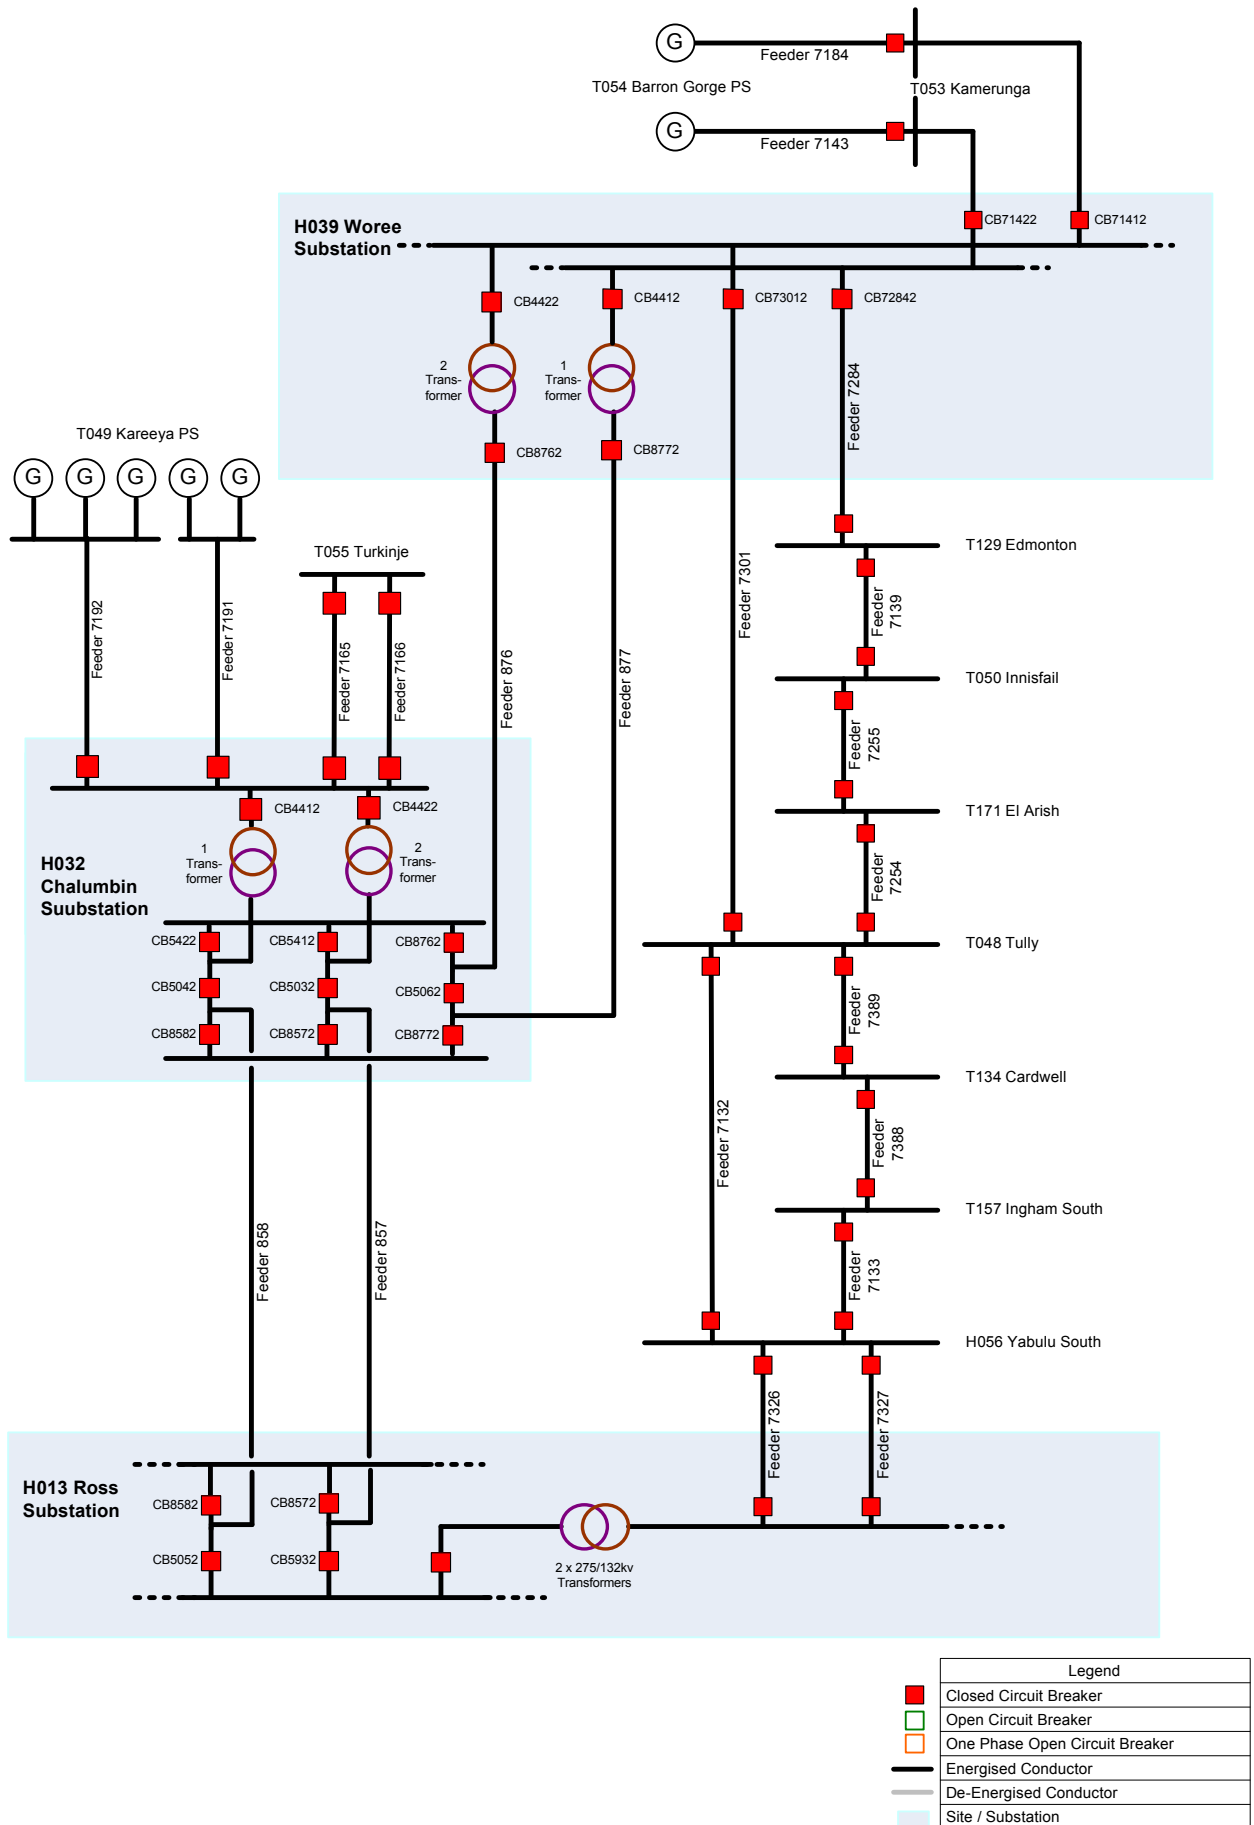
**Figure 1 - Single line diagram of relevant power system plant showing plant status prior to the event**

The single line diagram of relevant power system plant, equipment and circuit breakers is shown in Figure 1 below. For clarity, only plant and equipment that operated or provides connectivity between affected sites is shown in the line diagram.

Figure 1 also shows the status of applicable circuit breakers prior to the event.

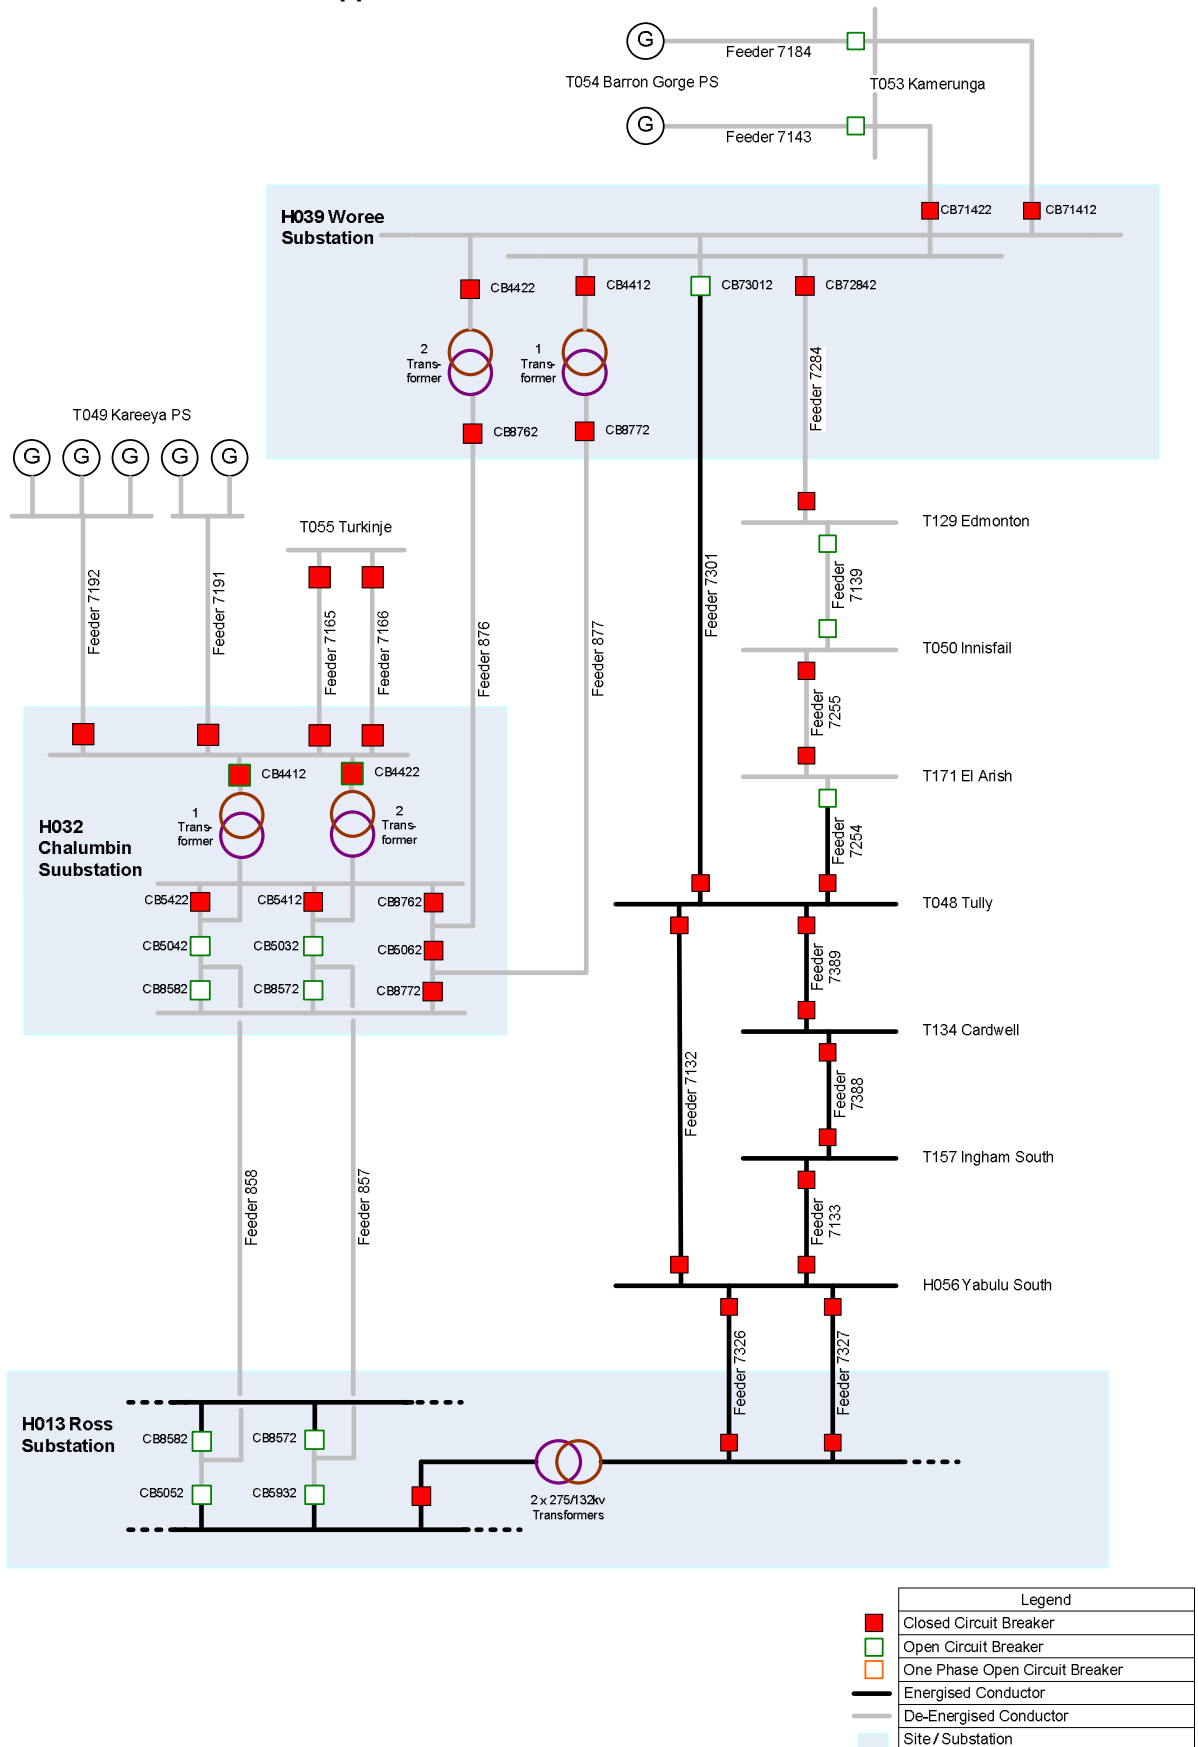
**Figure 2 - Single line diagram of relevant power system plant showing plant status immediately after all circuit breakers tripped**

Figure 2 below shows the status of relevant power system plant immediately after all circuit breakers tripped.

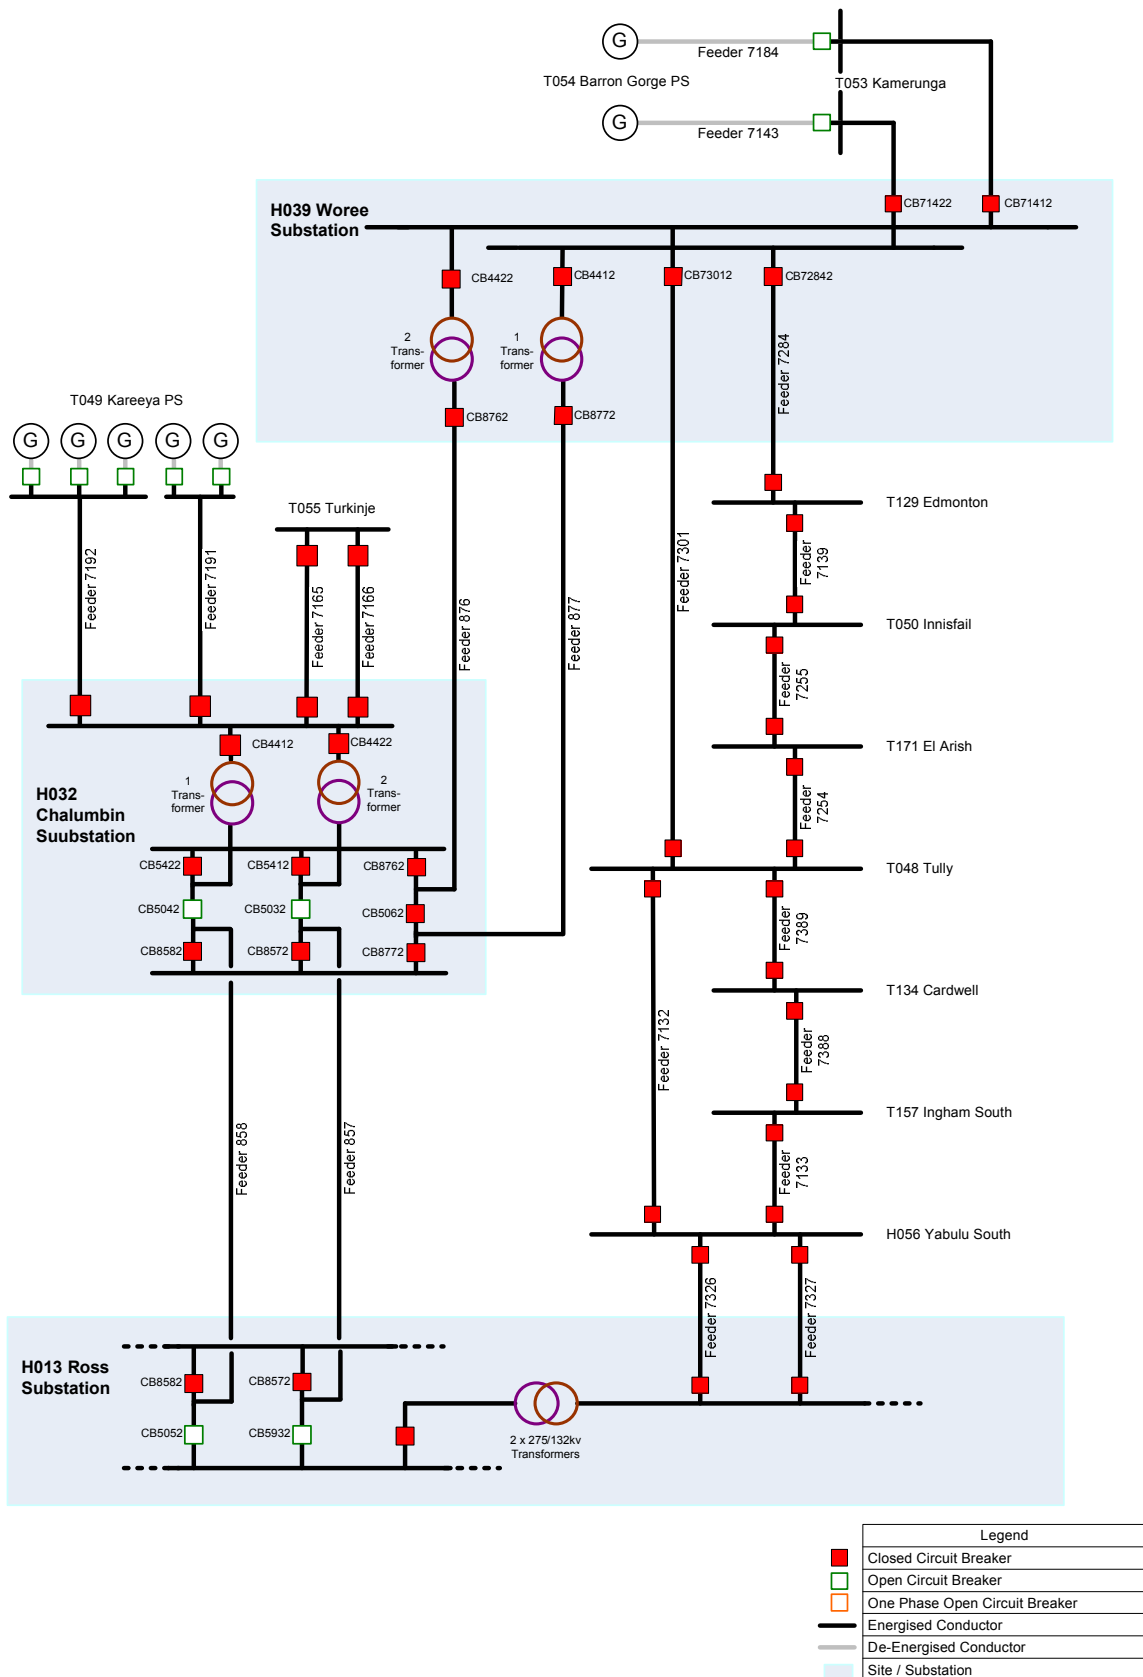
**Figure 3 - Single line diagram of relevant power system plant showing plant status after the autoreclose operations**

Figure 3 below shows the status of relevant power system plant after the autoreclose operations had occurred.
