TRIP OF HORSHAM-REDCLIFFS 220 KV TRANSMISSION LINE AND MURRAYLINK INTERCONNECTOR ON 12 NOVEMBER 2015

AN AEMO POWER SYSTEM OPERATING INCIDENT REPORT FOR
THE NATIONAL ELECTRICITY MARKET

Published: August 2016

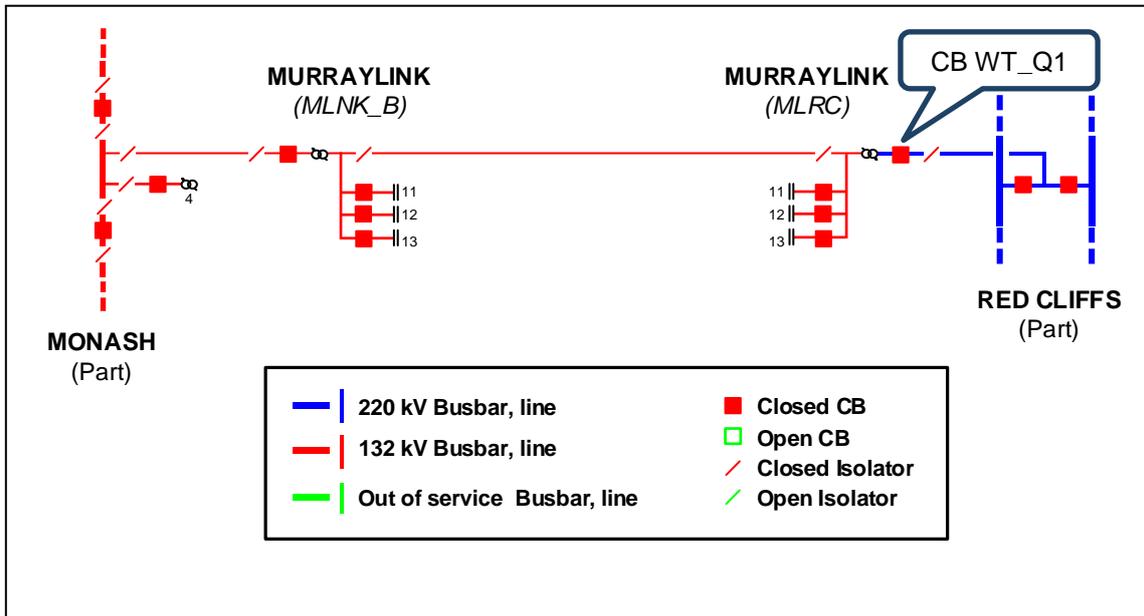
APPENDIX A. – MURRAYLINK INTERCONNECTOR

See Appendix A for a power system diagram illustrating the Murraylink interconnector.
