TRIP OF 330 KV A AND C BUSBARS AT CAPITAL SUBSTATION ON 3 MAY 2017 AND 28 JUNE 2017

REVIEWABLE OPERATING INCIDENT REPORT UNDER THE
NATIONAL ELECTRICITY RULES

Published: 1 September 2017

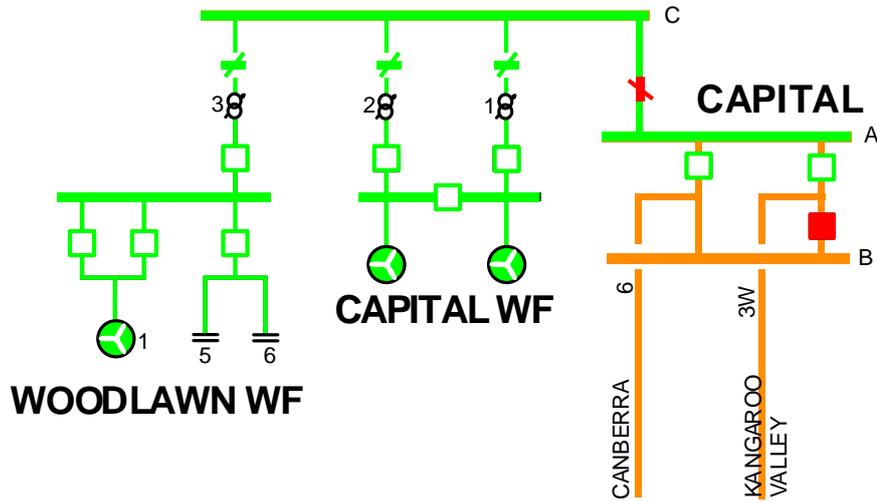
APPENDIX A. – POWER SYSTEM DIAGRAM

On Wednesday 3 May 2017 at 1214 hrs, maintenance on the tap changer of the No1 330/33 kV transformer at Capital Windfarm resulted in an intertrip signal being sent to trip the A and C busbars at Capital substation.

⁵ At Capital substation, there are no circuit breakers (CBs) on the 330 kV side of the transformers via which the wind farms connect to the network. See Appendix A for a diagram of the configuration of the network.

On Wednesday 28 June 2017 at 1810 hrs, the Woodlawn Wind Farm transformer was reinstated after maintenance. However, an active trip signal had not been properly reset prior to reinstatement and resulted in an intertrip signal being sent to trip the A and C busbars at Capital substation.

Capital Wind Farm tripped from 25 MW. The power system ended up in the same configuration as the incident on 3 May 2017, see Appendix A.

The power system immediately after the incident
