TRIP OF MUDGEERABA No.2 AND No.4 110 KV BUSBARS ON 24 OCTOBER 2017

REVIEWABLE OPERATING INCIDENT REPORT UNDER THE
NATIONAL ELECTRICITY RULES

Published: **13 February 2018**

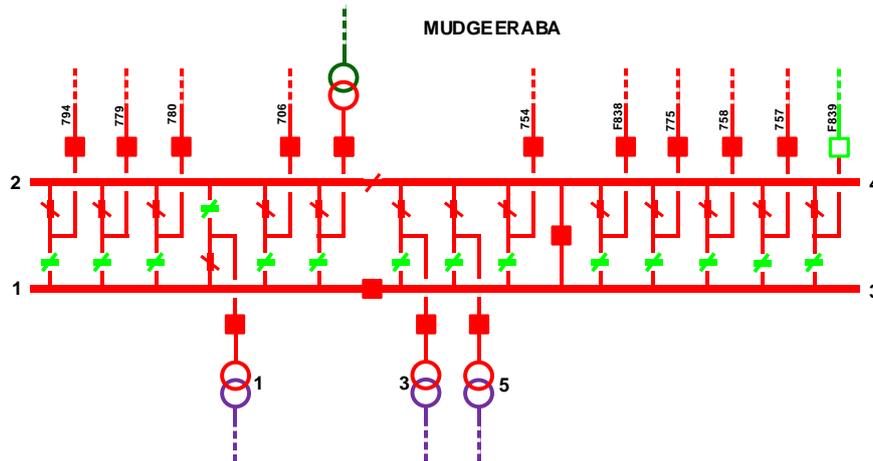
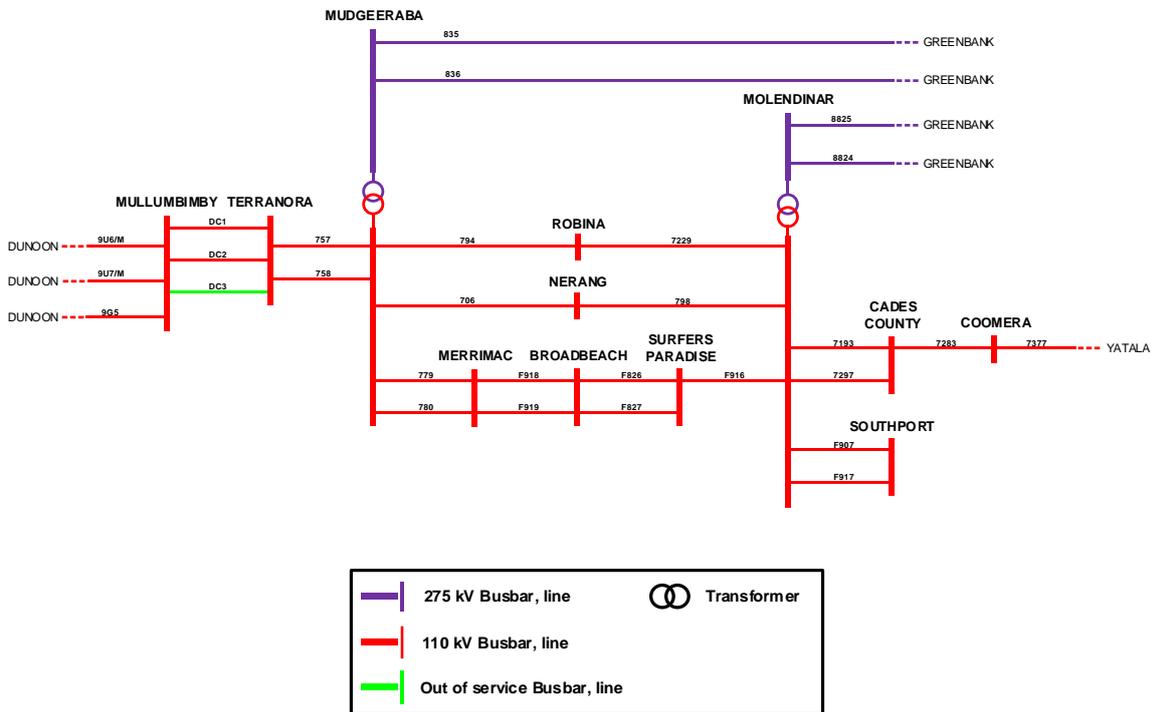
A.1 Prior to the incident

Immediately prior to this incident, 110 kV Feeder F839 from Mudgeeraba to Varsity Lakes (F839) was out of service for planned work by Energex. CB 78392 was open at Mudgeeraba.

Also as part of planned project work by Powerlink, all in service 110 kV transmission lines were switched to the 110 kV 2/4 busbar at Mudgeeraba.

The figures below show the Mudgeeraba substation and surrounding transmission network prior to this incident.

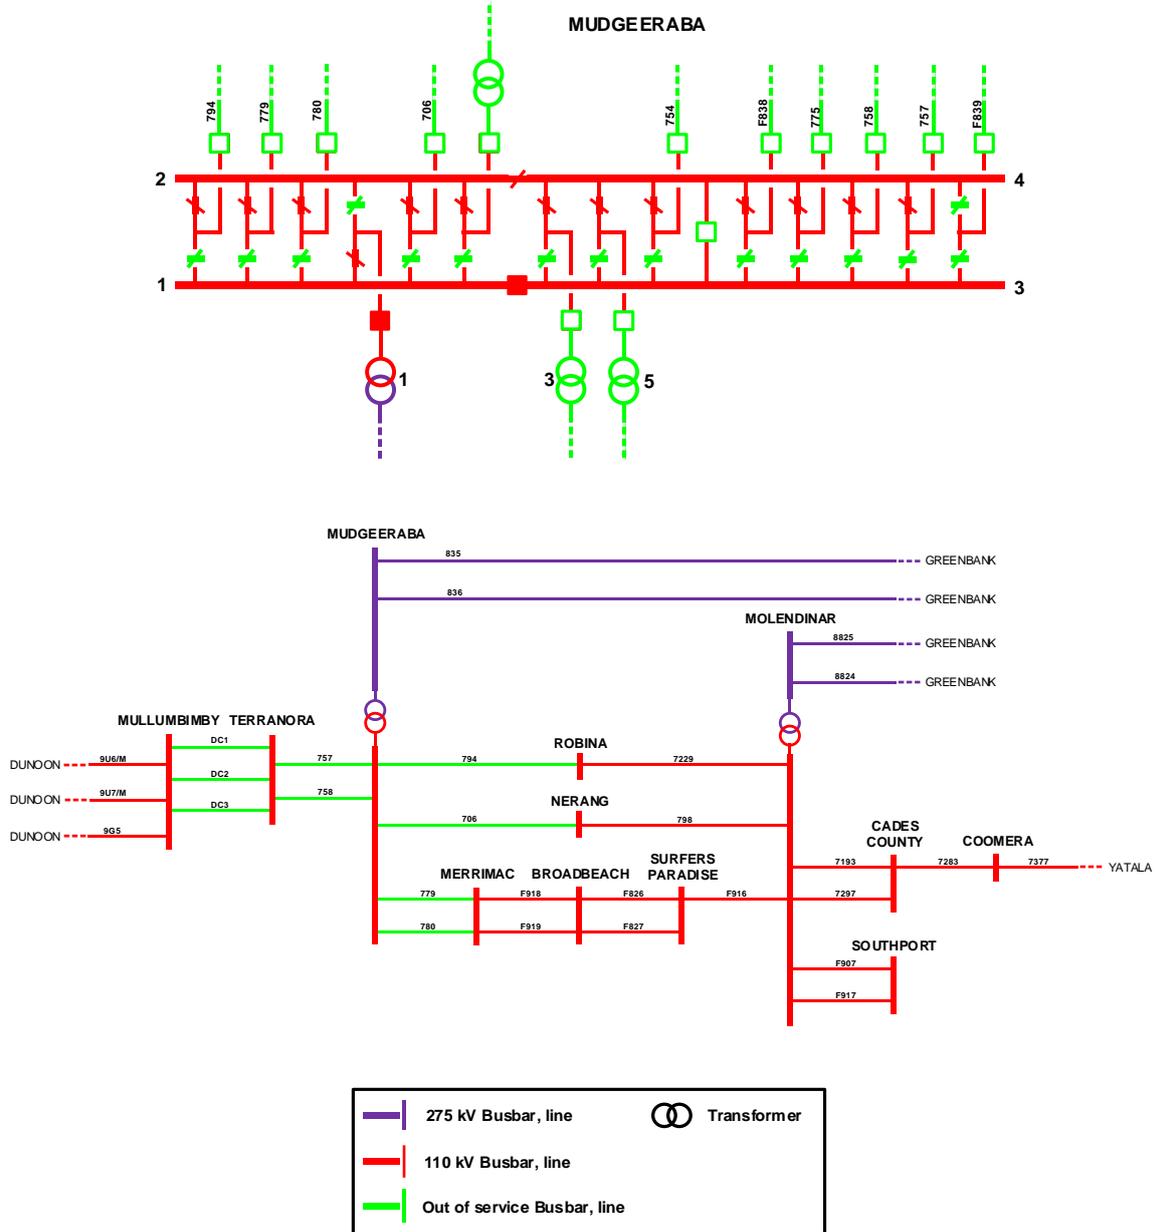
A.2 Immediately after the incident

On completion of the planned work by Energex, CB 78392 at Mudgeeraba was closed at 1443 hrs on 24 October 2017. At 1512 hrs, a fault developed internal to this CB, resulting in operation of the 110 kV 2/4 busbar protection tripping both busbars and all 110 kV transmission lines and transformers connected to these busbars.

This resulted in a loss of 111 MW of load at Mudgeeraba, Varsity Lakes, Burleigh Heads, and Terranora. The loss of the Mudgeeraba to Terranora 757 and 758 110 kV transmission lines also resulted in the outage of the Terranora interconnector and Directlink⁴. The Condong generating unit also tripped from 26 MW, due to the loss of supply to Terranora. (Refer to Appendix A2 for an overview of the Mudgeeraba substation and surrounding transmission network immediately after the incident.)

The figures below show the Mudgeeraba substation and surrounding transmission network immediately after this incident.
