Independent Market Operator

STEM Suspension Market Incident Report

30 October 2007

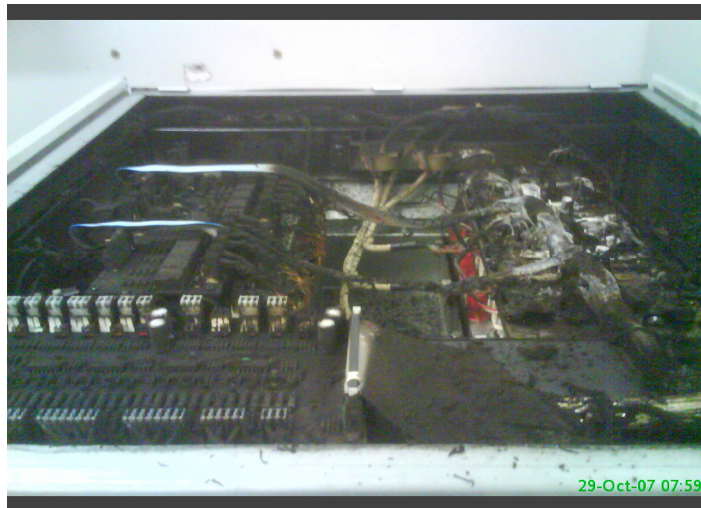
In the early morning hours of Monday 29 October there was a small electrical fire caused by a fault within the UPS unit. This fire produced sufficient smoke to trigger the VESDA, cutting power to the computer room and charging the sprinkler pipes with water. The VESDA also triggered an alarm with the Fire Brigade and an external security company, who then notified DTF staff. The burnt out UPS circuitry is pictured alongside.

The cause of the fire in the UPS is being investigated by the equipment supplier. It is known that the unit was running at maximum capacity for an extended period. However, this in itself does not explain the subsequent electrical fault.

The damaged UPS was replaced by DTF on the day of the incident with a unit of twice the capacity as the original. The computer room main power outlets are being upgraded to reflect the new capacity of the UPS.
