TRIP OF A 275 KV TRANSMISSION LINE AND SVC IN SOUTH AUSTRALIA ON 17 SEPTEMBER 2015

AN AEMO POWER SYSTEM OPERATING INCIDENT REPORT FOR
THE NATIONAL ELECTRICITY MARKET

Published: November 2015

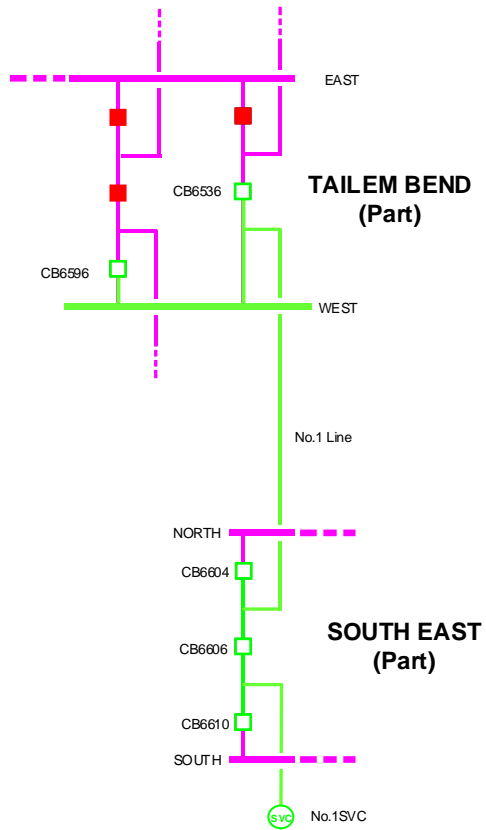
APPENDIX A. – POWER SYSTEM DIAGRAM

On Thursday 17 September 2015 at 1501 hrs, at SESS, the circuit breaker fail protection (CBF) associated with circuit breaker (CB) 6606 unexpectedly operated. This in turn correctly opened CBs 6604 and 6610 at SESS and CBs 6536 and 6596 at Tailem Bend Substation (TBSS). As a result the South East to Tailem bend No.1 275 kV transmission line (No.1 Line), and No.1 SVC at SESS were de-energised. No.1 SVC protection then correctly tripped CB6606 due to loss of the 275 kV supply.

The power system immediately after the incident.
