# POWER SYSTEM INCIDENT REPORT TRIP AND AUTORECLOSE OF THE MOUNT BEAUTY – DARTMOUTH 220 KV LINE AND LOSS OF WEST KIEWA PS UNITS 1 AND 4 ON 17 JUNE 2010

PREPARED BY: Electricity System Operations Planning and Performance

FINAL

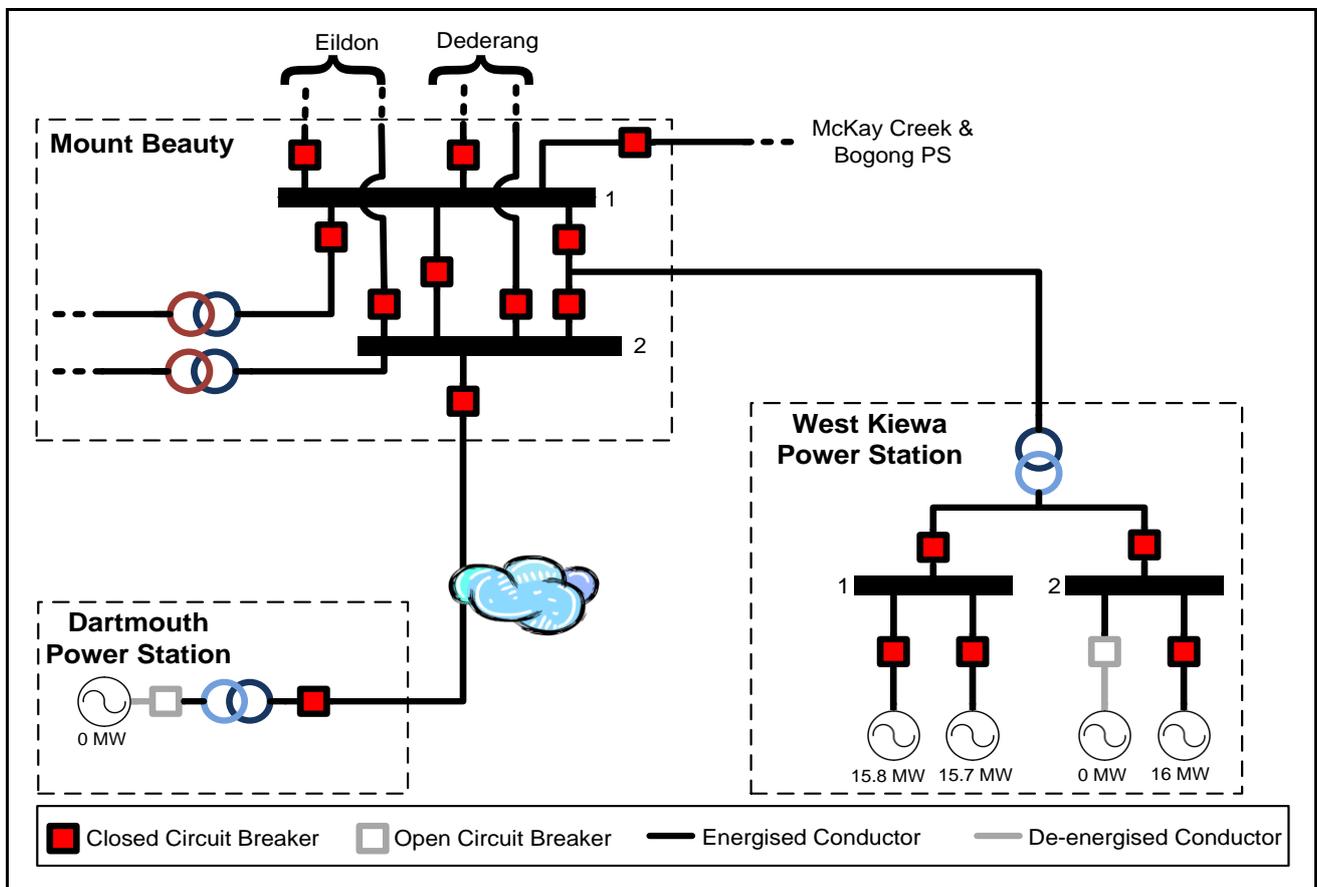
Figure 1 shows the status of the relevant circuit breakers, generating units and the relevant network elements prior to the event. There was a thunderstorm with lightning activity in the area at the time of the incident.

Figure 1 - Status of relevant circuit breakers, generating units and conductors prior to the event

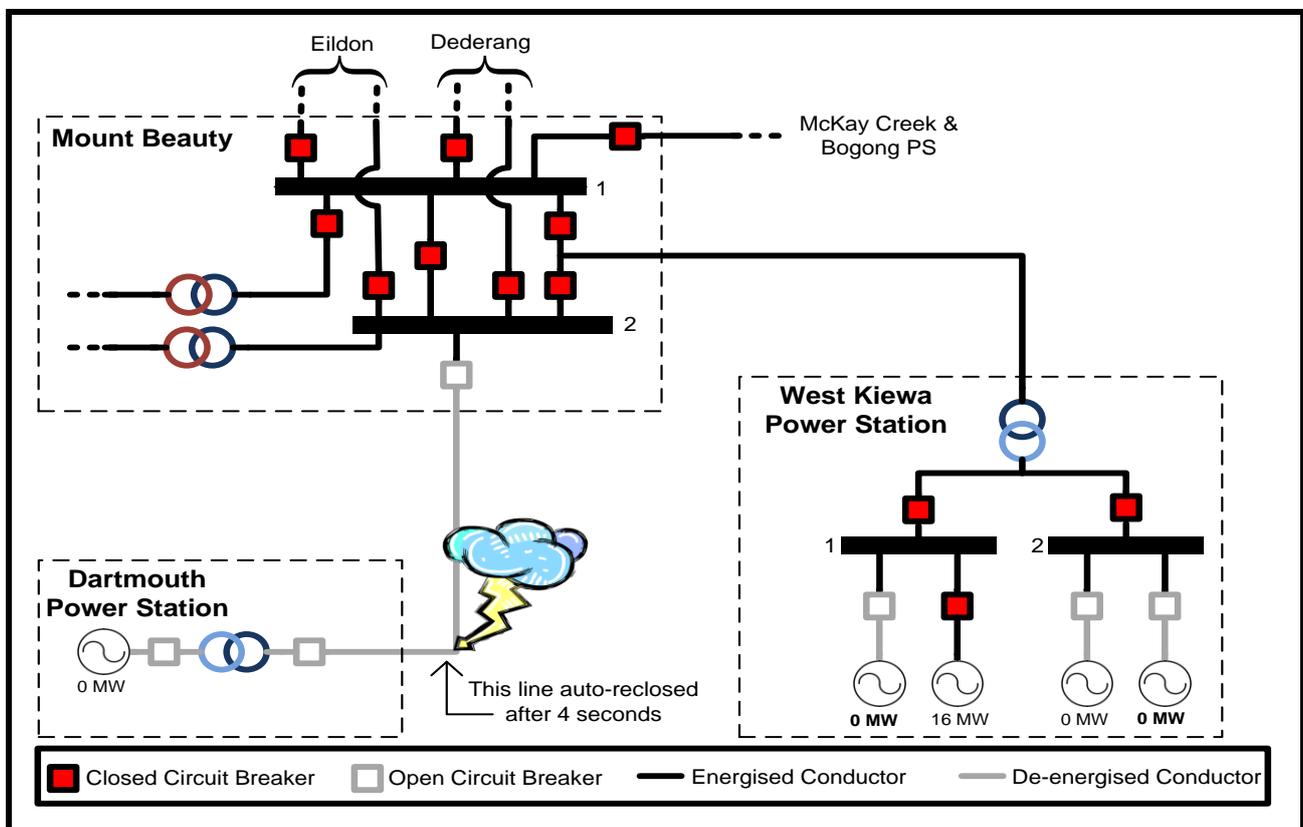
At 13:07 hrs on 17 June 2010, a lightning strike caused a two phase to ground fault on the Mount Beauty to Dartmouth Power Station 220 kV line approximately 16 km from the Mount Beauty transmission substation. The fault was cleared in 60ms when the following line circuit breakers opened to trip the line:

Generating units 1 and 4 at West Kiewa tripped at the same time on the operation of generator differential protection while the generating unit 2 continued operating, unaffected by the disturbance.

Figure 2 shows the status of the relevant circuit breakers, generating units and conductors after the line and two generating units tripped. The Mount Beauty to Dartmouth line is shown as de-energised, although it auto-reclosed 4 seconds after tripping.

Figure 2 - Status of relevant circuit breakers, generating units and conductors immediately after the event

The trip of generating units 1 and 4 at West Kiewa Power Station was not consistent with its agreed performance standards. As this was not the first time that AGL had experienced tripping of generating units similar to this, they revised the settings for the relays that tripped and simulated the fault in the laboratory. The relay rode through the fault, and the test was deemed successful. The relevant settings changes have since been made to the relays employed at West Kiewa power station and may be considered for AGL's other relays of the same type. The AER and Victorian TNSP have been advised of the non-compliance of West Kiewa Power Station to its agreed performance standard and that the non-compliance was resolved on 30 September 2010.

After successful testing of the revised relay settings, AGL deployed the protection relay settings to the West Kiewa generating units to avoid similar undesirable tripping in future.
