Trip of Braemar-Western Downs Transmission Line 8864 at Braemar end on 11 Sept 2014

AN AEMO POWER SYSTEM OPERATING INCIDENT REPORT FOR THE NATIONAL ELECTRICITY MARKET

PUBLISHED NOVEMBER 2014

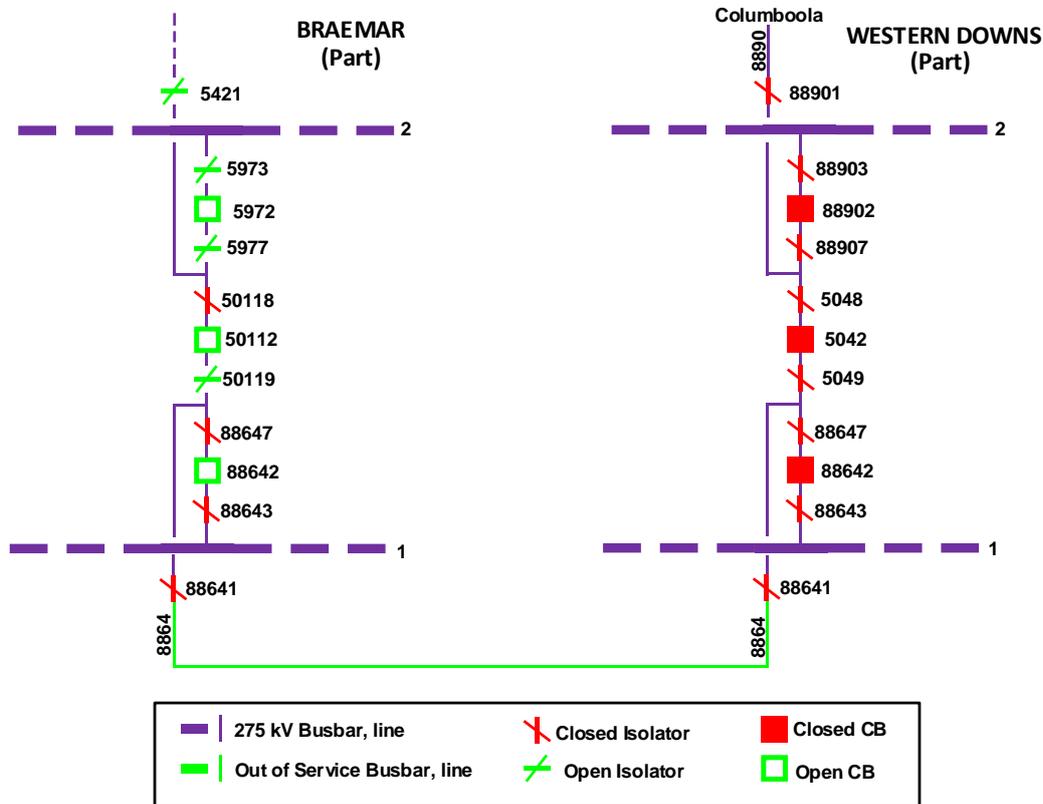
APPENDIX 1 – POWER SYSTEM DIAGRAM

On 11 September 2014, at 1717 hrs, the Braemar-Western Downs 8864 330 kV transmission line (Line 8864) opened at the Braemar end via circuit breaker 88642 (CB 88642) at Braemar. This resulted in Line 8864 being off-loaded. No load or generation was lost as a result of this incident and the line was returned to service at 1835 hrs the same day. See Appendix 1 for a diagram illustrating the incident and a chronological log of the incident.

The power system after the incident. Note circuit breakers 5972 and 50112 at Braemar substation were open prior to the incident.
