Power System Operating Incident Report – Trip of South Morang - Thomastown No.2 220 kV Transmission Line at the Thomastown End on 14 January 2014

PREPARED BY: AEMO Systems Capability

DATE: 10 February 2014

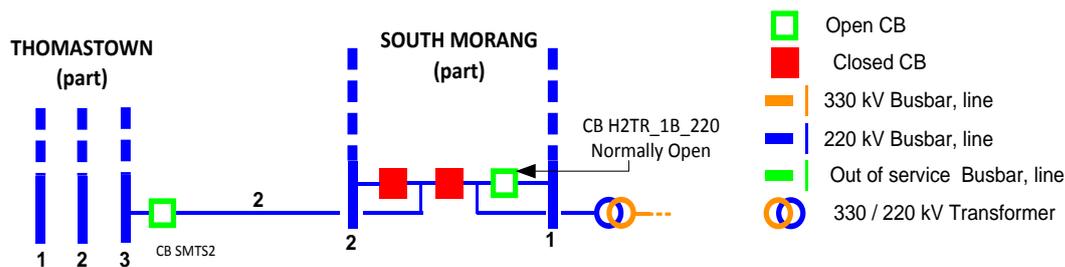
The status of the power system after the incident is shown below. Circuit Breaker SMTS2 at Thomastown is the circuit breaker that opened. Circuit breaker H2TR_1B_220 at South Morang Terminal Station (South Morang) is normally open and hence was open prior to the incident.

SP AusNet investigated this incident and found that a faulty protection relay caused the circuit breaker at Thomastown Terminal Station to open. SP AusNet reclosed the circuit breaker at 2155 hrs on 14 Jan 2014 having identified the faulty relay. The South Morang- Thomastown line was returned to service with X protection in service and Y protection out-of-service. The faulty relay was replaced on 15 Jan 2014 and the Y protection returned to service.
