MULTIPLE LINE OUTAGES IN THE MOUNT ENGLAND – TARONG AREA IN QUEENSLAND, 13 FEBRUARY 2017

REVIEWABLE OPERATING INCIDENT REPORT UNDER THE
NATIONAL ELECTRICITY RULES

Published: **3 August 2017**

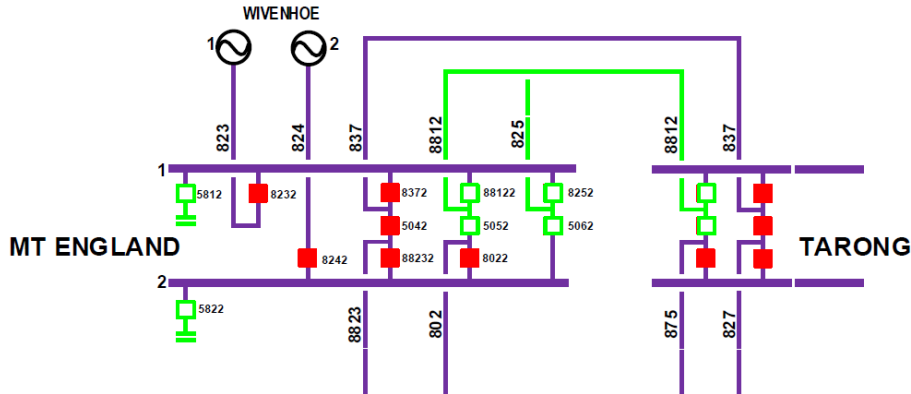
The power system in the area immediately before the incident

The Mt England–South Pine No.825 275 kV line (line 825) was out of service due to a previous fault, which has been separately reported, and is available on AEMO's website.

The Mt England–Tarong No.8812 275 kV line (line 8812) was out of service due to short notice planned work as part of repair works associated with the fault on line 825.

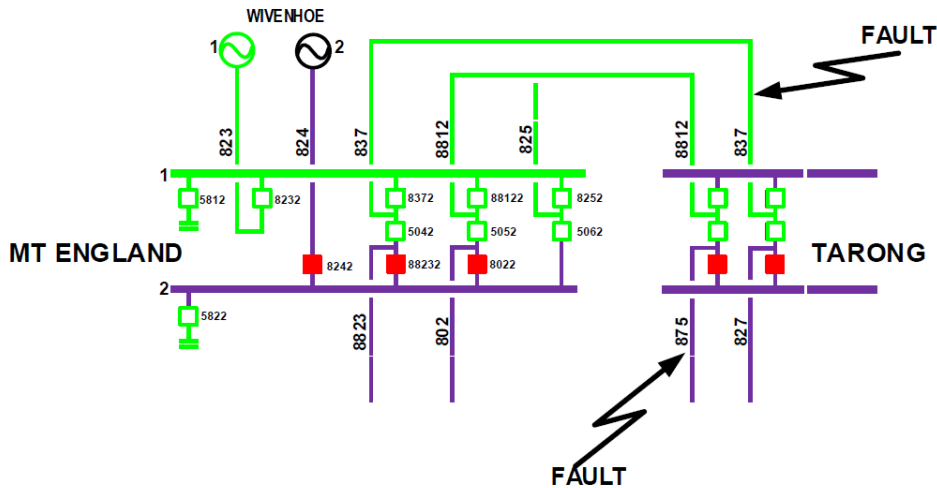
The power system after the initial set of events at 1709 hrs.

At approximately 1709 hrs on Monday 13 February 2017, an electrical storm passed through the Mount England and Tarong substation area, resulting in multiple faults on the following transmission lines:

- Mt England–Tarong No.837 275 kV line (line 837).
- Blackwall–Tarong No.875 275 kV line (line 875).

The faults and subsequent tripping of these lines, resulted in outages of the following:

- Mt England–Wivenhoe No.823 275 kV line (line 823).
- No.1 275 kV busbar at Mount England substation (Mt England No.1 busbar).

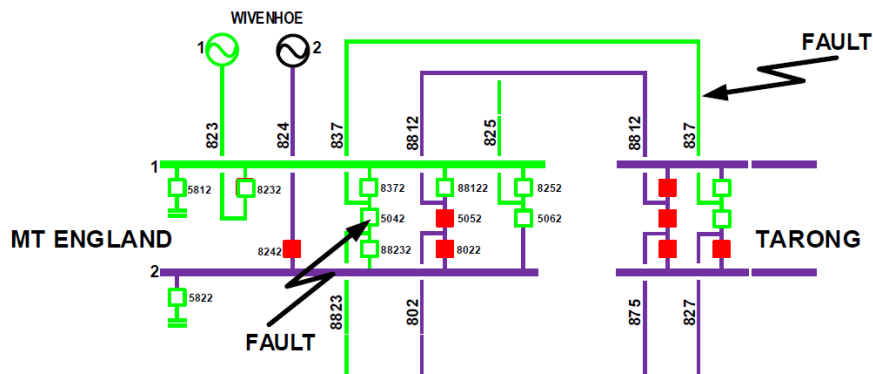
The power system after the next set of events at 1715 hrs.

At approximately 1715 hrs, line 8812 was returned to service after remedial works were completed on that line. Seven seconds later, the Mt England – Abermain No 8823 275kV line (line 8823) tripped.

| Time (hrs) | Event | Comment |
|---|---|---|
| 17:15:42.644 | Line 8823 trip due to operation of Circuit Breaker fail protection associated with CB 5042. (5042 is the tie breaker CB between line 8823 and line 837 at Mt England substation). This circuit breaker was already open due to the trip of line 837 at 17:09:08.510. | Protection operated due to occurrence of a high voltage fault on the circuit breaker as a result of a further lightning strike on the out of service 837 line causing an external flashover across the open CB 5042. |
