Trip of the No. 1 Transformer and
No. 2 Static Var Compensator at
South East substation on
20 June 2019

November 2019

Reviewable Operating Incident Report under the
National Electricity Rules

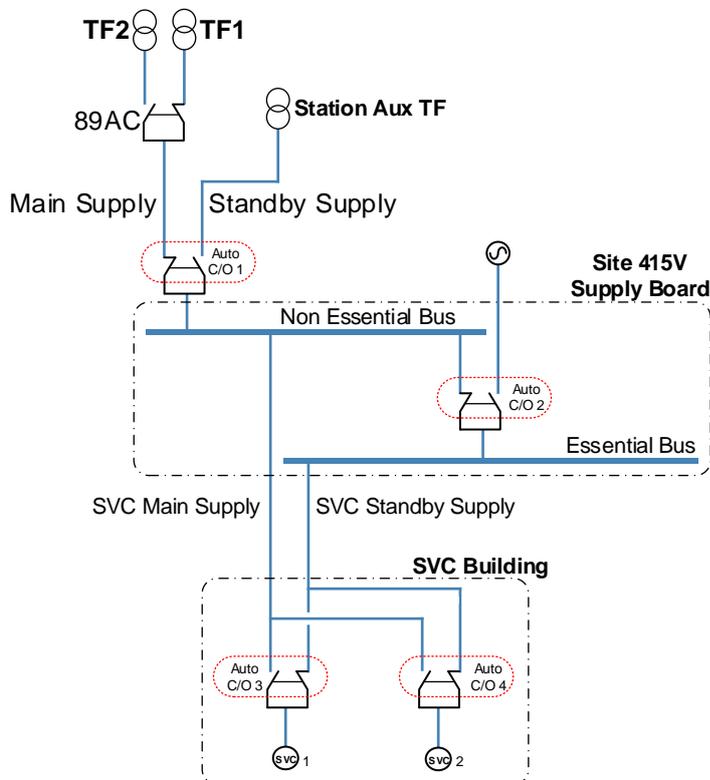
Figure 1 South East Substation 415 V supply

The 415 V supply to the SVCs is described in Appendix A. In this instance, the primary 415 V supply was from the Transformer 1 tertiary winding. On the loss of Transformer 1, the 415 V supply for SVC 1 successfully switched over to the Standby Supply, but the auto-changeover switch (C/O switch 4) for SVC 2 failed to correctly switch back to the Essential bus, resulting in a loss of 415 V supply to SVC 2 and subsequent tripping of SVC 2 due to loss of cooling.

South East substation SVCs 1 and 2 require a 415 V supply to maintain water cooling to the thyristor valves. If the 415 V supply to the cooling system pumps is interrupted for greater than six seconds, the SVCs are tripped.

The essential and non-essential boards are normally fed from No. 1 Transformer. Manual changeover to No. 2 Transformer is available via switch 89AC.

On loss of supply from No. 1 Transformer, the essential and non-essential boards auto-changeover (C/O switch 1) to the standby supply fed from the local 11 kV distribution network. This takes approximately two seconds.

During this changeover period, SVCs 1 and 2 auto-changeover from the essential to the non-essential board via C/O switches 3 and 4.

On restoration of supply via the standby supply, the SVCs then auto-changeover back to the essential board.

If normal and standby supplies fail, a standby generator is started automatically, and this will restore essential 415 V supplies to site, via changeover switch C/O 2. The diesel generator normally takes longer than six seconds to start, and cannot be relied on to maintain supply to the SVC cooling systems.

Consequently, ElectraNet has advised it has disabled the auto-changeover for SVC 2 (C/O switch 4) so it will remain permanently connected to the Essential bus. This configuration will remain until maintenance can restore the normal functionality of the auto-changeover scheme.

ElectraNet has advised there is a project underway to modify the 415 V supply to the South East SVCs. When the project is complete, the 415 V supply to the South East SVCs will be derived from auxiliary transformers connected to the South East North and South 275 kV busbars. This will fundamentally change the risk of losing the normal supply to the SVCs. Supply loss that results in operation of the voltage changeover to select an alternative source will then only occur for busbar faults or busbar outages, which will be less likely to occur than a transformer outage. In addition, each SVC will have its main supply selected to a different busbar transformer, such that loss of a bus will affect one SVC only, and the other SVC will remain supplied via its "normal" connection from the unaffected busbar. This project is due to be complete by mid-2020.
