TRIP OF BANNABY - MARULAN 330 KV TRANSMISSION LINE ON 2 JULY 2015

AN AEMO POWER SYSTEM OPERATING INCIDENT REPORT FOR THE NATIONAL ELECTRICTY MARKET

Published October 2015

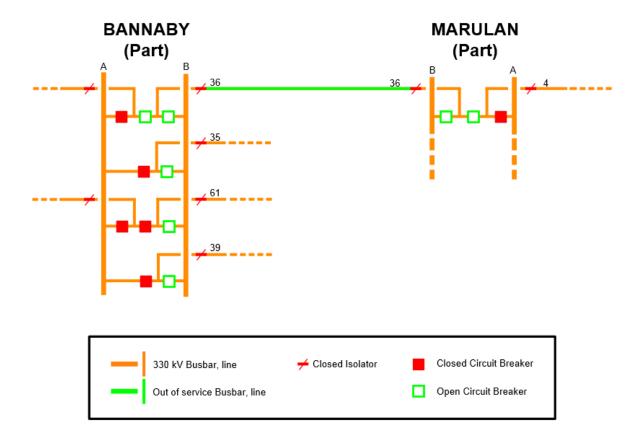
APPENDIX A. POWER SYSTEM DIAGRAM

On Thursday 2 July 2015 between 0742 hrs and 0744 hrs, Line 36 tripped and reclosed, at the Bannaby end, three times before tripping a final time at 0745 hrs. At 0750 hrs Line 36 tripped at the Marulan end, and B busbar tripped.

TransGrid investigated this incident and found that a faulty protection relay on Line 36 at Bannaby caused the trip of Line 36 and B busbar. The analogue signal processing in the relay failed and caused the relay to generate spurious trip and auto reclosed signals.

The power system immediately after the incident

The faulty relay was initially isolated which allowed B busbar to return to service later the same morning at 1029 hrs. The faulty relay was then replaced and Line 36 returned to service on the same day, with all protection in service, at 1906 hrs.
