TRIP OF YALLOURN POWER STATION NO.2 220 KV BUSBAR ON 6 DECEMBER 2015

AN AEMO POWER SYSTEM OPERATING INCIDENT REPORT
FOR THE NATIONAL ELECTRICITY MARKET

Published: March 2016

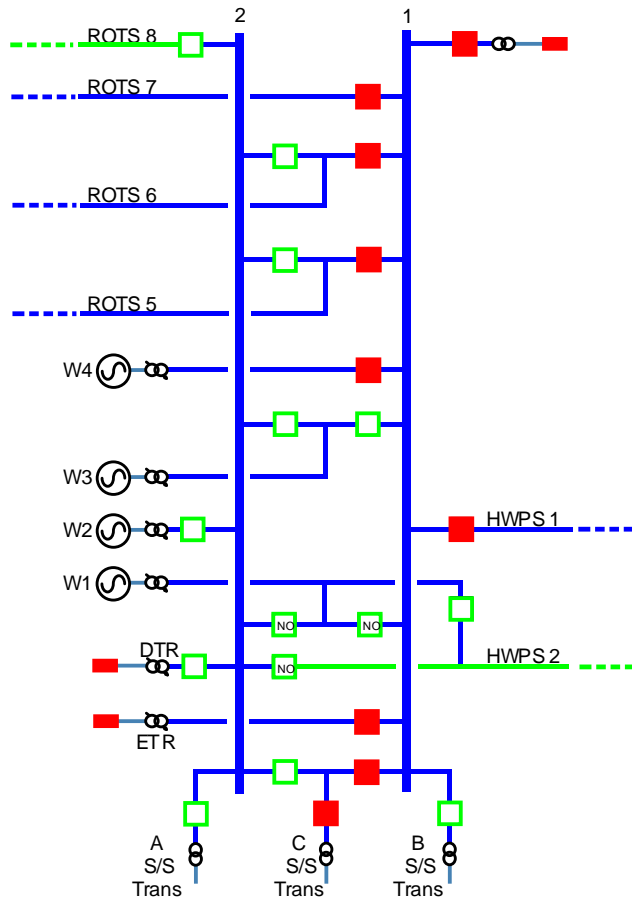
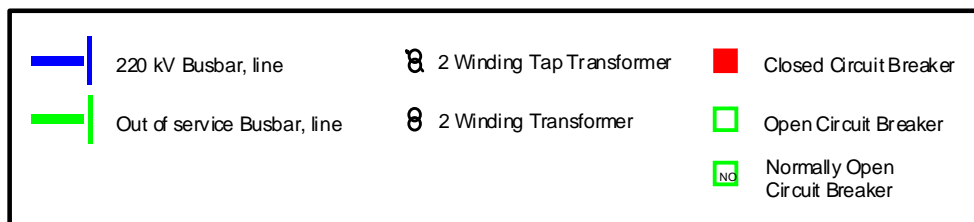
APPENDIX A. – POWER SYSTEM DIAGRAM

At the time of the incident, the auxiliary supplies for YWPS unit 1 were being fed via auxiliary transformer ‘A’, which is connected to the YPS No.2 220KV busbar. Auxiliary transformer ‘B’ fed from the YPS No.1 220KV bus was out of service at the time of the incident. Auxiliary supplies normally fed from the ‘B’ transformer were being fed from auxiliary transformer ‘C’. Appendix A shows the 220KV connections of the YWPS auxiliary supply transformers.

The power system immediately after the incident
