Preliminary Report – Trip of Liapootah – Palmerston 220 kV lines

October 2022

A preliminary operating incident
report for the National Electricity
Market – information as at
19/10/2022

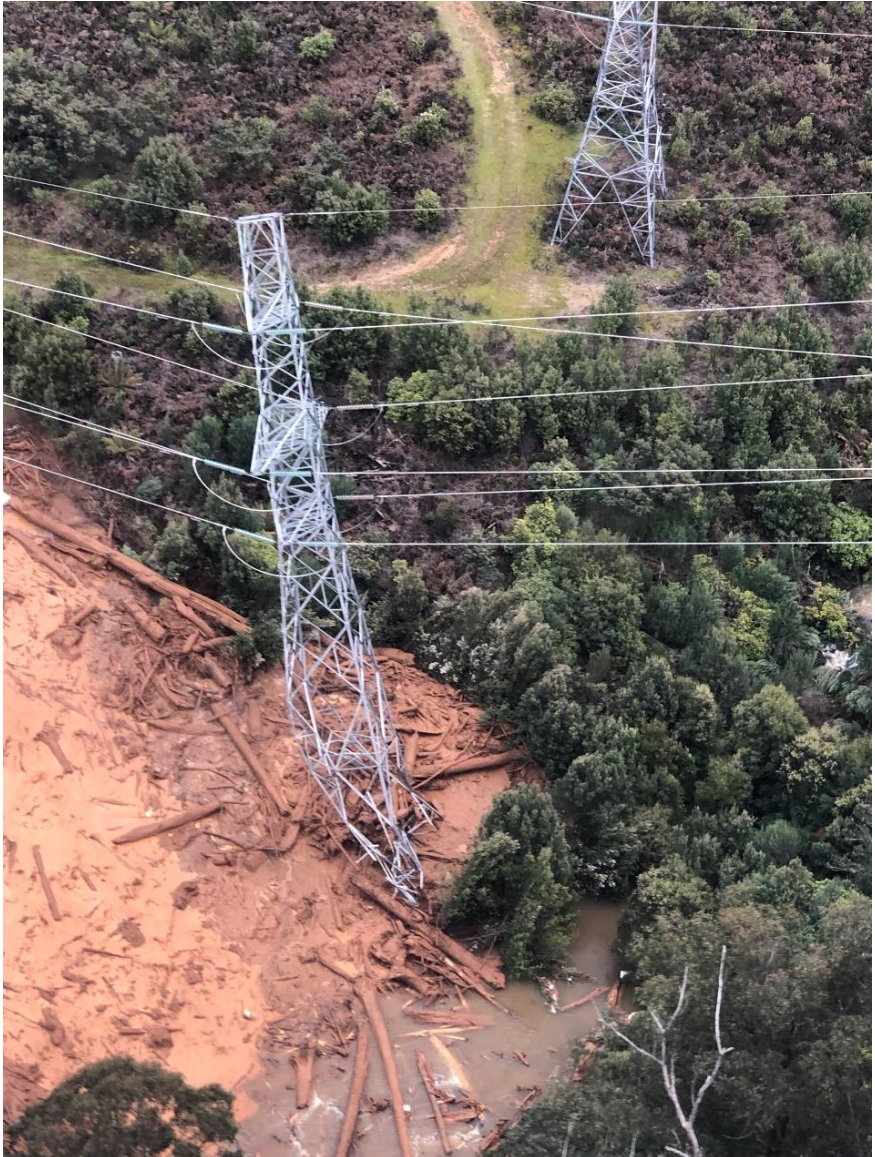
Figure 1 Double circuit strain tower damaged by landslide

- Both Liapootah – Waddamana – Palmerston 220 kV lines (No. 1 and No. 2 lines). This was caused by a landslide impacting the footings of a double circuit strain tower between Palmerston and Waddamana.
- Both Waddamana – Lindisfarne 220 kV lines (at the Waddamana end only).
- Basslink high voltage direct current (HVDC) interconnector, which was importing 425 megawatts (MW) to Tasmania at the time.
- Cattle Hill Wind Farm, Musselroe Wind Farm and Lemonthyme Power Station.
- Approximately 530 MW of electrical load (495 MW of this being industrial load)².

At approximately 0919 hrs on 14 October 2022, both Liapootah – Waddamana – Palmerston 220 kV lines tripped. It was later established that these line trips were caused by a landslide impacting the footings of a strain tower on this double circuit transmission line (as shown in Figure 1).

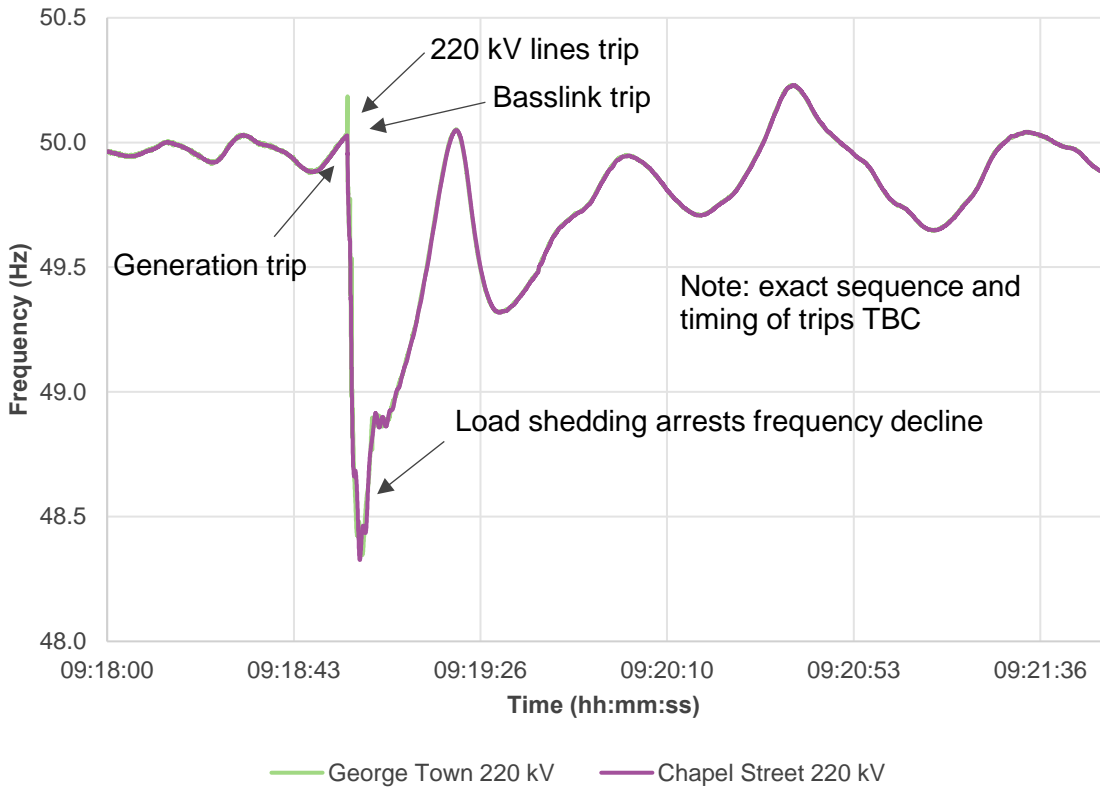
Figure 2 Tasmanian frequency during the incident (PMU recordings)

Figure 2 below shows Tasmanian frequency during the event. It shows that measured frequencies were closely aligned across the island, as expected given that North and South Tasmania remained electrically connected throughout the incident. Frequency declined to a minimum of approximately 48.3 hertz (Hz) before recovering. Mainland National Electricity Market (NEM) measured frequency remained within the normal operating frequency band during the incident.

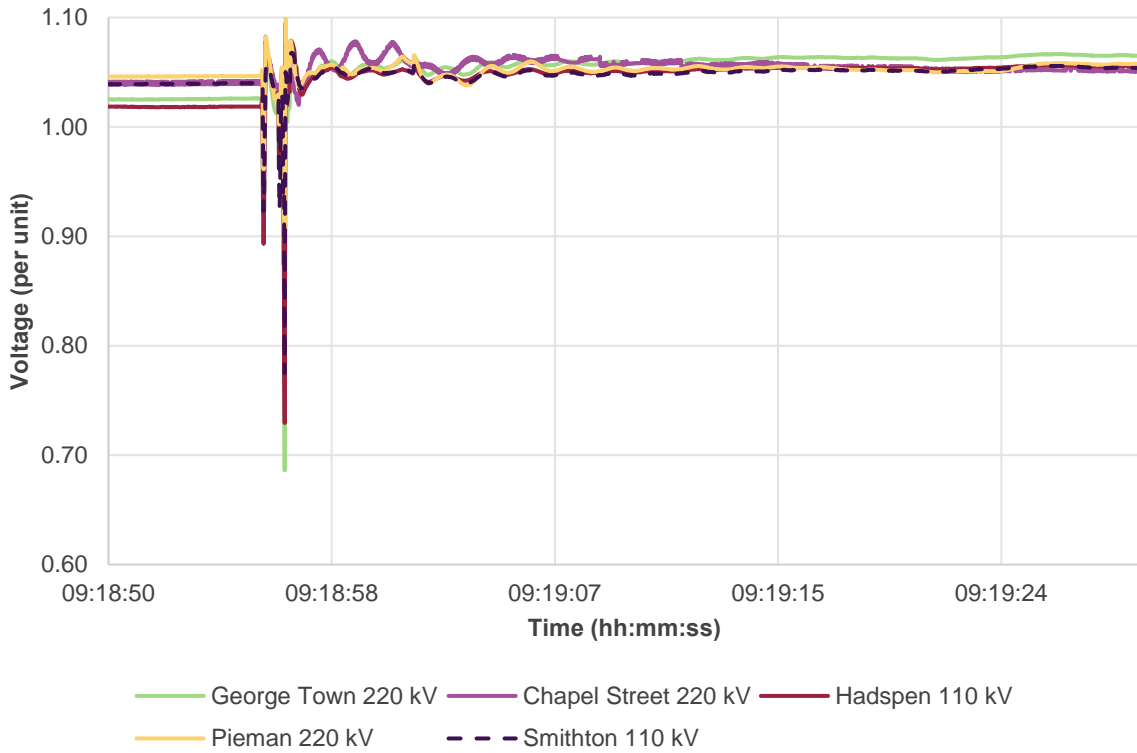
Figure 3 Voltages during the incident (PMU recordings)

Figure 3 shows voltages at various locations across Tasmania during the incident. It indicates there were some post fault voltage oscillations that damped out over approximately 10 seconds.

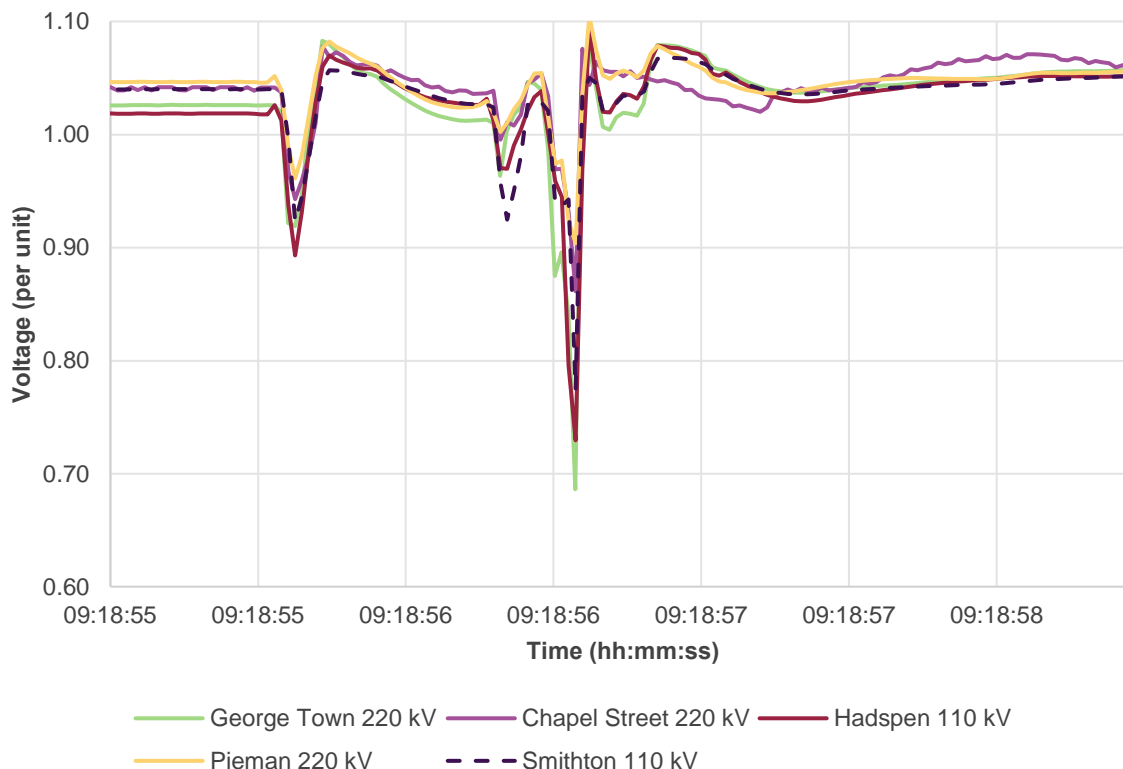
Figure 4 Voltages during incident (PMU) zoomed in on initial voltage disturbances

Figure 4 shows the same voltages, but zoomed in on the initial voltage disturbances. It shows a shallow voltage disturbance at first, followed by a deeper disturbance approximately one second later.
