POWER SYSTEM INCIDENT REPORT T055 TURKINJE 132KV NO 2 BUS TRIP

PREPARED BY: Electricity System Operations Planning and Performance

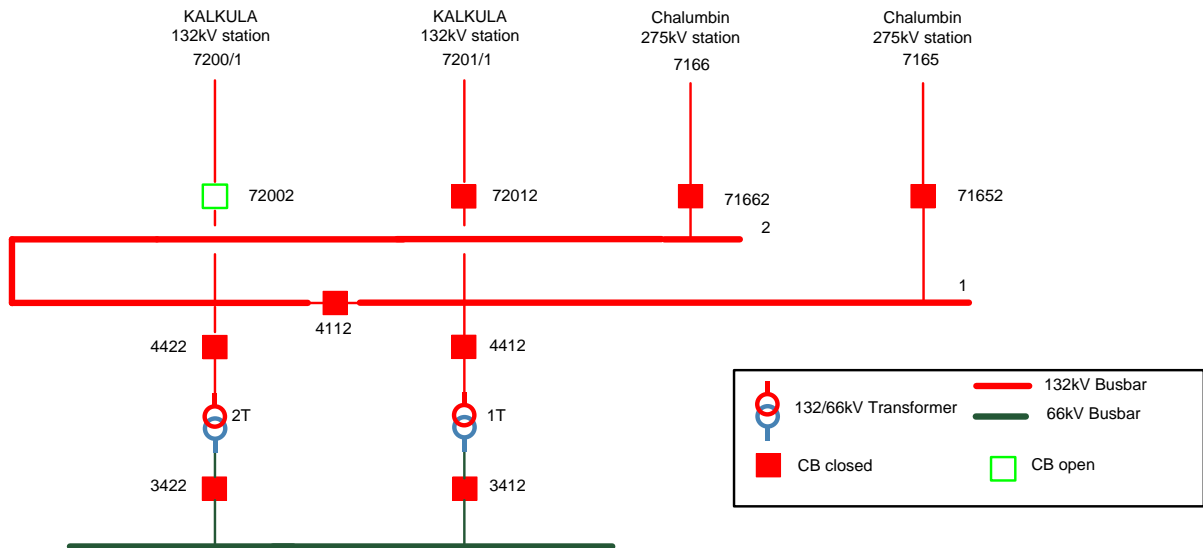
T55 Turkinje 132kV station configuration prior to No.2 busbar tripping:

On Friday 16th April 2010, at 11:15 hrs, the No.2 busbar at T55 Turkinje substation tripped. There was a prior planned outage of the Turkinje – Kalkula 7200/1 132kV line at the time.

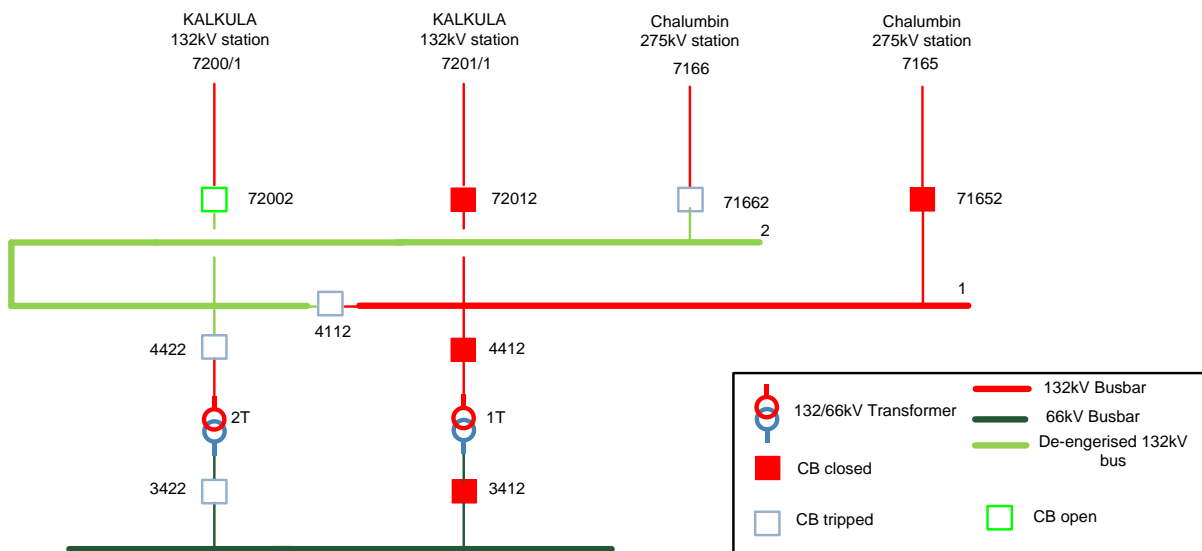
T55 Turkinje 132kV station configuration after No.2 busbar tripped:

At 11:15 hrs on 16 April 2010, the No.2 132kV busbar at T055 Turkinje substation tripped. The busbar trip occurred due to operation of a circuit breaker fail protection system during planned accuracy testing of 132kV current transformers associated with circuit breaker 72002.

T55 Turkinje CB4112 – 1 - 2 Bus Section 132kV circuit breaker
T55 Turkinje CB71662 – Feeder 7166 Chalumbin 132kV circuit breaker
T55 Turkinje CB4422 – 132/66kV #2 Transformer 132kV circuit breaker
T55 Turkinje CB3422 – 132/66kV #2 Transformer 66kV circuit breaker

- Chalumbin – Turkinje 132kV line 7166 was off-loaded at Turkinje
- Turkinje No.2 132/66kV Transformer was de-energised

As a part of the testing activities, electrical signals generated by the test equipment were being injected to secondary systems at the time the 132kV Feeder 7200 protection systems operated. The 132kV Feeder 7200 protection system operation initiated a trip signal to the already open circuit breaker 72002 and also triggered the Circuit Breaker Fail protection system associated with this circuit breaker. These conditions existed for a period sufficient for the 132kV Circuit Breaker Fail protection systems to operate and trip the No.2 132kV busbar.

After the event, Powerlink reviewed the work processes and guidelines to ensure adequate isolation of test signals from all in service protection systems would be implemented during testing of secondary equipment to avoid similar occurrences in future.
