# LOSS OF SWANBANK B1 AND B2 GENERATING UNITS ON 15 JUNE 2010

PREPARED BY: Electricity System Operations Planning and Performance

DATE: 7 September 2010

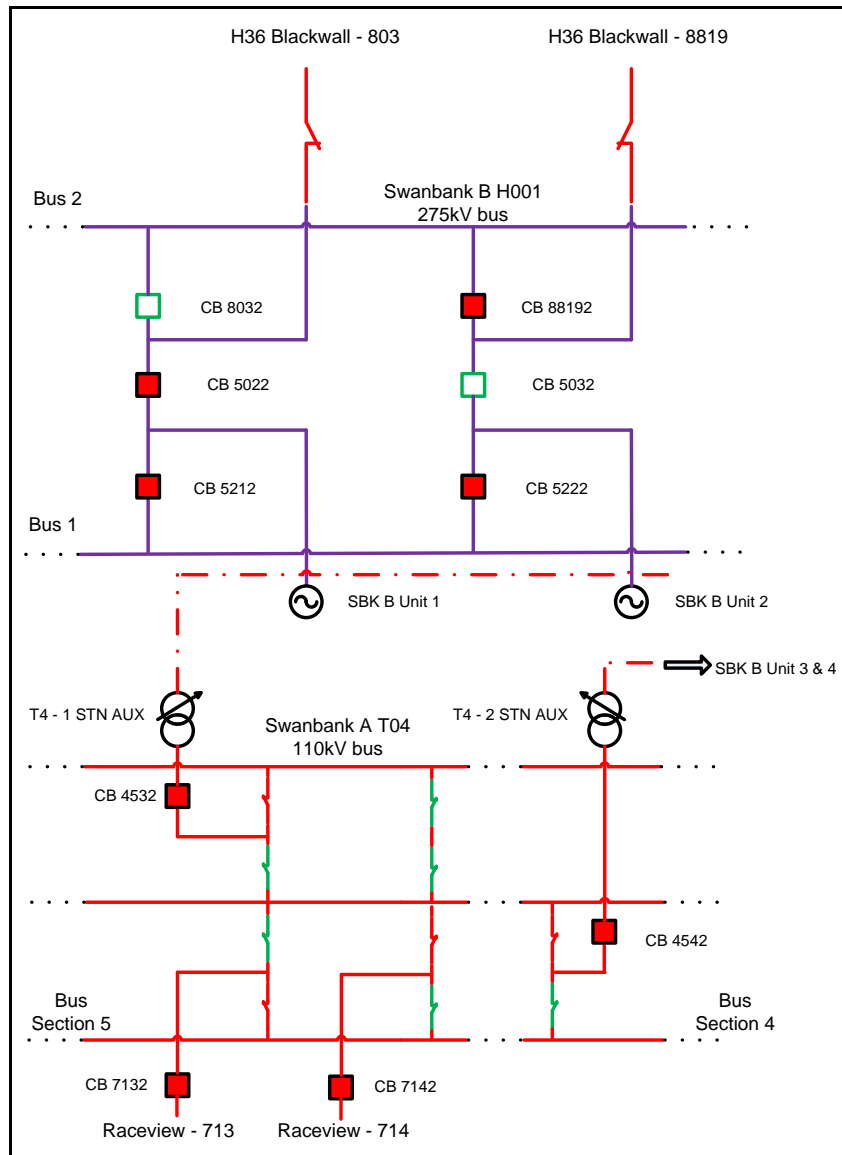
Figure 1 below shows the configuration at Swanbank B. Note that CB 8032 and CB 5032 are open under normal conditions.

Figure 1 Swanbank system configuration before events occurred (only relevant sections of the bus are shown)

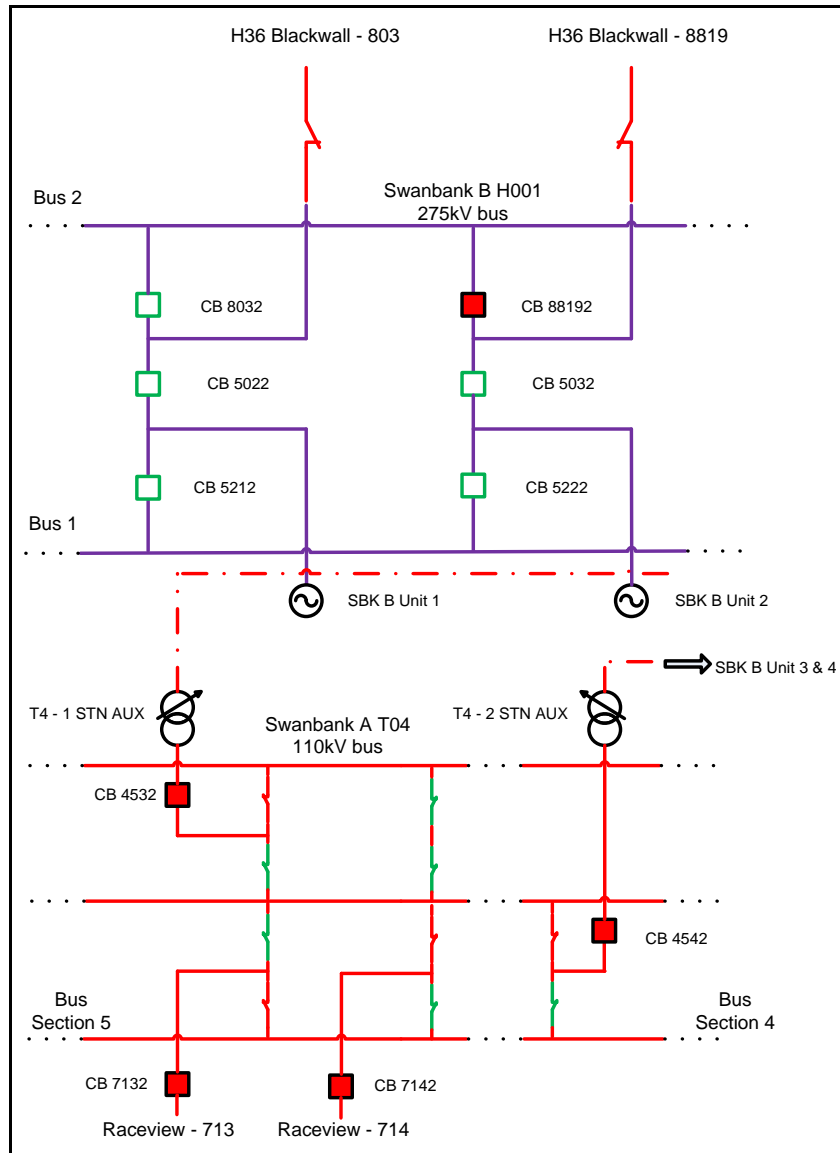
fabric filter controller caused a Master Fuel Trip (MFT) signal to be triggered for the in service generating units. Unit 1 tripped when Swanbank B CB 5212 (Unit 1, No.1 bus cb) and CB 5022 (feeder 803, unit 1 centre cb) opened via trip signals following the initiation of MFT signals. The 275 kV Blackwall - Swanbank 803 line was offloaded as a consequence. At the same time, CB 5222 (Unit 2) also opened, tripping the No.2 generating unit.

Figure 2 Configuration following the isolation of Unit 1 & 2

The Blackwall – Swanbank 803 line was placed back on load at 01:19 hours by closing CB 8032. Swanbank B units 1 and 2 were synchronised and returned to service at 04:07 and 06:47 hours respectively.
