POWER SYSTEM INCIDENT REPORT

TRIP OF TAMWORTH NO.3 330KV BUSBAR SECTION ON 1 JUNE 2010

PREPARED BY: Electricity System Operations Planning and Performance

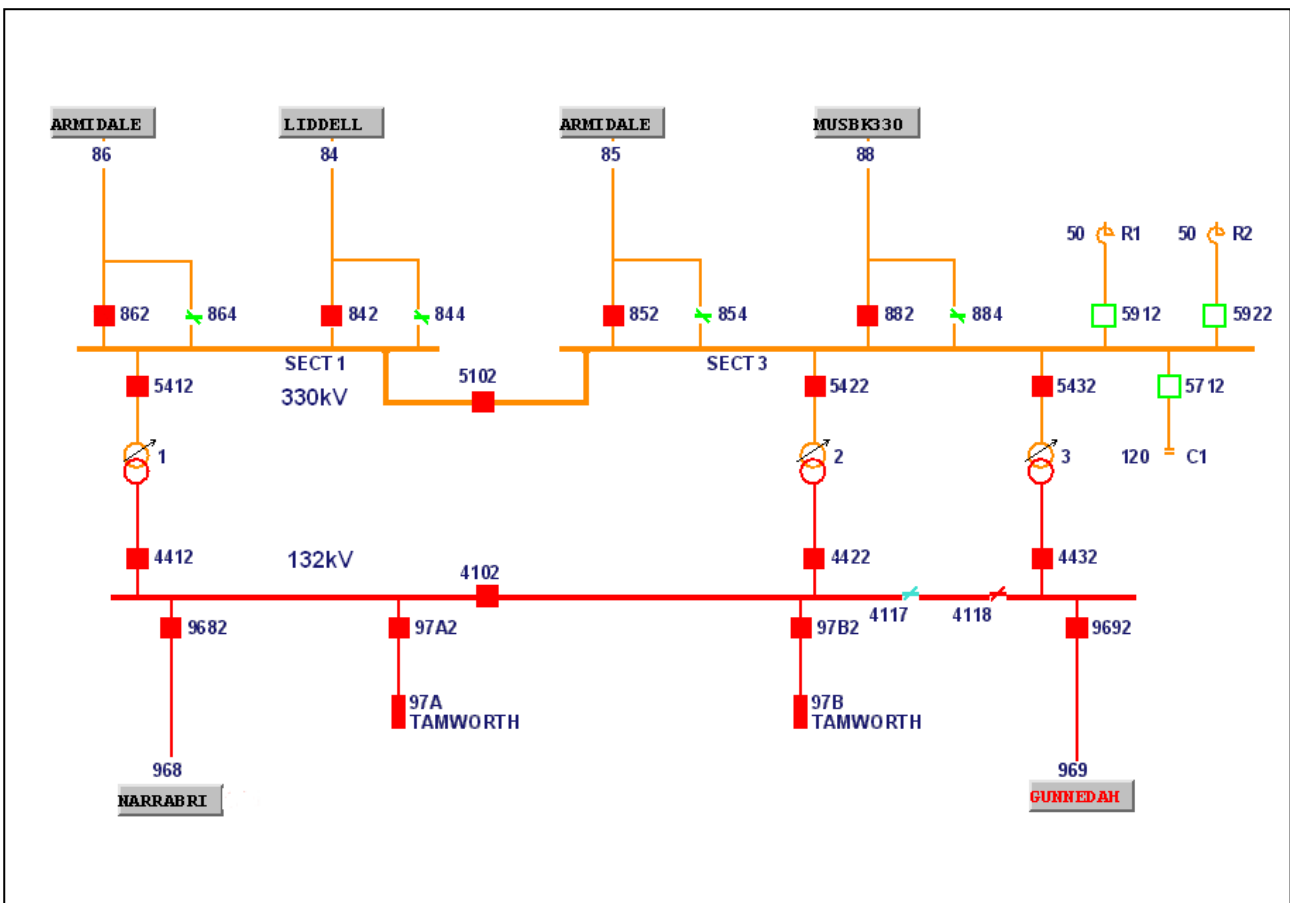
Figure 1: Status of relevant conductors, circuit breakers and system components at Tamworth Substation prior to the system incident event

Prior to the system incident, reactors R1 and R2 and the capacitor C1 on No. 3 330kV busbar were not in service. The figure 1 shows the status of all relevant circuit breakers and isolators at Tamworth Substation prior to the system incident.

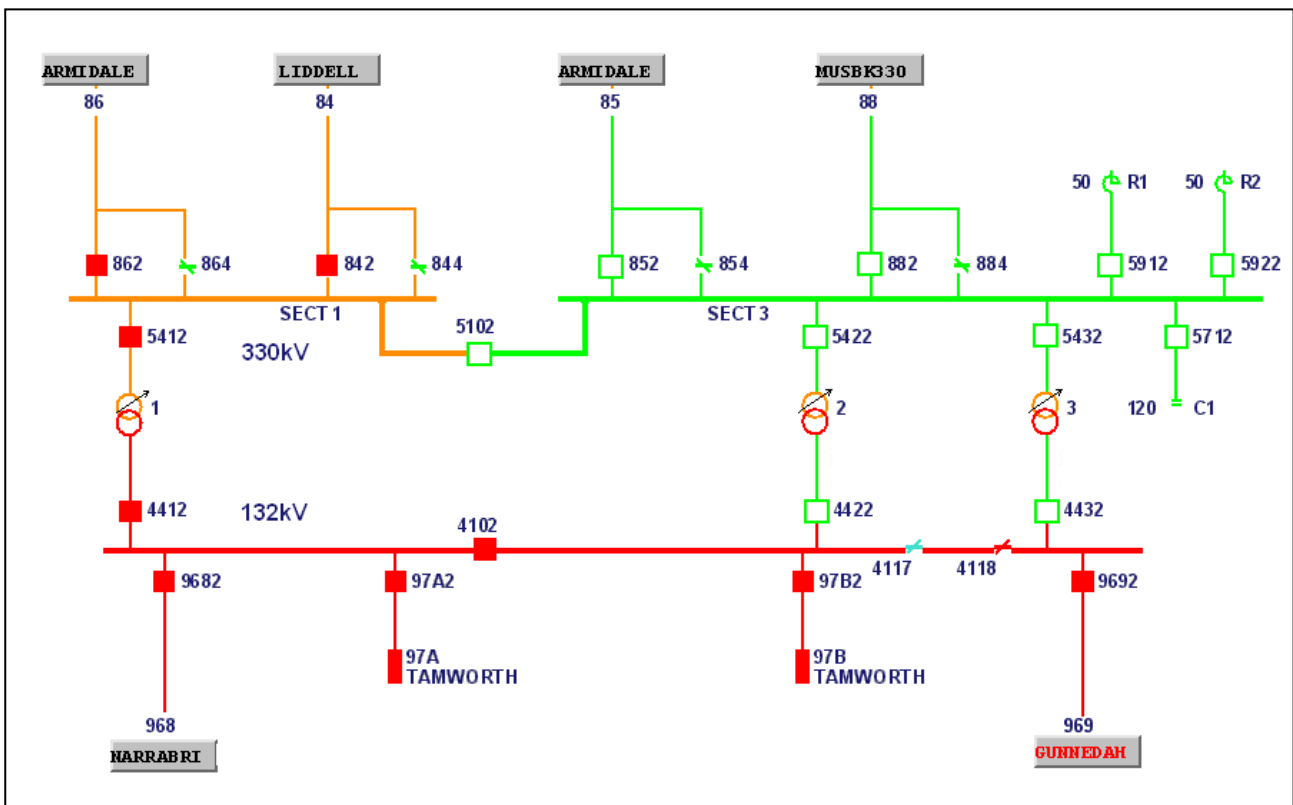
Figure 2: Status of relevant conductors, circuit breakers and system components at Tamworth Substation post system incident event

At 1723 hrs on 1 June 2010, the No.3 330kV busbar section at Tamworth substation tripped. The trip was due to the explosive failure of the CT associated with the “White phase” of CB 852 at Tamworth Substation. The explosion resulted in the operation of the protection systems associated with the No.3 busbar section, effectively tripping all network components connected to it. The following circuit breakers tripped:

- CB 852 off-loading No.85 330kV Armidale to Tamworth transmission line. The line also tripped at Armidale on the operation of protection inter-trips.
- CB 882 offloading No.88 330kV Muswellbrook to Tamworth transmission line. The line also tripped at Muswellbrook on the operation of protection inter-trips.
- CB 5422 and CB 4422 off-loading No.2 330/132 kV transformer.
- CB 5432 and CB 4432 off-loading No.3 330/132 kV transformer.
- CB 5102 splitting No. 3 busbar section from No. 1 busbar section.

The figure 2 illustrates the status of network components at Tamworth substation after the trip of the No. 3 330kV busbar section.

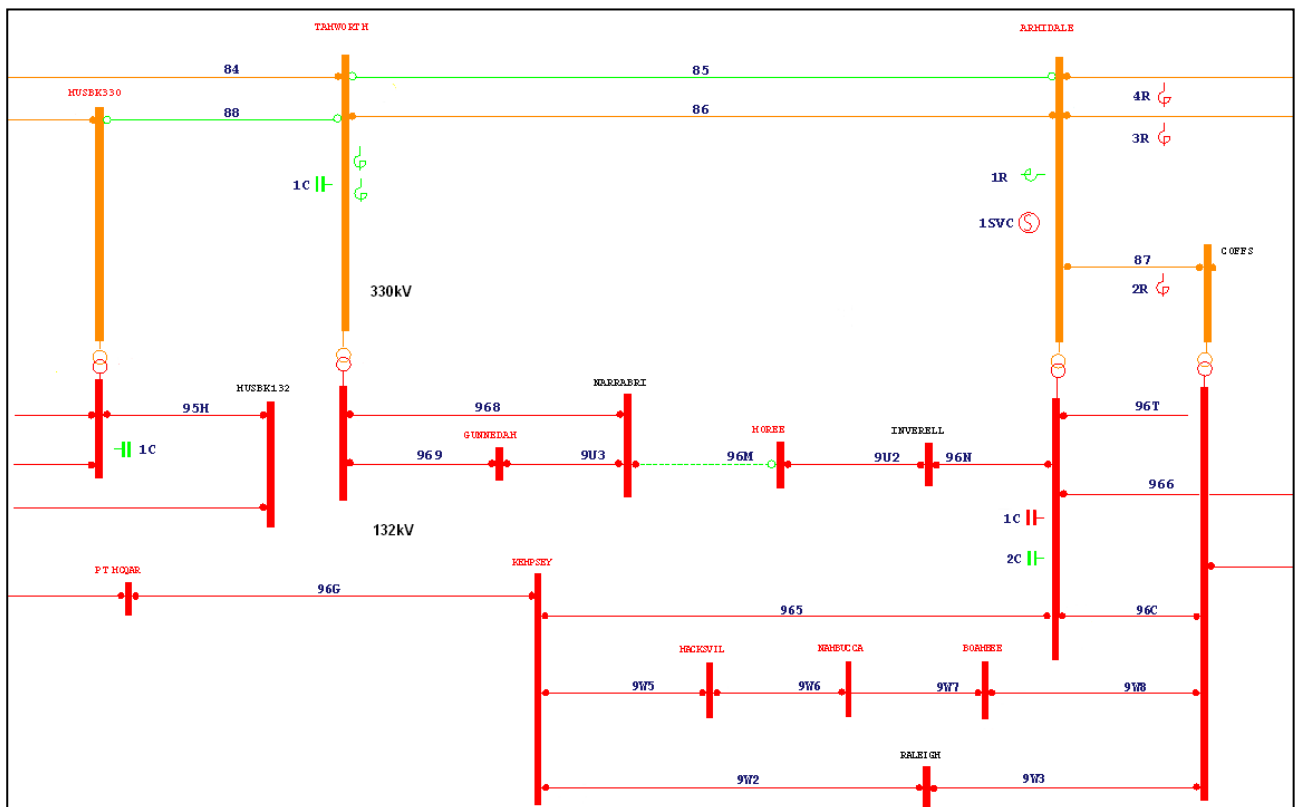
Figure 3: Status of 330kV and 132kV System between Tamworth and Armidale Substation after trip of Section 3 busbar

At 1727 hrs, TransGrid rearranged the power system by manually opening the CB 96M2 at 132kV Moree substation, thereby off-loading the No.96M 132kV line between Moree and Narrabri substation. This effectively split the 132kV network between Tamworth and Armidale substations.

Figure 3 shows the power system between Muswellbrook and Armidale substations after this system rearrangement.
