POWER SYSTEM INCIDENT REPORT TRIP OF MULTIPLE TRANSMISSION LINES IN THE VICINITY OF BRAEMAR 275 KV SUBSTATION 10 JUNE 2010

PREPARED BY: Electricity System Operations Planning and Performance

FINAL

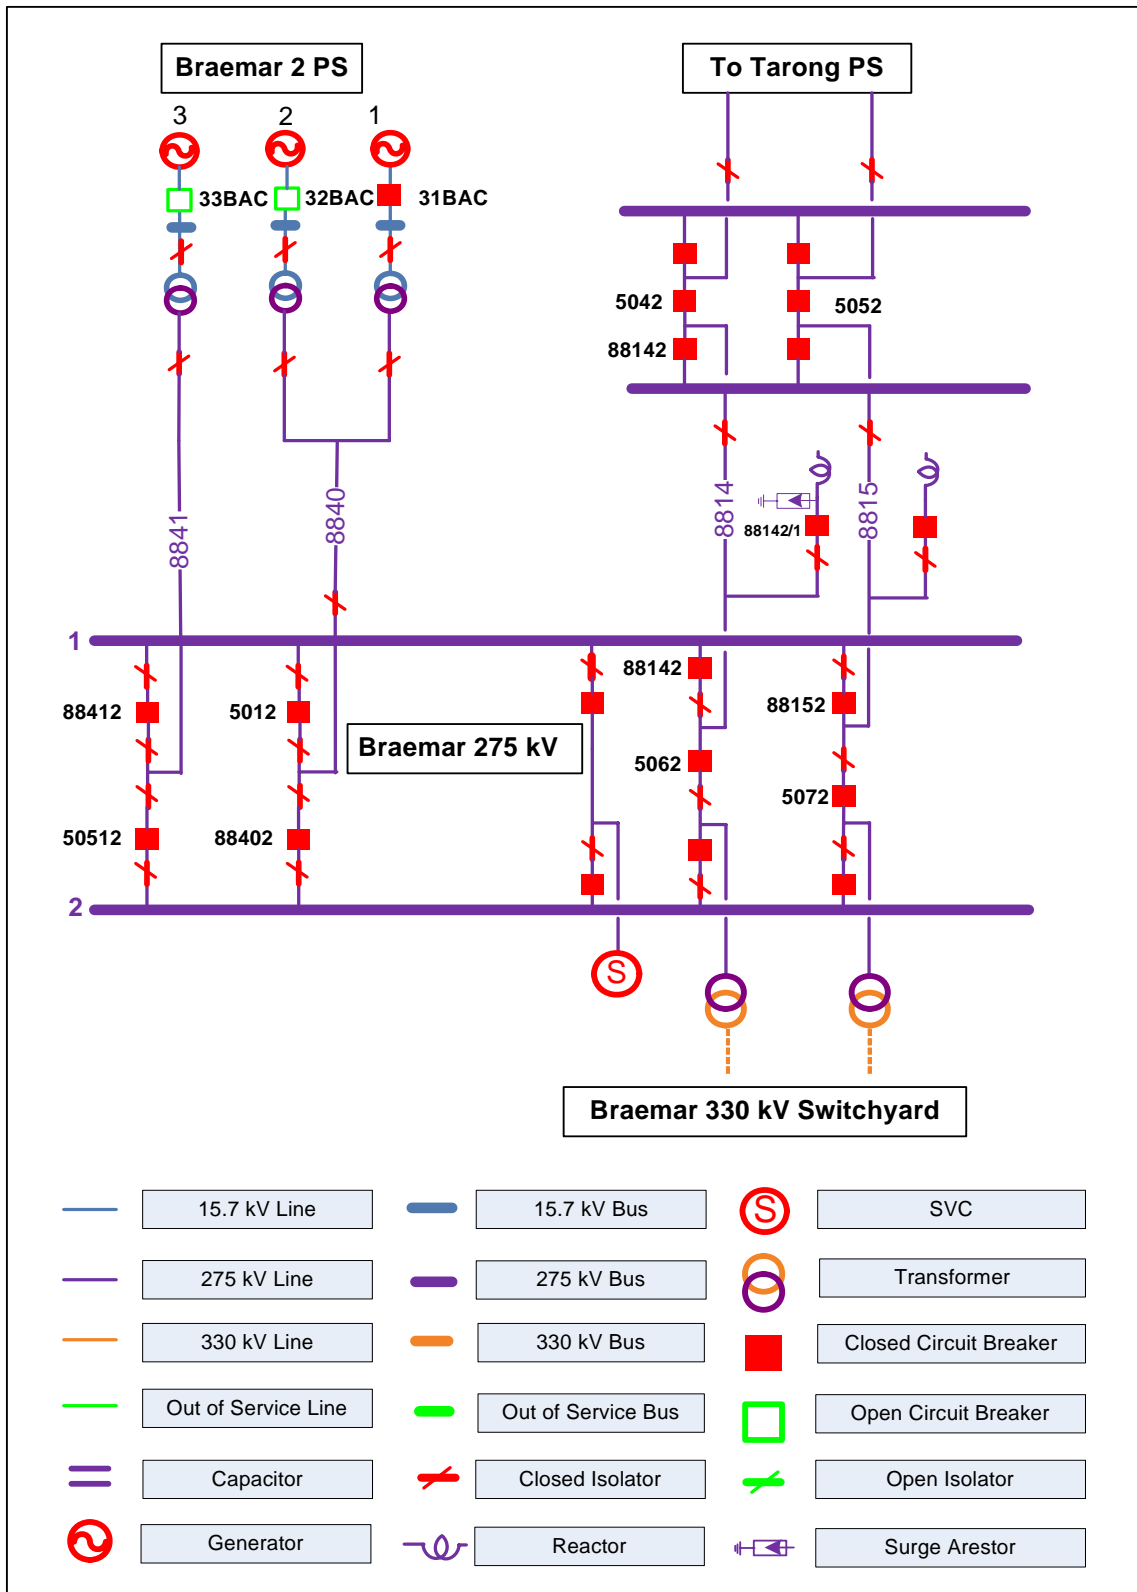
Figure 1: Single line diagram showing status of the relevant transmission plant at Braemar and Tarong 275 kV substation before the high voltage transmission network fault

<p>Immediately on closing of phase A pole of circuit breaker 88142 a high voltage phase to earth fault occurred on the power system. The cause of the high voltage fault was the failure of a 275 kV surge arrester associated with 8814 transmission line reactor at Braemar 275 kV substation.</p> <p>The high voltage fault resulted in the operation of 8814 transmission line protection systems at Braemar 275 kV substation. Protection systems tripped circuit breaker 88142 at Braemar (all phases). The coupler circuit breaker 5062 was already open. Protection systems also tripped 8814 transmission line reactor circuit breaker 88142/1 at Braemar 275 kV substation.</p>	<p>Braemar; line still energised via B and C phases at Tarong.</p>
	<p>Coincident with the high voltage transmission network fault the following 275 kV transmission lines also tripped:</p> <ul style="list-style-type: none"> • Transmission line 8815 Tarong – Braemar 275 kV tripped at the Braemar end only via circuit breaker 88152 and bus coupler circuit breaker 5072. The Tarong end of transmission line 8815 remained closed. • Transmission lines 8840 and 8841 connecting Braemar 2 power station to the transmission network also tripped due to operation of Braemar 2 power station protection systems. 	<p>Braemar-Tarong 275 kV 8815 transmission line including the line reactor and surge arrester open at Braemar; 8815 line still energised from Tarong.</p> <p>Braemar-Braemar 2 power station 275 kV 8840 and 8841 transmission lines disconnected.</p>

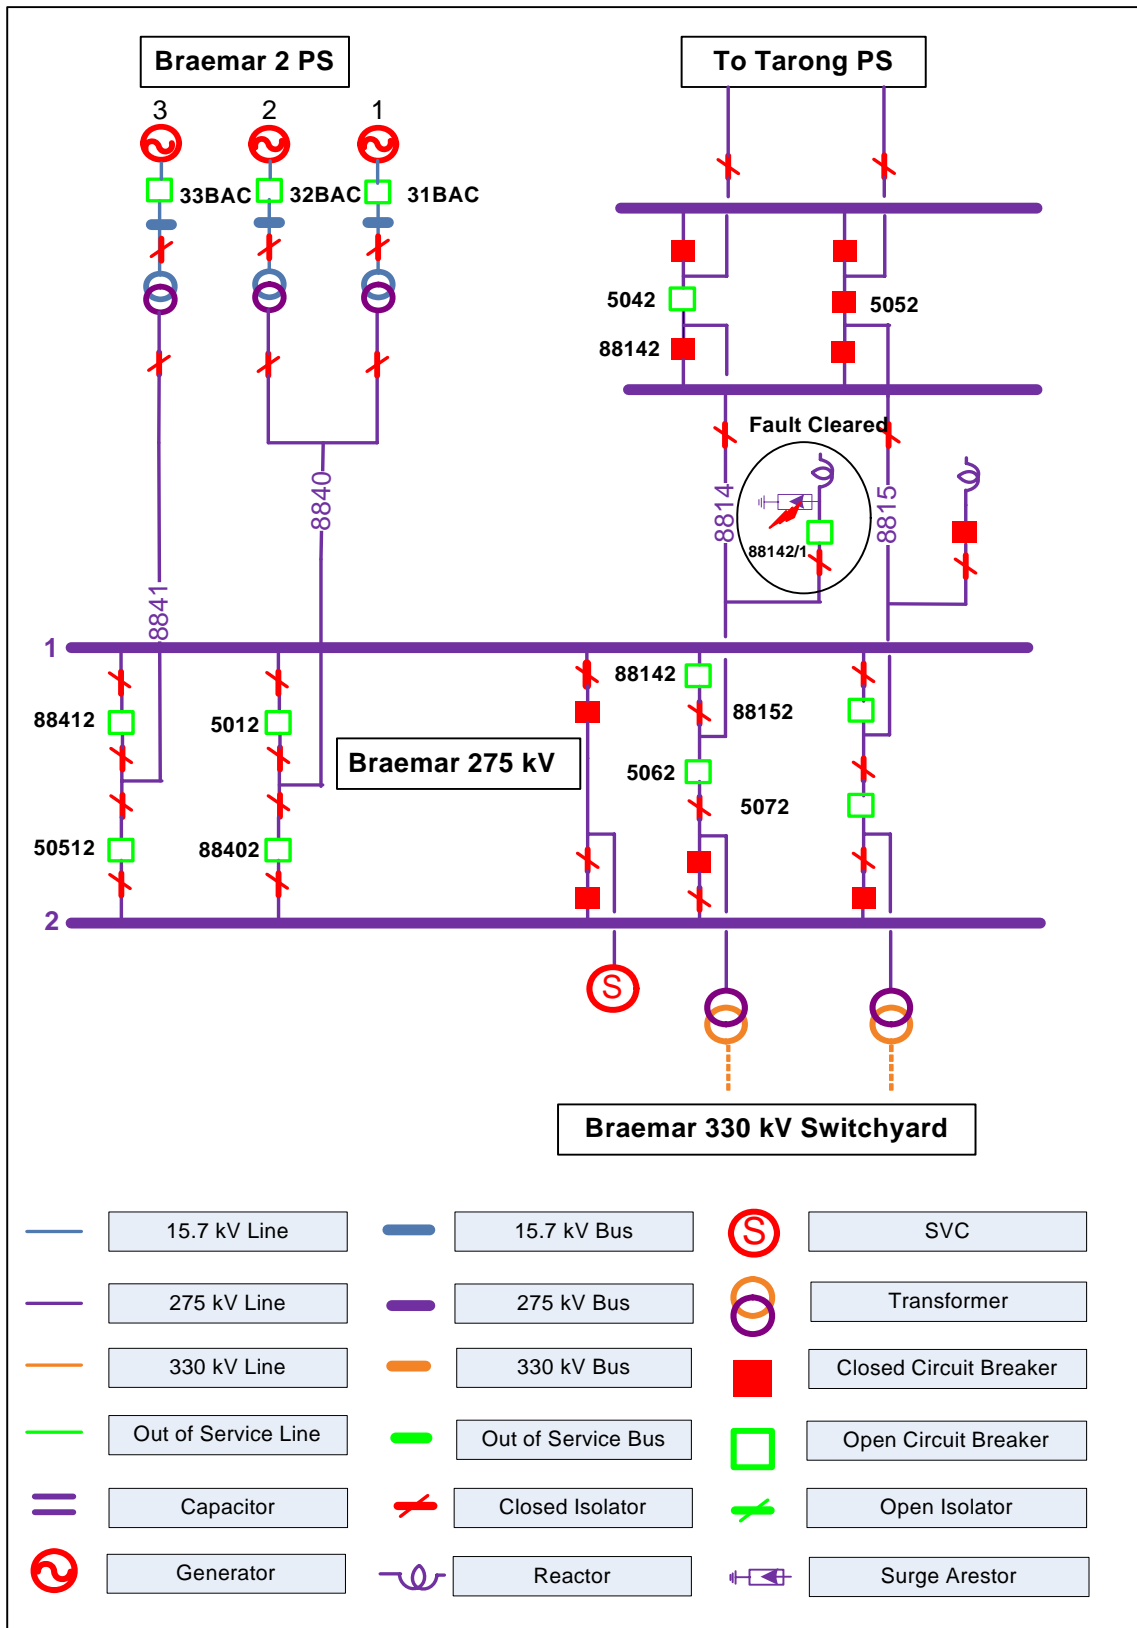
Figure 2: Single line diagram showing status of relevant transmission plant at Braemar and Tarong 275 kV substation after the high voltage transmission fault

The high voltage transmission network fault existed on conductors associated with Braemar-Tarong 275 kV 8814 transmission line resulting in disconnection of transmission lines 8815, 8840 and 8841.

This condition occurs as a result of the 8814 transmission line reactor earthing configuration at Braemar 275 kV substation. To eliminate the risk of the occurrence of over-voltage, the single pole auto-reclose on both Braemar-Tarong 275 kV transmission lines (8814 and 8815) has been turned off. Three pole auto-reclose on these lines remains in service.

Investigation found that the feeder 8815 transmission line Y protection relay at Braemar 275 kV substation had a setting issue causing it to operate for the high voltage fault on feeder 8814. Powerlink resolved this issue by modifying the relay setting on 10 June 2010.
