# POWER SYSTEM INCIDENT REPORT

## TRIP OF SYDNEY NORTH 132 KV 'A' AND 'B' SECTION 1 BUSBARS ON 7 JULY 2010

PREPARED BY: ESOPP  
FINAL

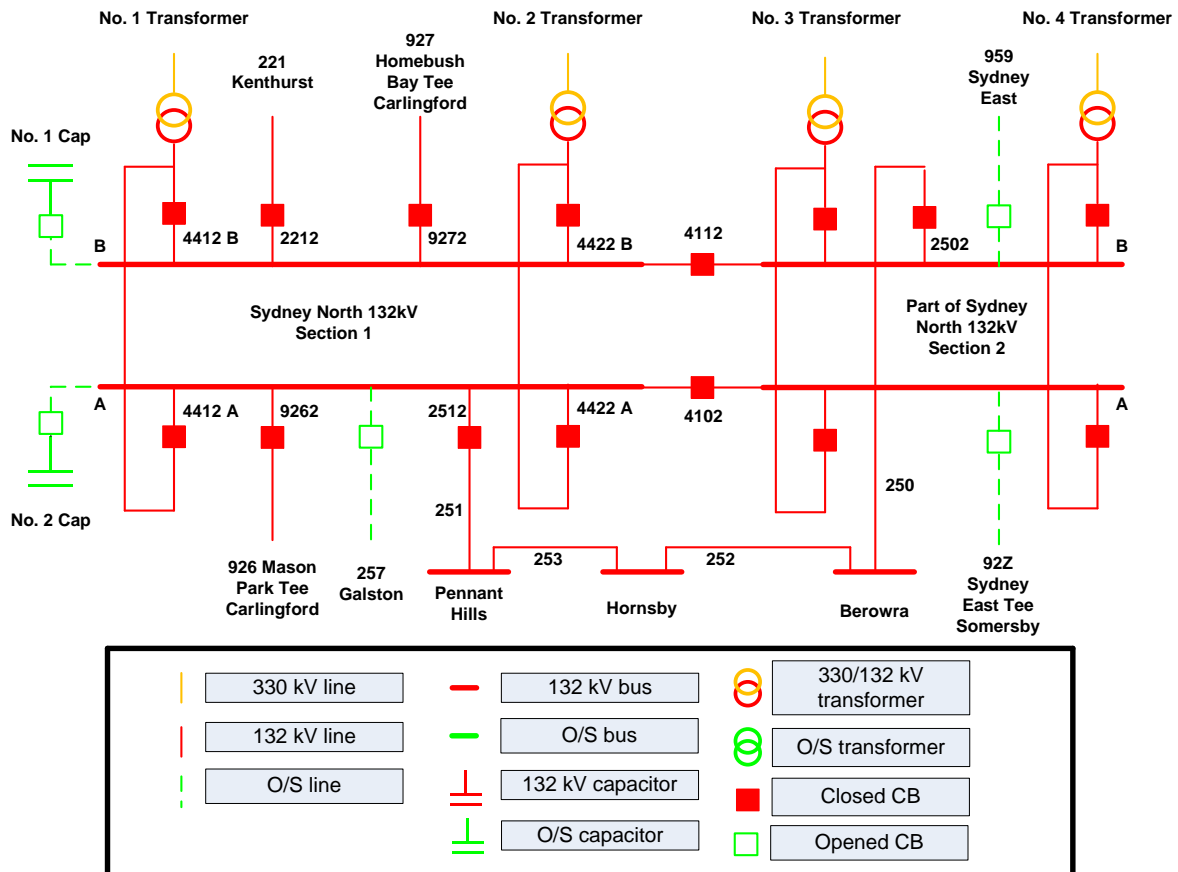
FIGURE 1. SYDNEY NORTH SUBSTATION BEFORE THE INCIDENT

On Wednesday 7 July 2010 at 04:57 hrs, both 132 kV 'A' and 'B' section 1 busbars at Sydney North tripped and the following lines were off-loaded—see Figure 1:

- Sydney North to Kenthurst (221) 132 kV line
- Sydney North to Berowra (250) 132 kV line
- Sydney North to Pennant Hills (251) 132 kV line
- Sydney North to Mason Park tee Carlingford (926) 132 kV line
- Sydney North to Homebush Bay tee Carlingford (927) 132 kV line

The Sydney North to Galston (257) 132 kV line was out of service at the time of the incident. Before the busbar trip, approximately 148 MW of customer load in the areas of Pennant Hills, Hornsby and Berowra was supplied via No. 250 and No. 251 132 kV lines from Sydney North, and therefore the trip of these two lines caused an interruption of supply to these areas—see Figures 1 and 2. At 06:33 hrs, TransGrid attempted to restore supply via No. 250 line, however the line tripped at 06:48 hrs when approximately 24 MW load had been restored. The line was restored later at 08:53 hrs with modified protections. Its pilot wire protection was repaired and returned to service on 16 July 2010 at 11:23 hrs.

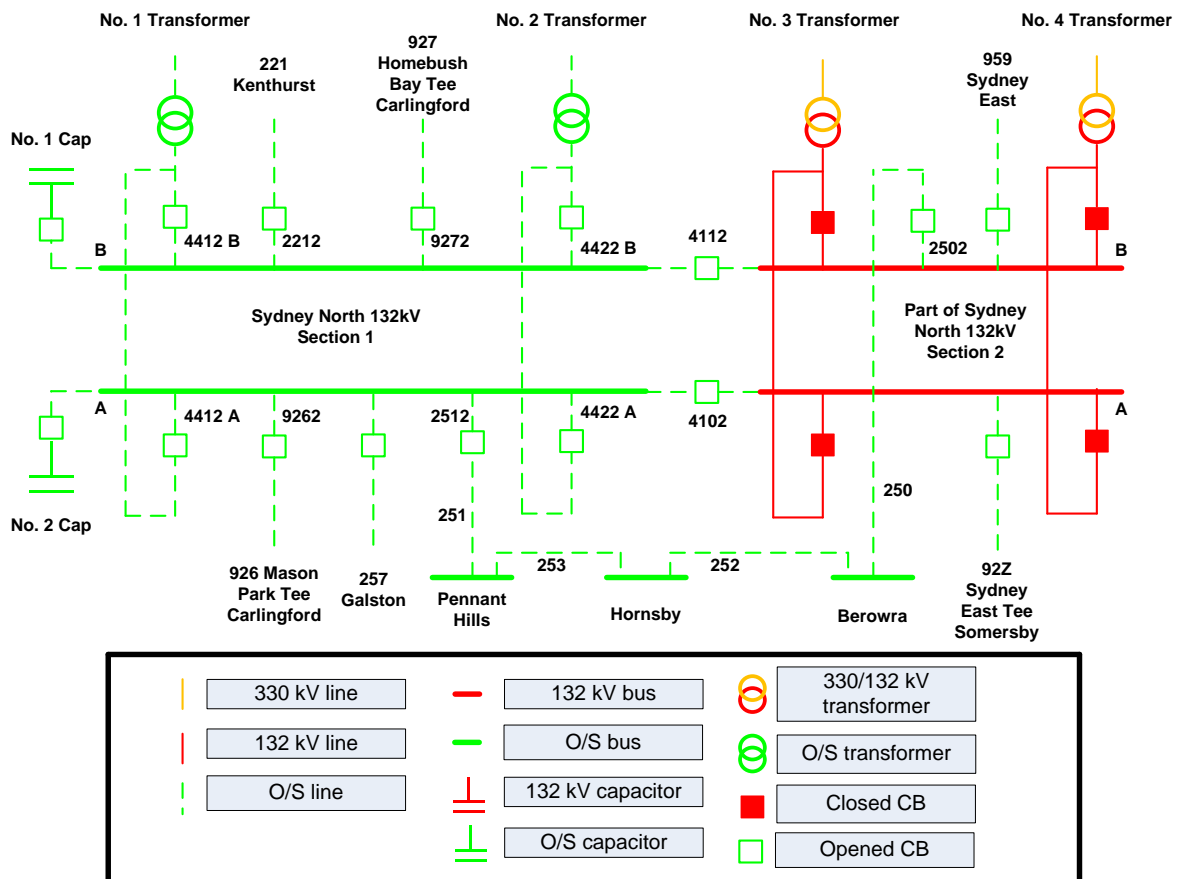
FIGURE 2. SYDNEY NORTH SUBSTATION AFTER THE INCIDENT

TransGrid investigations revealed that the busbar trip resulted from a fire in a cable trench that destroyed approximately 80 control and protection cables affecting services on the 132 kV 'A' and 'B' section 1 busbars. The likely cause of the fire was determined to be a high impedance fault in a low voltage AC supply cable. It is suspected that damage to the AC supply cable caused by rodents would have been the main cause of the fault.

The trip of No. 250 line was caused by an earth fault created by a pre-existing wiring defect in a termination box of a current transformer combined with stray earth currents caused by the cable trench fire.

- The 132 kV 'A' section 1 busbar, No. 2 330/132 kV transformer, No. 2 132 kV capacitor bank and No. 251 line were returned to service on 7 July 2010 at 20:58 hrs.
- The No. 1 330/132 kV transformer was returned to service on 9 July 2010 at 20:16 hrs.
- The 132 kV 'B' section 1 busbar, No. 1 132 kV capacitor bank and No. 221 line were returned to service on 12 July 2010 at 19:39 hrs.
- No. 927 line was returned to service on 13 July 2010 at 18:02 hrs.
- No. 926 line was returned to service on 28 July 2010 at 19:24 hrs.
