# POWER SYSTEM INCIDENT REPORT: TRIP OF DOUBLE CIRCUIT MACKAY- COLLINSVILLE TEE - PROSERPINE 132 KV LINES AND STRATHMORE SVC ON 29 DECEMBER 2010

PREPARED BY: Electricity System Operations Planning and Performance

FINAL

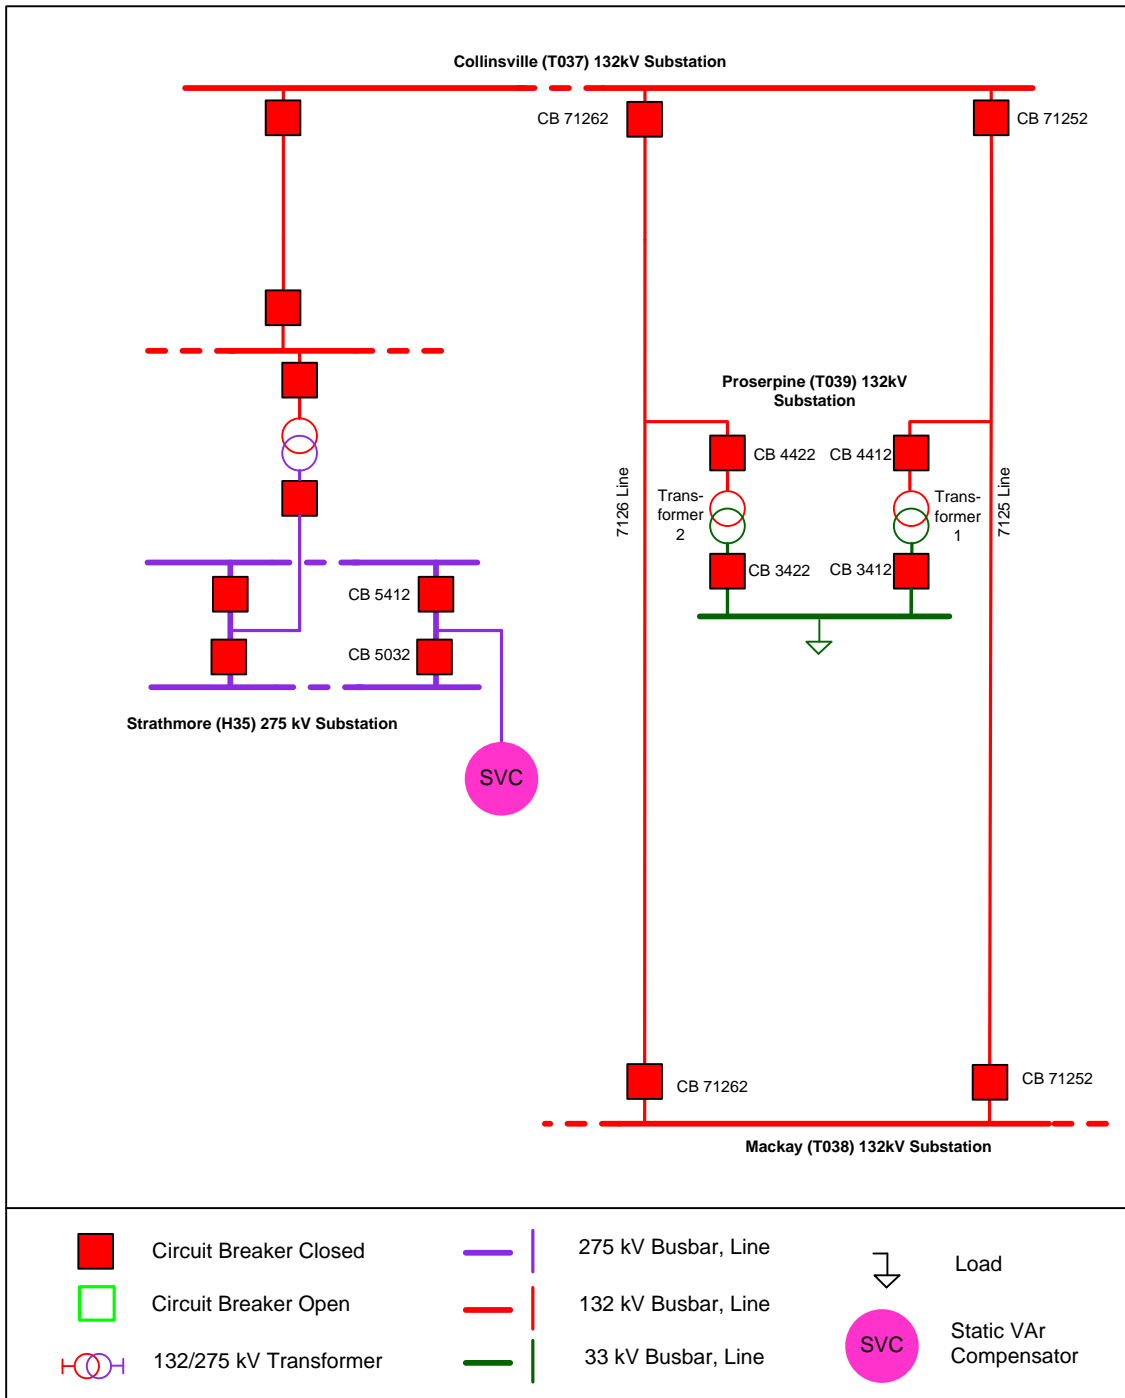
The status of the relevant power system equipment prior to the incident is shown in Figure 1. Before the incident 16 MW was flowing from Collinville to Proserpine and 12 MW from Mackay to Proserpine on each of 7125 and 7126 lines. The Strathmore SVC was in service and absorbing 11 MVar.

Figure 1 – Status of the power system prior to incident

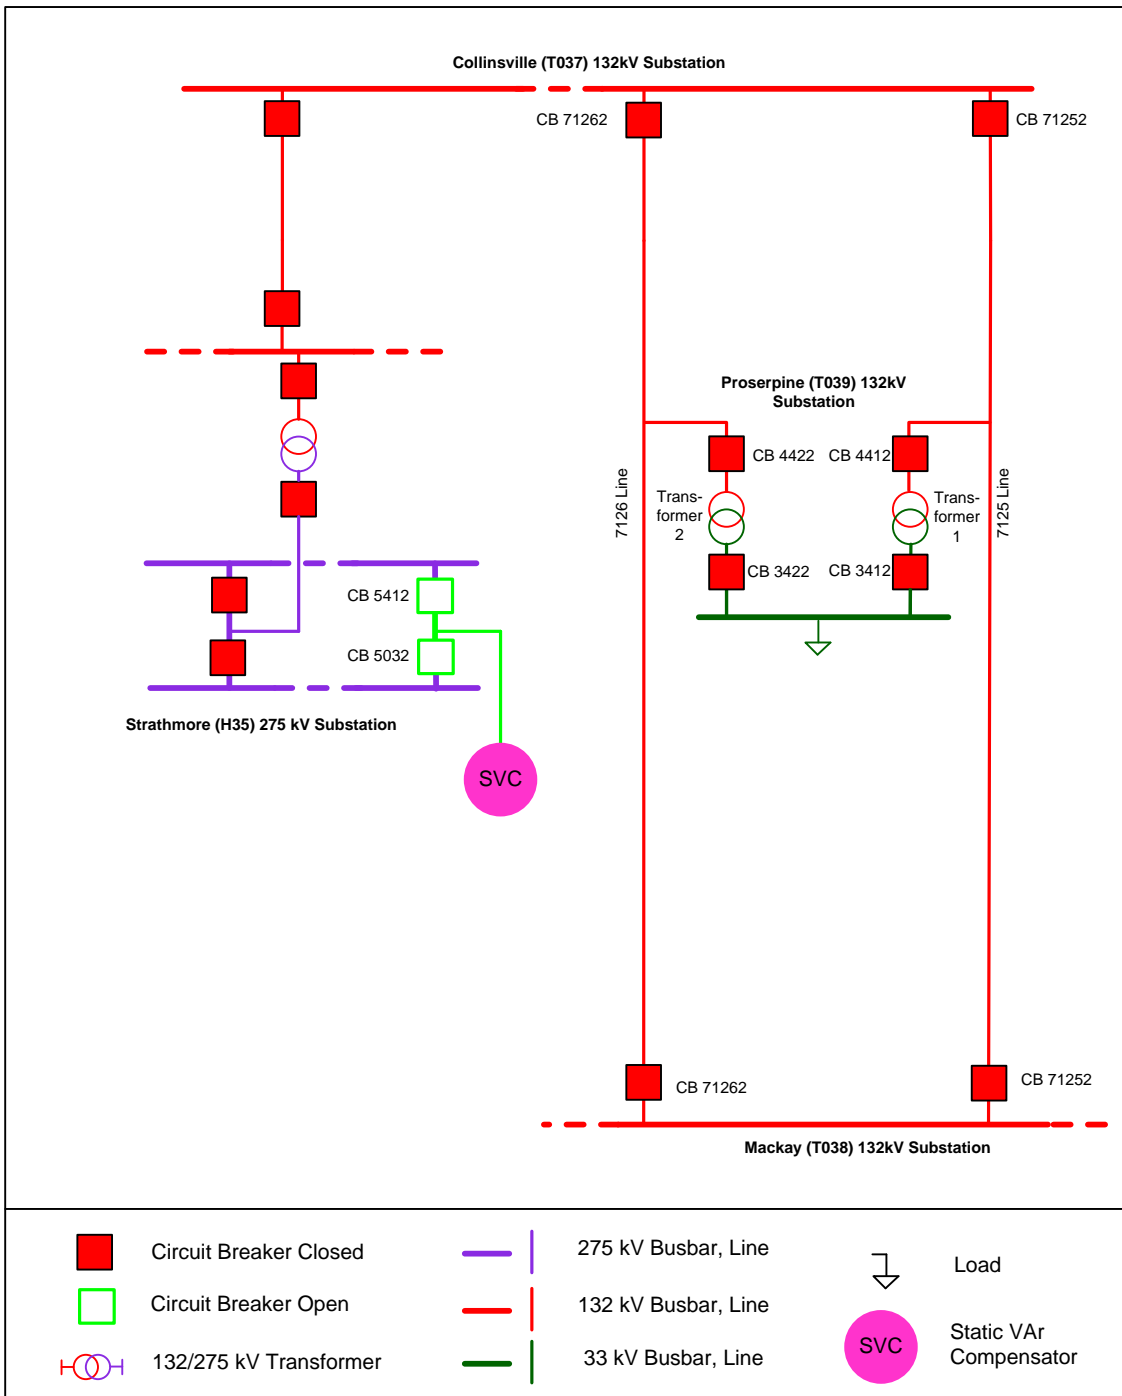
The status of the relevant power system equipment following the auto-reclosing of 7125 and 7126 lines is shown in Figure 2.

Figure 2 – Status of the power system following tripping and auto-reclosing of 7125 and 7126 lines
