# POWER SYSTEM OPERATING INCIDENT REPORT – TRIP OF 220 KV C BUSBAR AT GORDON POWER STATION ON 26 NOVEMBER 2011

PREPARED BY: Electricity System Operations Planning and Performance

DATE: 22 March 2012

FINAL

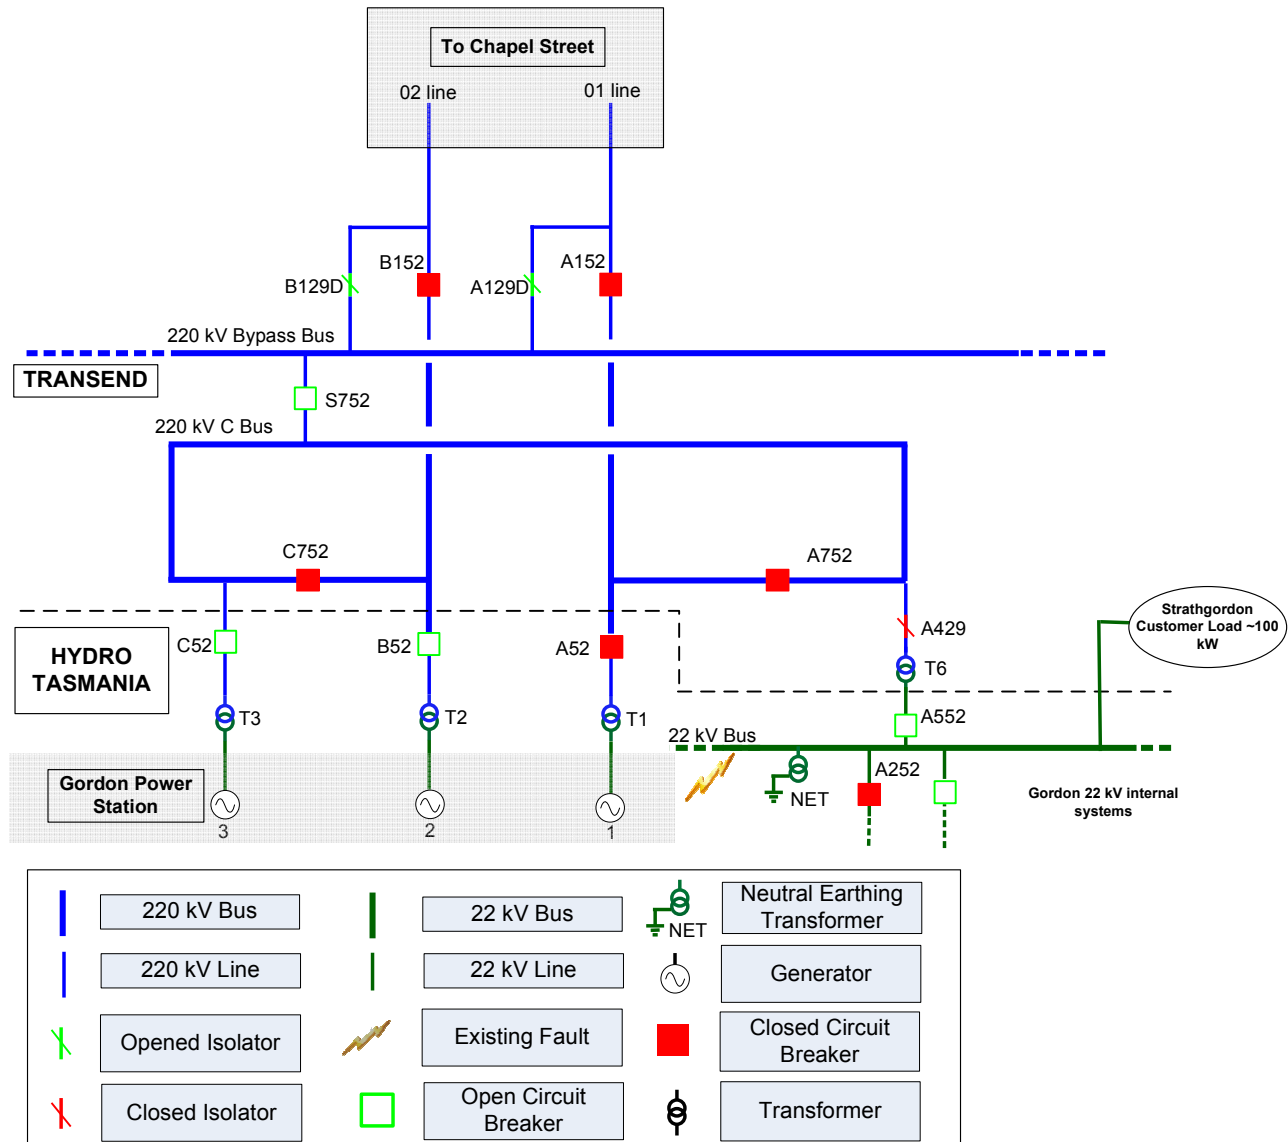
Figure 1 - Status of the power system prior to the incident

Prior to the incident, Gordon 1 generating unit was generating 23 MW. Gordon 2 and 3 generating units were out of service.

The status of the power system prior to the incident is shown in Figure 1. For clarity, only equipment relevant to this incident has been included in the diagram.

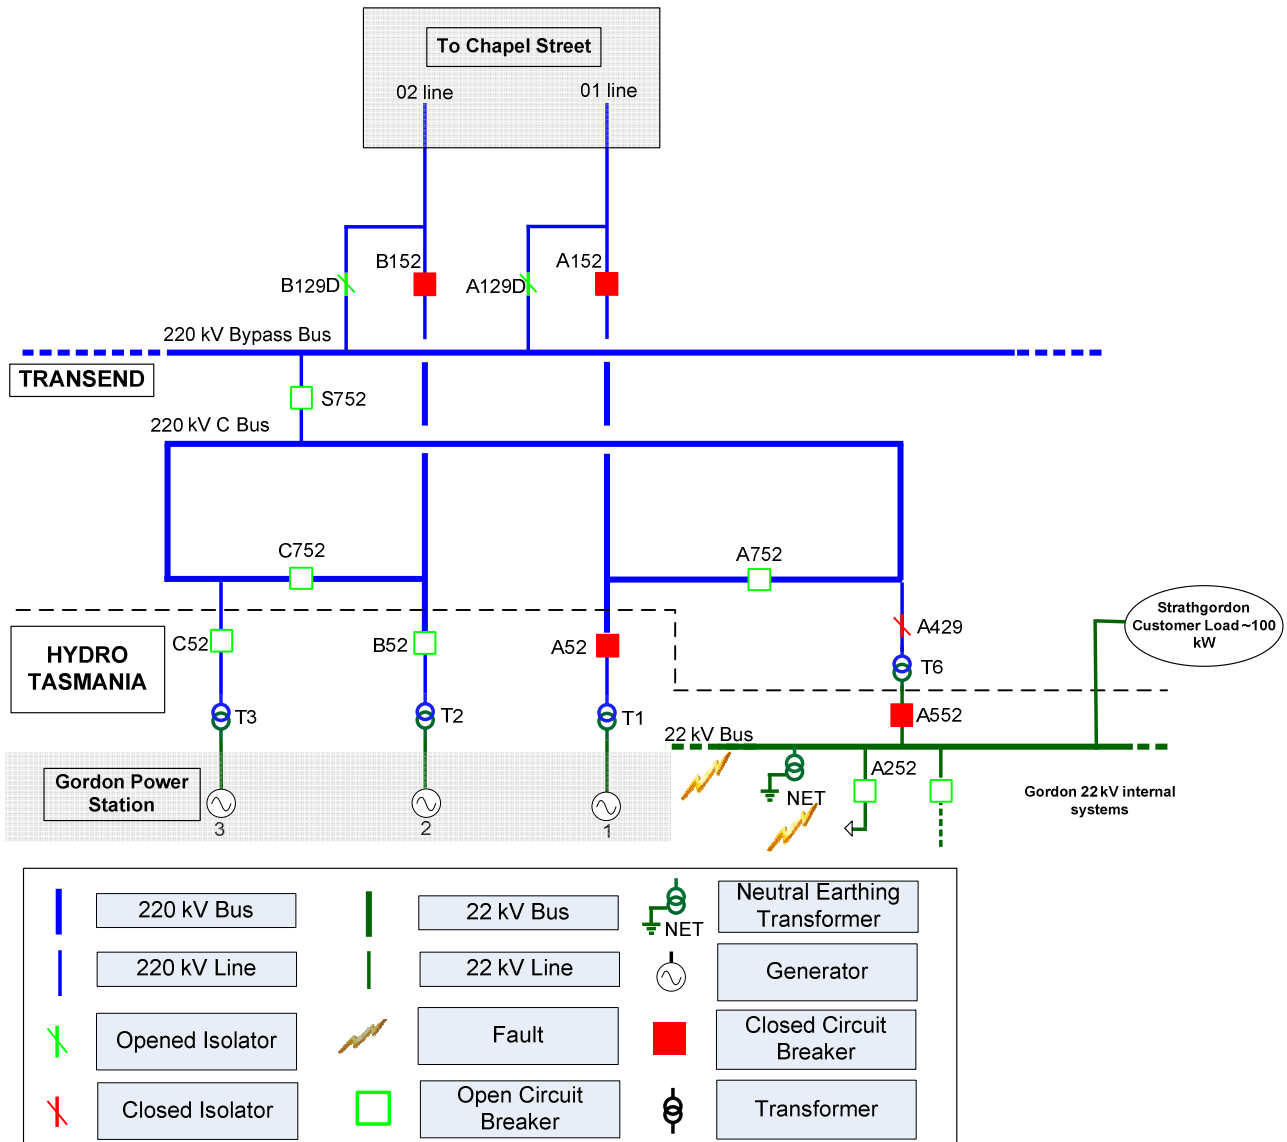
Figure 2 - Status of the power system after the incident

The status of the power system immediately after the incident is shown in Figure 2.
