POWER SYSTEM OPERATING INCIDENT REPORT TRIP OF MULTIPLE TRANSMISSION LINES ON 27 DECEMBER 2011

PREPARED BY: Electricity System Operations Planning and Performance

DATE: 18 April 2012

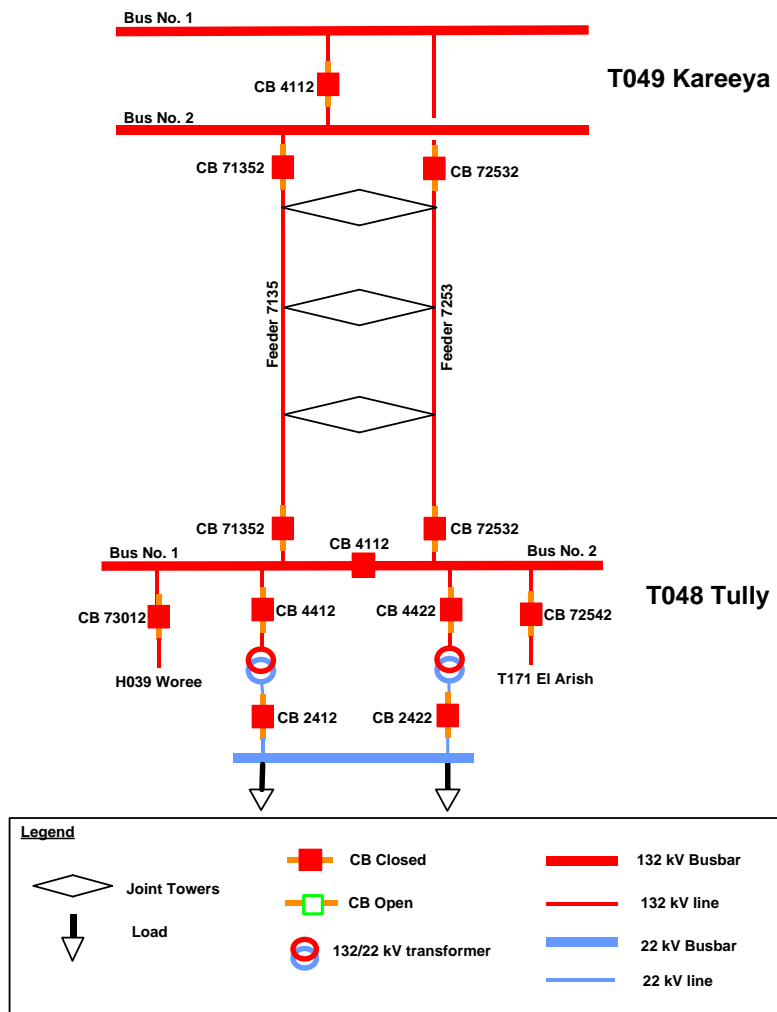
Figure 1 – Network topology prior to the incident

The 7135 and 7253 Kareeya–Tully 132 kV lines are double circuit lines that share common towers along their route length.

The status of the power system prior to the incident is shown in Figure 1. For clarity only equipment relevant to this incident has been included in the diagram.

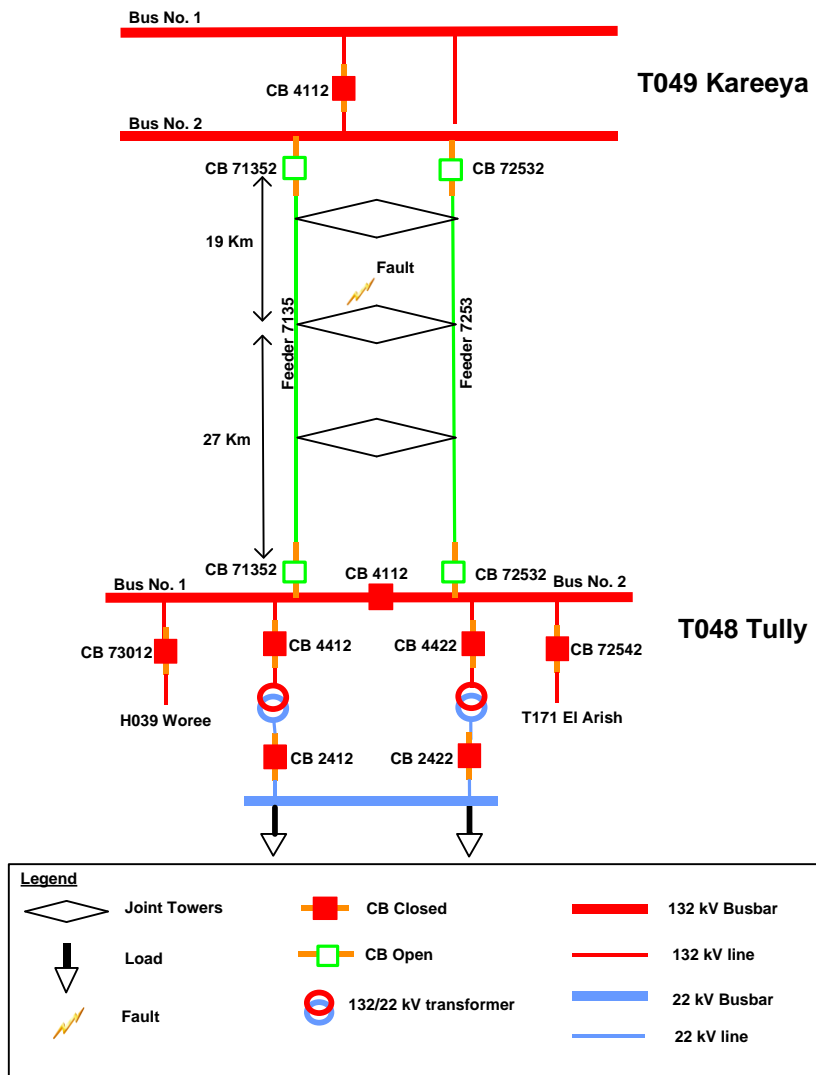
Figure 2 – Network topology following the incident

At a time of lightning activity on 27 December 2011, simultaneous high voltage faults occurred on the 7135 and 7253 Kareeya–Tully 132 kV parallel lines. The high voltage faults occurred at the time of an electrical storm in the area of the lines. The faults on both lines were successfully cleared by the operation of their respective distance protection systems. However, neither line auto-reclosed. The 7253 line did not auto-reclose because auto-reclose on the line was disabled due to maintenance work. For the 7135 line auto-reclose was initiated, but due to a fault in the auto-reclose relay at Kareeya, the line remained de-energised.

Powerlink’s incident report confirmed the high voltage faults occurred immediately following a lightning strike as recorded by the Lightning Tracker System. The line protection systems indicated the faults occurred at similar locations on both lines. The fault location was determined to be 27 km from Tully substation and 19 km from Kareeya substation. The fault location calculated by the protection relays was consistent with the location of the lightning strike as recorded by the Lightning Tracker System.

The status of the power system immediately after the incident is shown in Figure 2.

Powerlink confirmed that 7135 line did not auto-reclose due to a fault with the auto-reclose relay at Kareeya. Powerlink has replaced the auto-reclose relay to mitigate the risk of similar incidents occurring in future.
