# POWER SYSTEM INCIDENT REPORT SIMULTANEOUS LOSS OF NO.1 MOUNT BEAUTY TO DEDERANG AND MOUNT BEAUTY TO MACKAY CREEK TEE BOGONG 220 KV LINES ON 24 JANUARY 2011

PREPARED BY: ESOPP  
VERSION: 1.0  
DATE: 31 May 2011  
FINAL

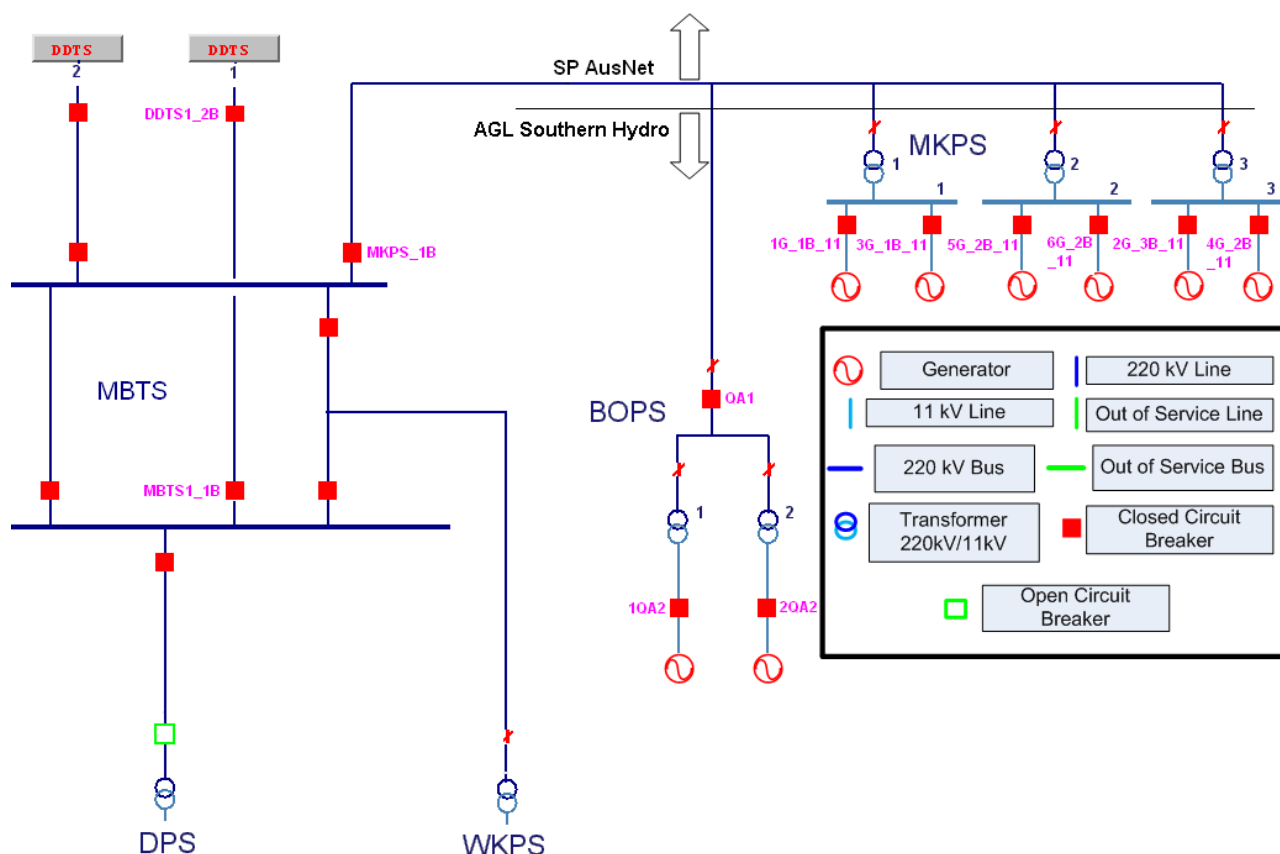
Figure 1 –Network in the vicinity of SP AusNet’s MBTS switchyard and AGL’s MKPS and BOPS before the incident

On 24 January 2011, the Mount Beauty 220 kV terminal station (MBTS) was operating in its system normal configuration. Refer to Figure 1 for the network configuration in the vicinity of Mount Beauty 220 kV terminal station and the connections to Dederang 220 kV terminal station (DDTS), as well as Mackay and Bogong power stations, before the incident took place.

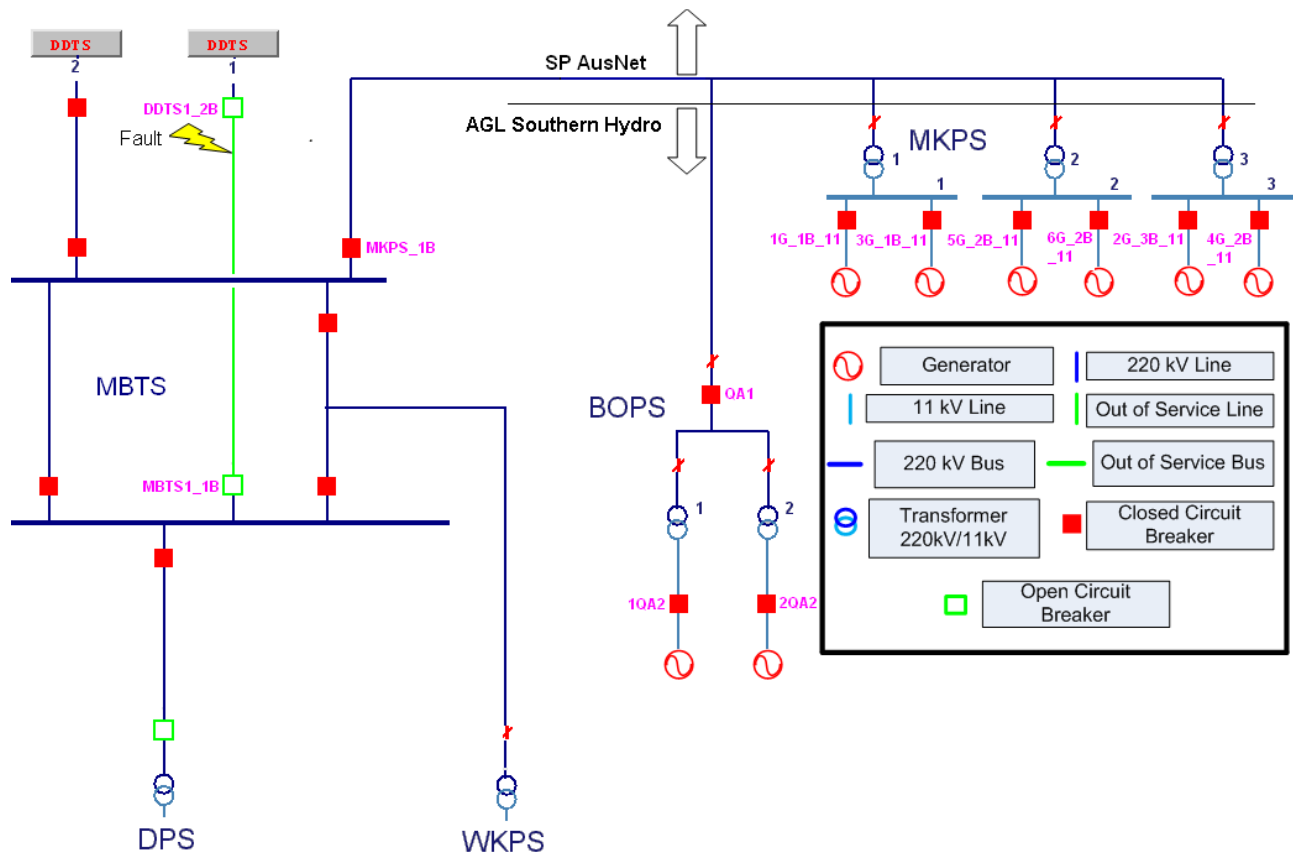
Figure 2 – Network in the vicinity of SP AusNet’s MBTS switchyard and AGL’s MKPS and BOPS immediately after the fault

Though the No.1 DDTS to MBTS 220 kV line auto-reclosed successfully the white phase conductor of the line had broken at the DDTS end during the fault, resulting in power transfer on two phases only and causing the parallel No.2 MBTS to DDTS 220 kV line to carry a much higher current in its white phase. Immediately after the line auto-reclosed the neutral to earth currents on the MKPS and BOPS generator transformers reappeared with increasing magnitude.

Refer to Figure 2 for an overview of MBTS and the connections to DDTS, MKPS and BOPS immediately after the fault on the No.1 DDTS to MBTS 220 kV line.

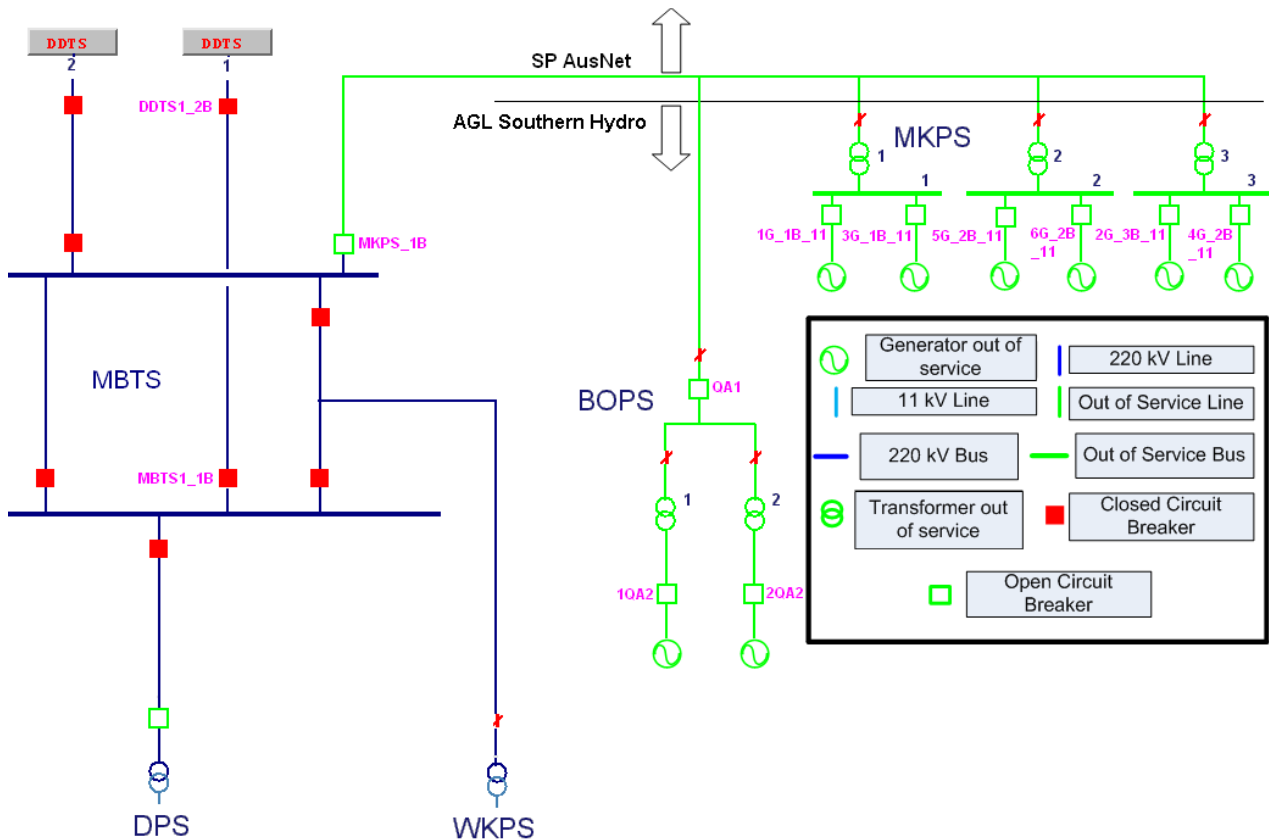
Figure 3 – Network in the vicinity of SP AusNet’s MBTS switchyard and AGL’s MKPS and BOPS immediately after the trip of MBTS to MKPS tee BOPS 220 kV line

The increasing earth fault current was seen by a common earth fault protection relay installed on the MKPS No.1 and No.2 generator transformers, which sent a protection inter-trip to BOPS and MBTS after a set time delay. The MBTS to MKPS tee BOPS 220 kV line tripped on receiving this intertrip, interrupting 197 MW of generation at MKPS and BOPS. Refer to Figure 3 for an overview of MBTS and the connections to DDTS, MKPS and BOPS immediately after the trip of MBTS to MKPS tee BOPS 220 kV line.

The redundant earth fault protection at MKPS should not have operated for the earth fault on the No.1 DDTS to MBTS 220 kV line. Investigations by AGL found that the protection that sent intertrips to BOPS and MBTS should have been removed from service after commissioning of the more suitable earth fault protection installed as part of the MKPS No.3 generator transformer installation. However AGL had inadvertently left this old protection relay element in service.

At 1907 hrs, SP AusNet returned the MBTS to MKPS tee BOPS 220 kV line to service following AGL’s initial investigations and the removal of the redundant MKPS No.1 and 2 generator transformer earth fault protection that had sent intertrips to MBTS and BOPS. At 1931 hrs AEMO revoked the relevant constraint set V-MBMK.

A redundant earth fault protection relay at MKPS incorrectly sent a protection intertrip to BOPS and MBTS, resulting in the trip of the MBTS to MKPS tee BOPS 220 kV line and the interruption of 197 MW of generation at MKPS and BOPS. AGL has since removed this protection relay element from service.
