# POWER SYSTEM OPERATING INCIDENT REPORT – LOSS OF MULTIPLE TRANSMISSION ELEMENTS ON 22 AND 23 OCTOBER 2012 IN QUEENSLAND REGION.

PREPARED BY: Systems Performance and Commercial

DATE: 18 January 2013

FINAL

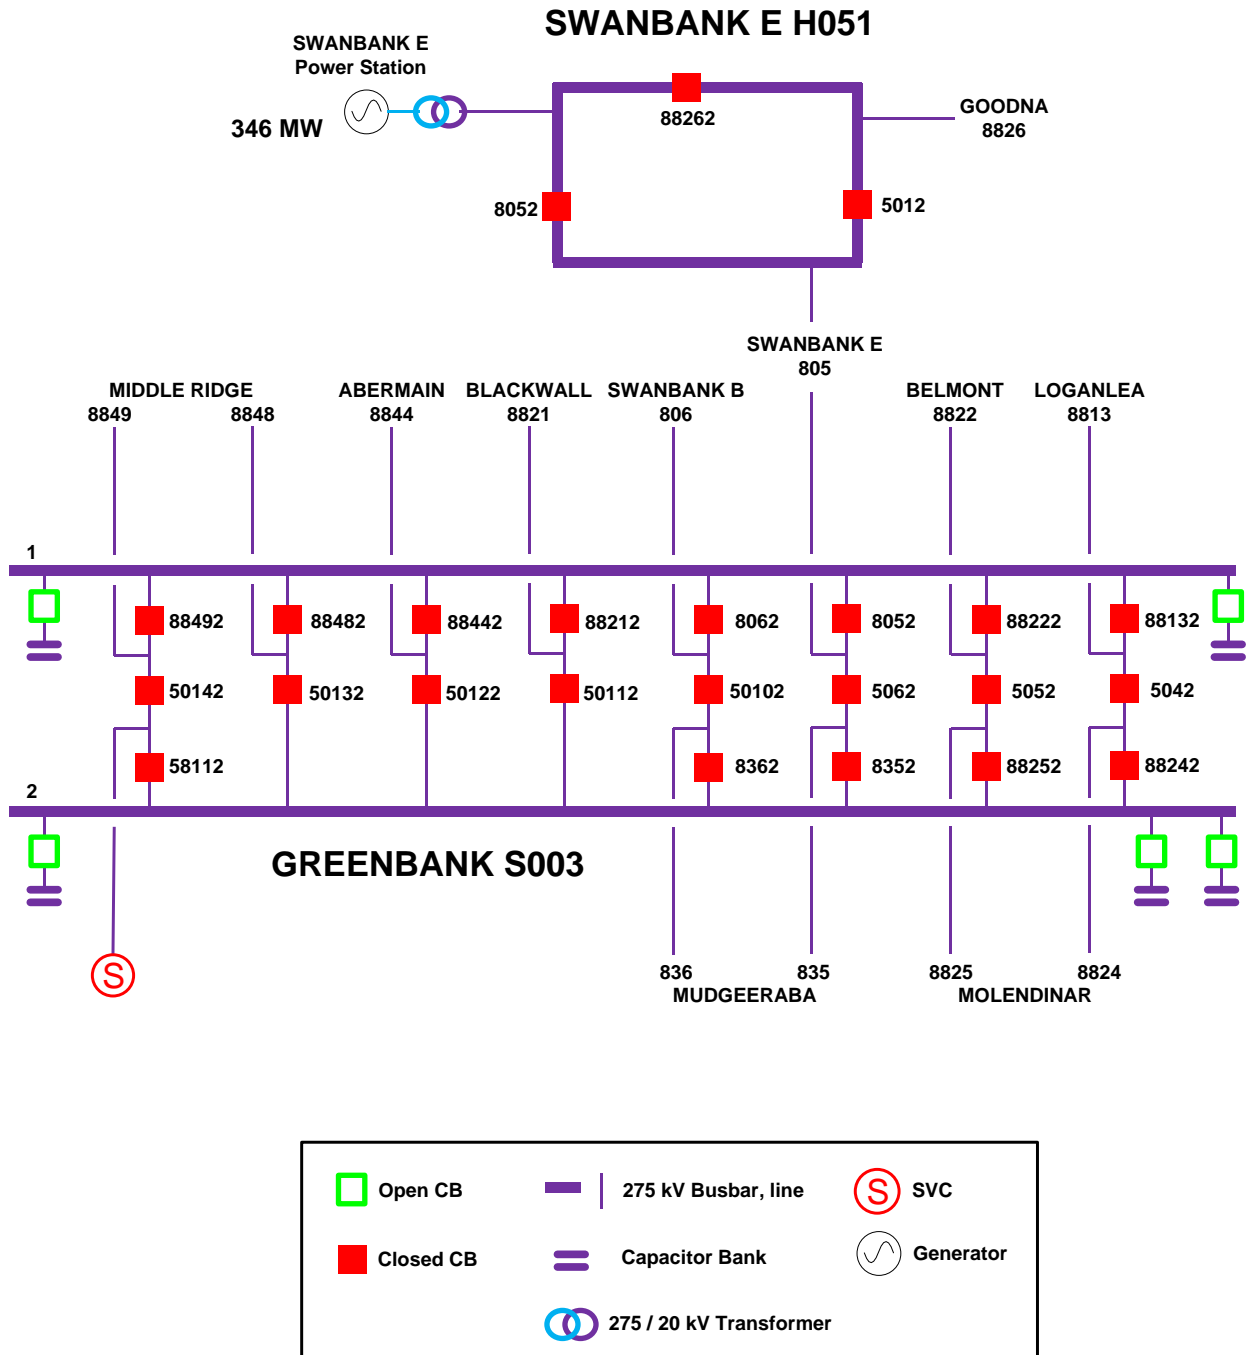
Figure 1 - Status of the power system prior to the incident on 22 October 2012

The status of the power system prior to the incident on 22 October 2012 at 18:36 hrs is shown in Figure 1.

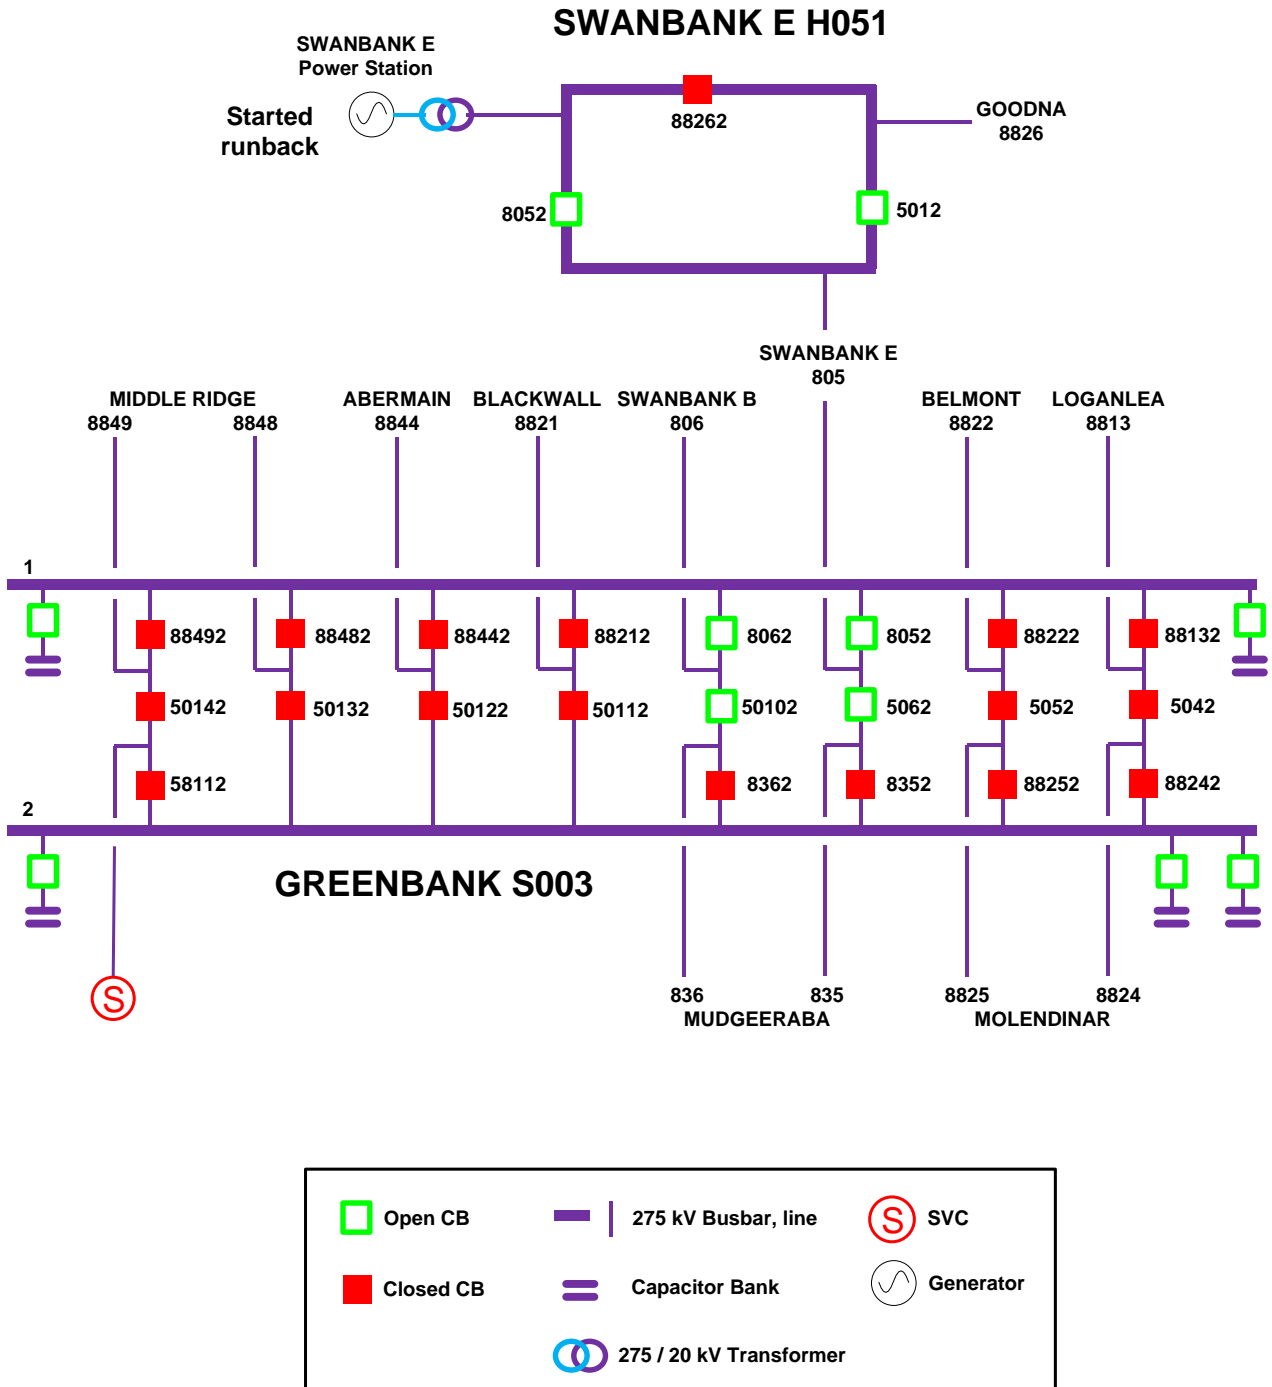
Figure 2 - Status of the power system immediately after the event on 22 October 2012

The status of the power system immediately after the event on 22 October is shown in Figure 2.

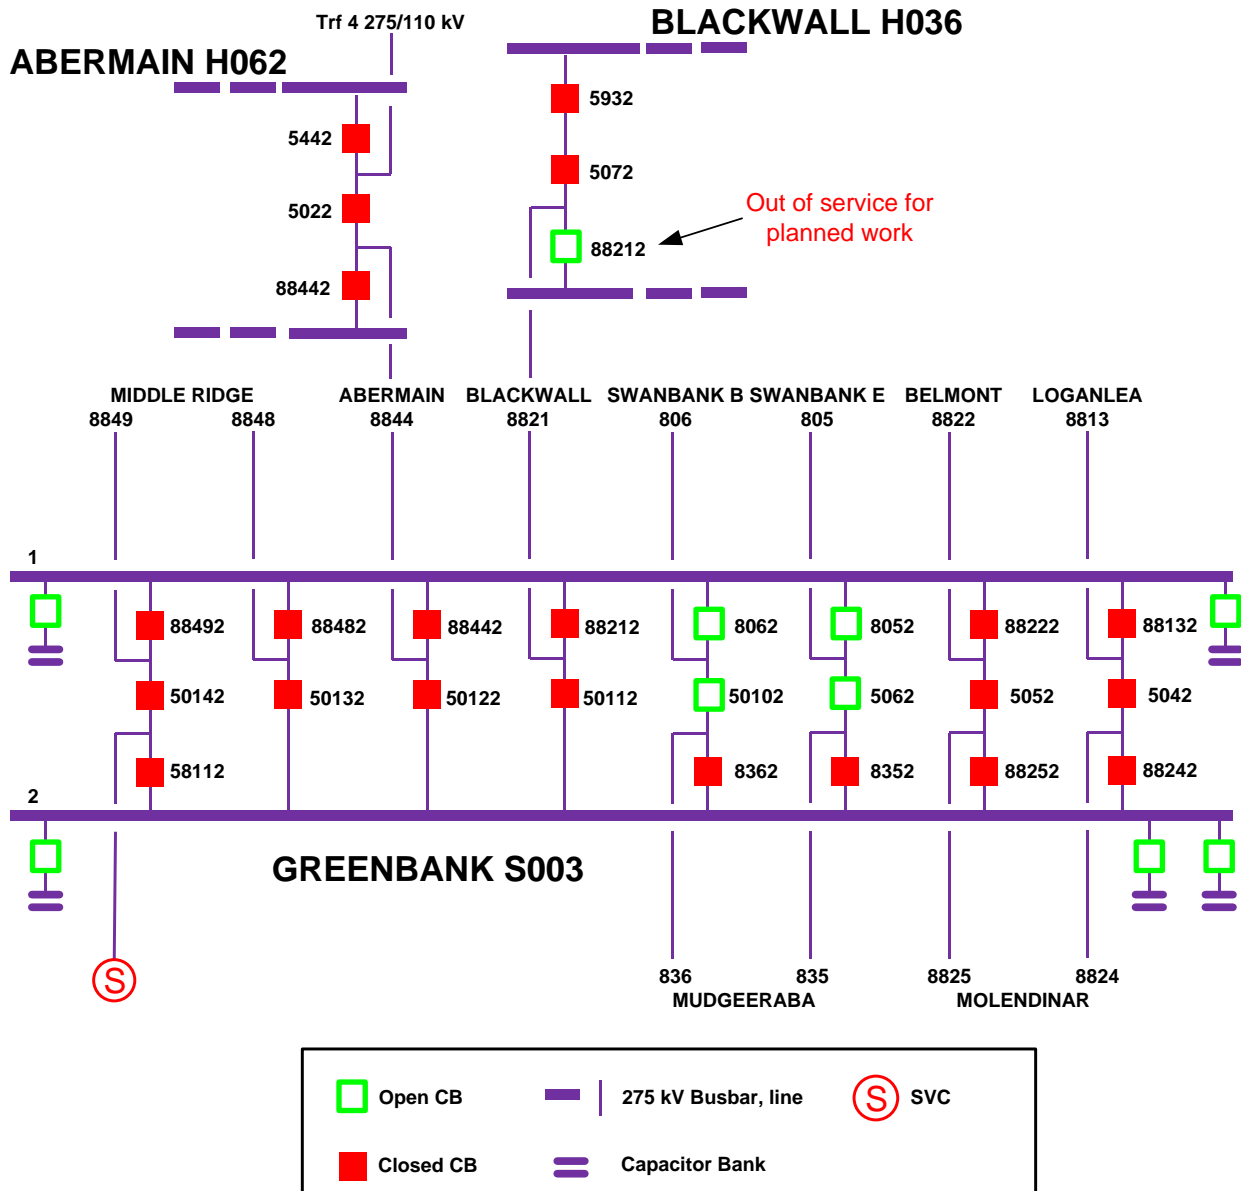
Figure 3 - Status of the power system prior to the incident on 23 October 2012

Figure 3 represents the status of the power system prior to the incident on 23 October at 12:17 hrs. CB 88212 at Blackwall was taken out of service from 09:58 to 16:26 hrs on 23 October due to a planned outage, and 275kV lines 805 and 806 remained out of service after the events on 22 October.

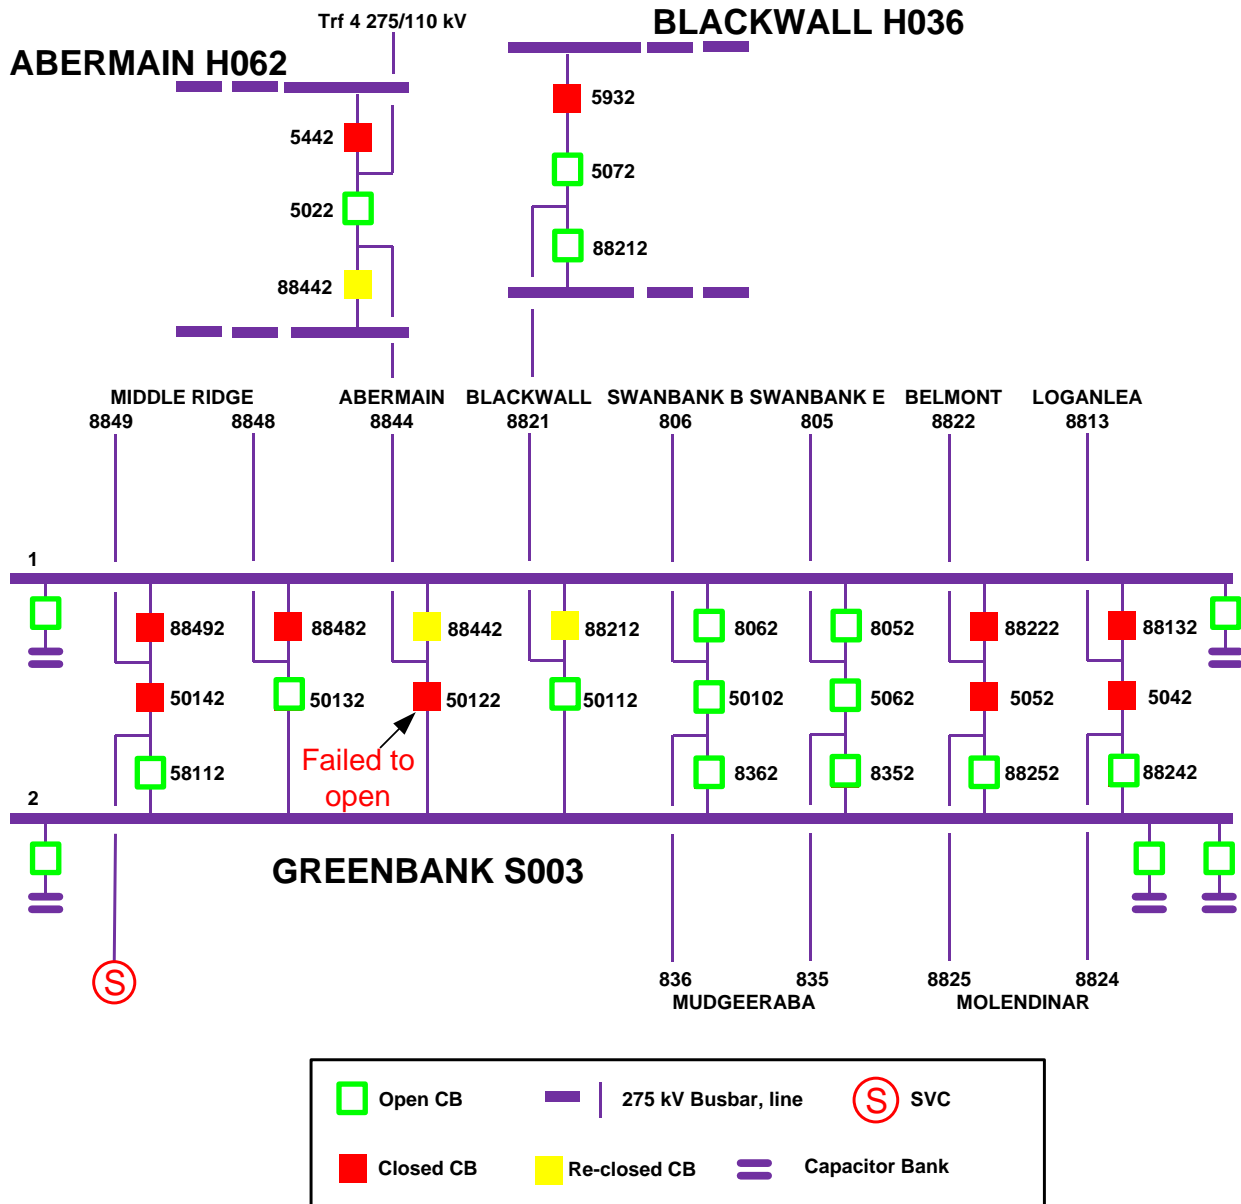
Figure 4 - Status of the power system immediately after the event on 23 October 2012

Figure 4 shows the condition of the power system immediately after the event on 23 October.
