POWER SYSTEM OPERATING INCIDENT REPORT

SIMULTANEOUS TRIP OF 71 MT PIPER – WALLERAWANG 330 KV LINE AND MT PIPER NO.1 UNIT ON 13 FEBRUARY 2012

PREPARED BY: Electricity System Operations Planning and Performance

DATE: 7 June 2012

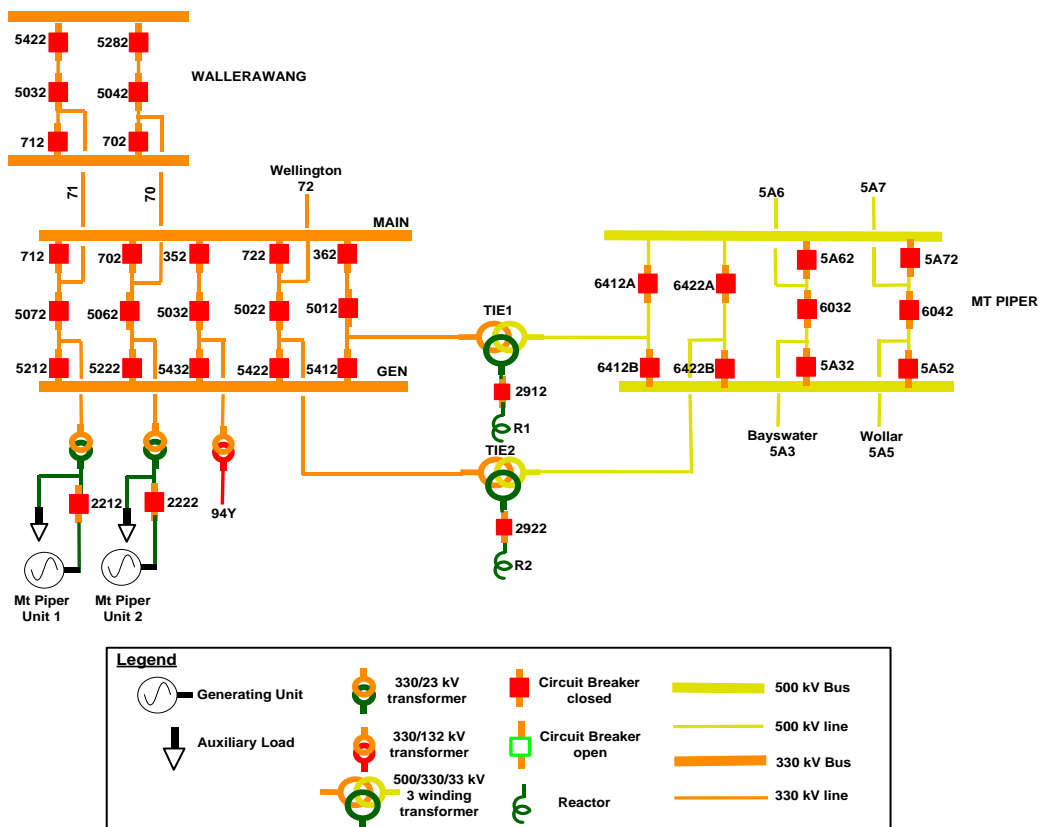
Figure 1 – Network topology prior to the incident

The status of the power system prior to the incident is shown in Figure 1. For clarity only equipment relevant to this incident has been included in the diagram.

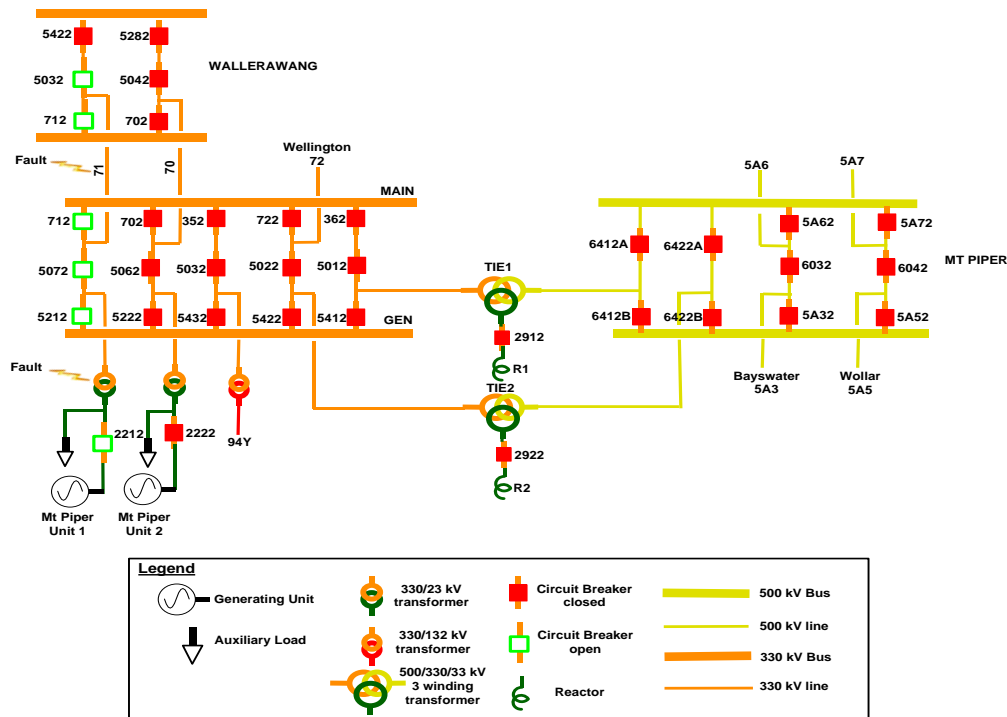
Figure 2 – Network topology following the trip of 71 line and Mt Piper No.1 generating unit

The status of the power system immediately following the trip of the 71 line and Mt Piper No.1 generating unit is shown below.

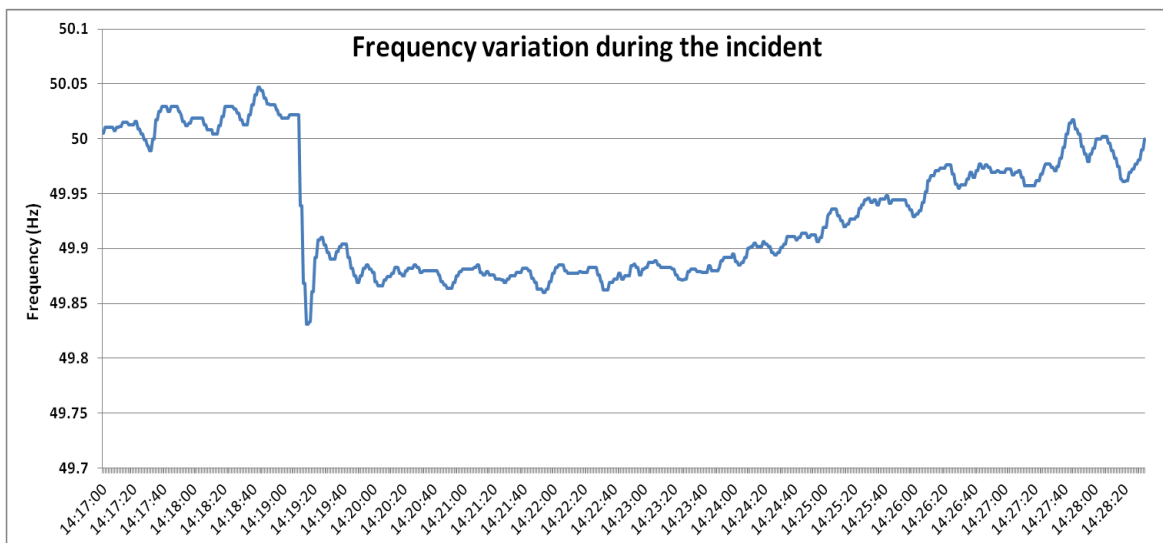
Figure 3 – Frequency variation during the incident

As a result of the incident, the mainland power system frequency dropped to 49.83 Hz, below the normal operating band of 49.85 Hz – 50.15 Hz. However, the frequency was well within the mainland frequency operating standard of 49.5 Hz – 50.5 Hz for a generation event. The frequency returned to the normal operating band (49.85 Hz – 50.15 Hz) within 4 seconds. The power system frequency variation in the mainland is shown in Figure 3 below.
