POWER SYSTEM OPERATING INCIDENT REPORT – TRIP OF 275 KV WEST BUSBAR AT TORRENS ISLAND B POWER STATION ON 23 MAY 2012

PREPARED BY: Systems Capability

DATE: 14 September 2012

FINAL

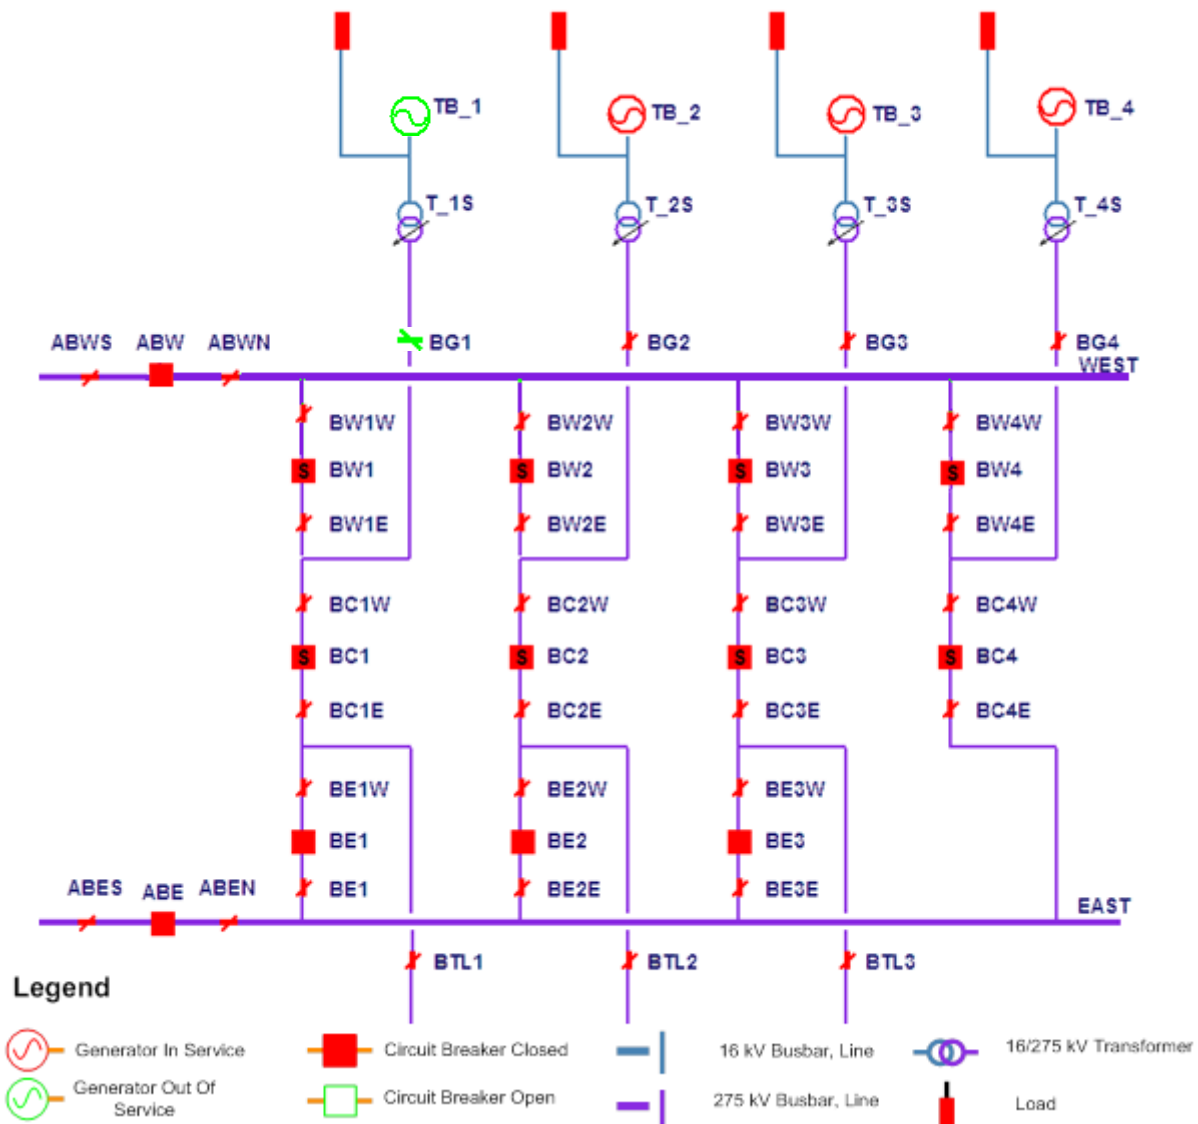
Figure 1 - Status of Torrens B 275 kV power station immediately prior to the incident

At 1059 hrs on 23 May 2012, the 275kV West busbar at TIPS B tripped. Staff were working at the site as part of the TIPS B protection upgrade project.

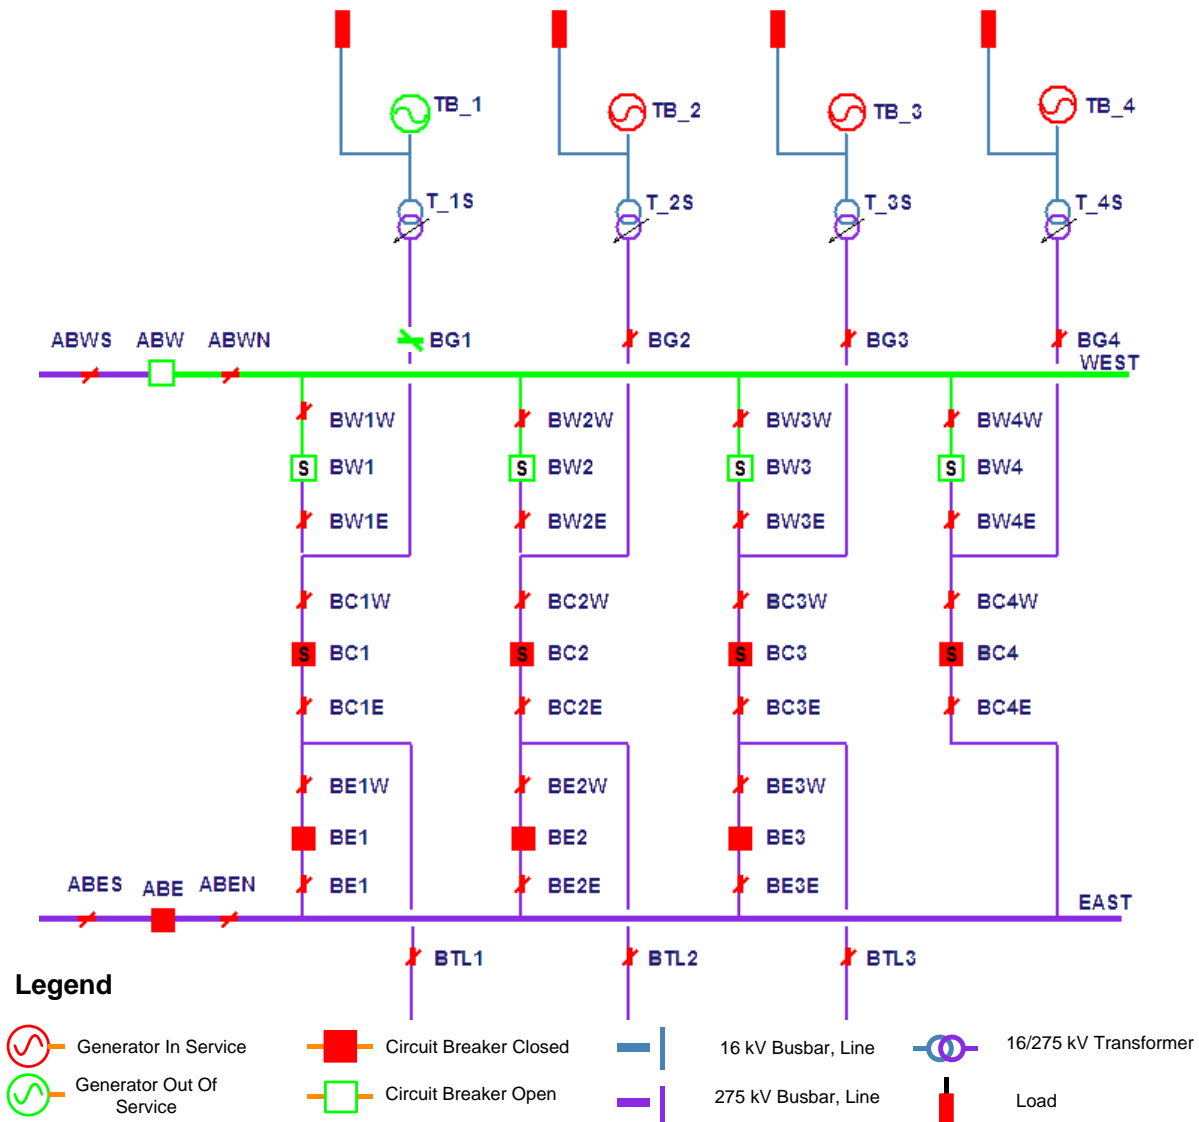
Figure 2 - Status of Torrens B 275 kV power station immediately after the incident

ElectraNet advised that the busbar trip occurred on operation of the busbar protection multi-trip relay, but found no evidence of a high voltage busbar fault.

ElectraNet suspected that the inadvertent busbar trip could have occurred due to a short circuit of the busbar protection multi-trip relay wiring during nearby cabling work (the wiring was old and only single layer insulation). However, ElectraNet's investigation of the auxiliary relays and secondary wiring insulation did not identify any faults, and there were no visible signs of damage to cables.

At 1029 hrs on 23 May 2012 the 275kV West busbar at TIPS B tripped. The exact reasons for the busbar trip could not be found. Poor insulation of the old wiring on the protection multi-trip relays, possibly disturbed by workmen pulling new cables at the time, is the most likely cause of the incident. The old wiring has since been replaced.

ElectraNet performed corrective actions to prevent the recurrence of the problem by installing temporary, armoured wiring to replace the old wiring. Permanent wiring was installed on 30 June 2012.
