POWER SYSTEM OPERATING INCIDENT REPORT – TRIP OF BELMONT NO.7 110 KV BUSBAR ON 16 JUNE 2012

PREPARED BY: Systems Capability

DATE: 4 October 2012

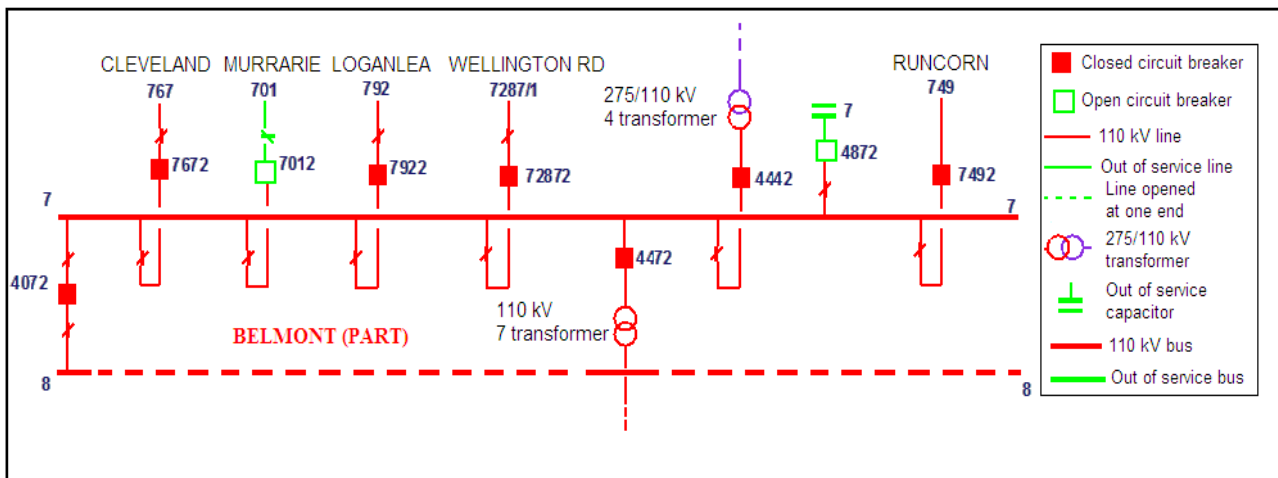
Figure 1 – Status of Belmont No.7 110 kV busbar and its connections prior to the incident

At 2018 hrs on 16 June 2012, Powerlink switched the No.7 110 kV capacitor bank out of service at Belmont substation by opening the capacitor bank circuit breaker CB 4872 for voltage control.

The Belmont No.7 110 kV busbar and the status of its connections prior to the incident are shown in Figure 1. Only the equipment relevant to this incident has been included in the diagram for clarity.

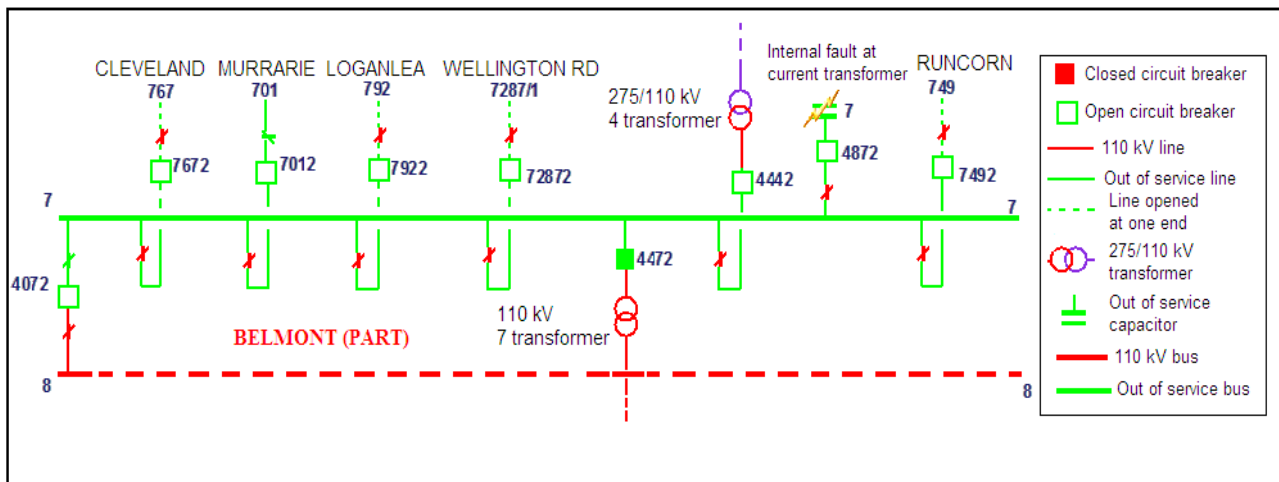
Figure 2 - Status of Belmont No.7 110 kV busbar and its connections immediately after the incident

At 2025 hrs, the Belmont No.7 110 kV busbar tripped out of service due to operation of circuit breaker failure protection associated with the No.7 110 kV capacitor bank CB 4872. This caused the off-loading of the following network elements:

- 749 Belmont–Runcorn 110 kV transmission line
- 767 Belmont–Cleveland 110 kV transmission line
- 792 Belmont–Loganlea 110 kV transmission line
- 7287 Belmont–Murrarie Tee Wellington Road 110 kV transmission line at the Belmont end
- Belmont No.4 275/110 kV transformer
- Belmont No.7 110/33 kV transformer

The status of Belmont No.7 110 kV busbar and its connections immediately after the incident are shown in Figure 2.

Investigation by Powerlink found that switching of the CB 4872 at 2018 hrs was not successful. Only A and B phases of the CB opened while C phase remained closed. This resulted in C phase of the capacitor bank remaining connected to the power system. The protection system associated with the capacitor bank is not designed to monitor the differences between the normal load current of each phase. For this reason, the unsuccessful opening of the CB was not detected immediately by the protection systems of the capacitor.

Due to the unbalanced loading conditions caused by the C phase remaining in service, a current transformer associated with the capacitor bank balance protection developed an internal fault. As a result, the capacitor bank protections sent a trip signal to open the No.7 110 kV capacitor bank CB 4872. The trip signal as well as the load current still present on the C phase of the CB 4872 initiated operation of circuit breaker failure protection associated with this CB.

AEMO concludes that the trip of Belmont No.7 110 kV busbar was caused by the failure of CB 4872 associated with the No.7 110 kV capacitor bank at Belmont to open.

1. Powerlink will return the No.7 110 kV capacitor bank to service after repairs to the CB 4872 are completed. Powerlink will inform the progress of this task to AEMO by the end of October 2012.
2. Powerlink will investigate the possibility of enhancing the protection systems associated with CBs which have similar settings to the CB 4872 such that faster detection of unsuccessful switching can be achieved. Powerlink will complete this action and inform AEMO by the end of December 2012.
