# POWER SYSTEM OPERATING INCIDENT REPORT - TRIP OF BOULDERCOMBE NO.2 275 KV BUSBAR ON 14 NOVEMBER 2012

PREPARED BY: System Performance and Commercial

DATE: 4 January 2013

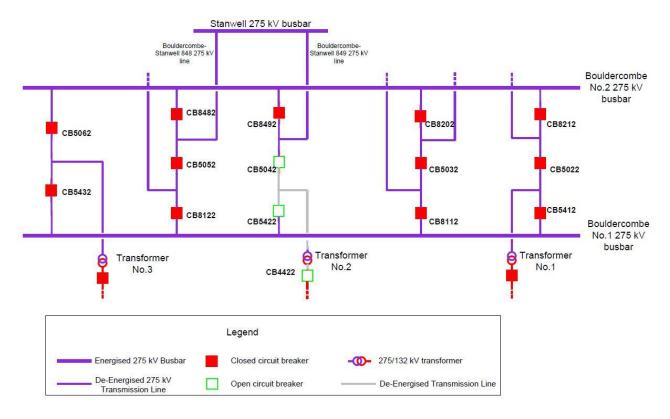
The status of the power system prior to the incident is shown in Figure 1. For clarity only equipment relevant to this incident has been included in the diagram.

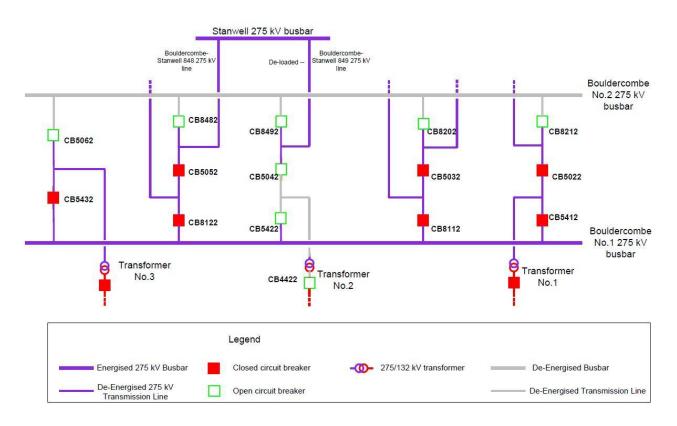
Figure 2 - Status of the power system immediately after the incident

At 1200 hrs while technicians were removing the redundant cables, established work procedures were not fully observed causing a wire to be inadvertently pulled from a terminal which initiated bus zone trip signals. The protection scheme triggered and the following 275 kV CBs at Bouldercombe operated:

The status of the power system immediately after the incident is shown in Figure 2.

At 1200 hrs on 14 November 2012, the No.2 275 kV busbar at Bouldercombe in Queensland tripped due to the operation of bus zone protection. The protection scheme was triggered when a wire was inadvertently pulled from a terminal during removal of redundant cables from the bus zone protection cubicle.

After discussions between AEMO and Powerlink to ascertain the nature of the trip, the No.2 275 kV busbar at Bouldercombe was returned to service at 1207 hrs. The 849 Bouldercombe–Stanwell 275 kV transmission line was returned to service at 1210 hrs.

Powerlink advised that the wire had been re-terminated and that other connections had been checked. AEMO applied SO\_OP3715 Power System Security Guidelines<sup>1</sup> in determining that the simultaneous trip of the No.2 275 kV busbar at Bouldercombe and the 849 Bouldercombe– Stanwell 275 kV transmission line was unlikely to re-occur and would not be classified as a credible contingency.

Field technicians were reminded to check the mechanical strength of electrical connections in the vicinity before performing any work that may place mechanical stress on the connections as per established work procedures.
