# POWER SYSTEM OPERATING INCIDENT REPORT - TRIP OF HADSPEN A 110 KV BUSBAR ON 24 OCTOBER 2012

PREPARED BY: System Performance and Commercial

DATE: 20 December 2012

FINAL

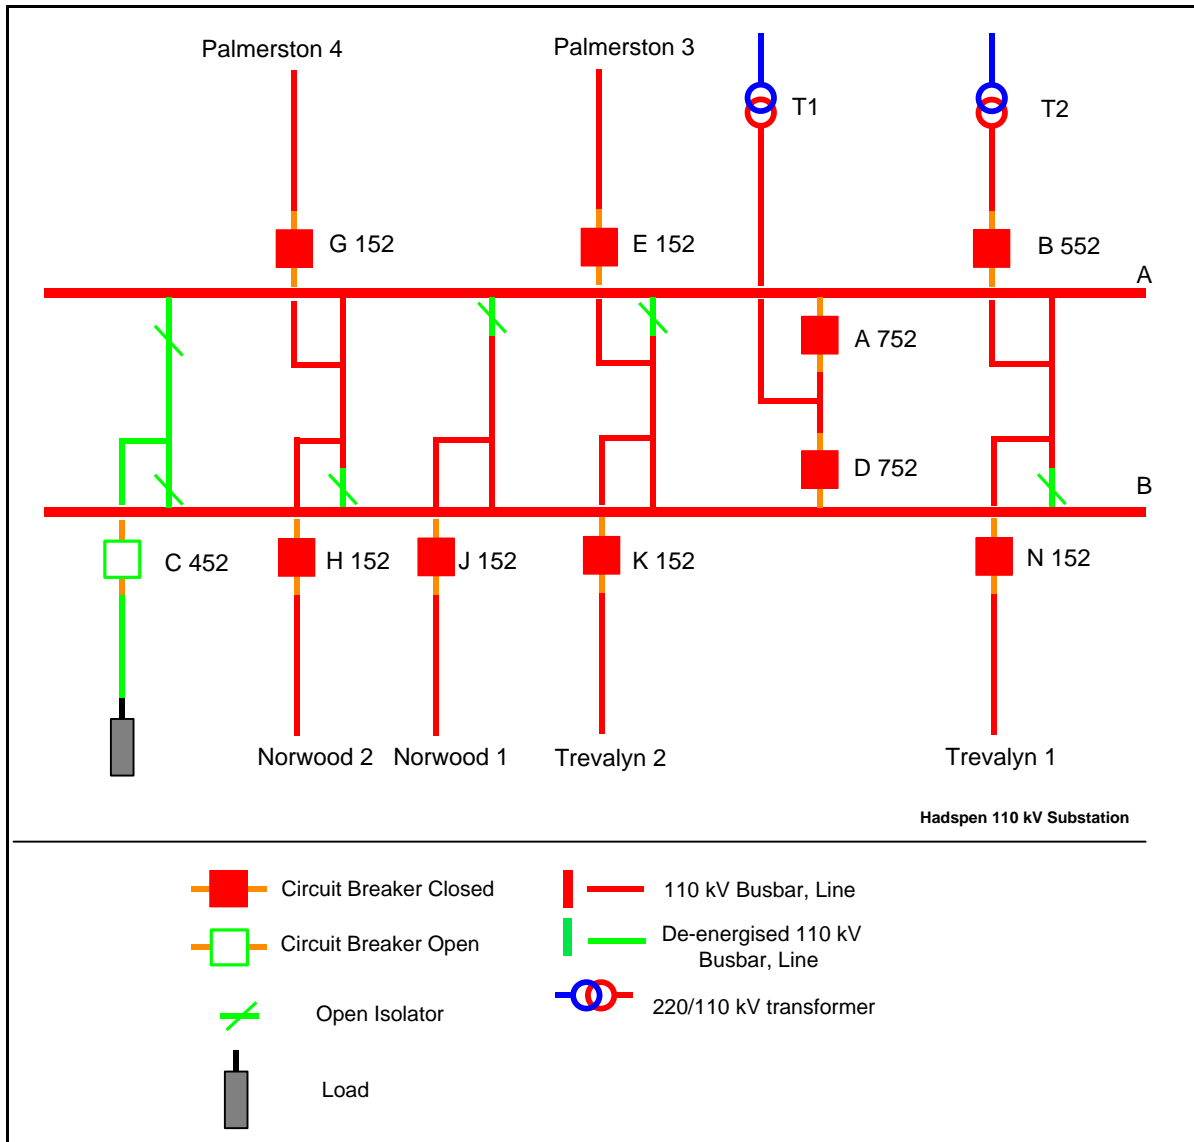
The status of the power system prior to the incident is shown in Figure 1. For clarity only equipment relevant to this incident has been included in the diagram. Note that 110 kV CB C452 was open and isolated for testing.

Figure 1 Status of the power system prior to the incident.

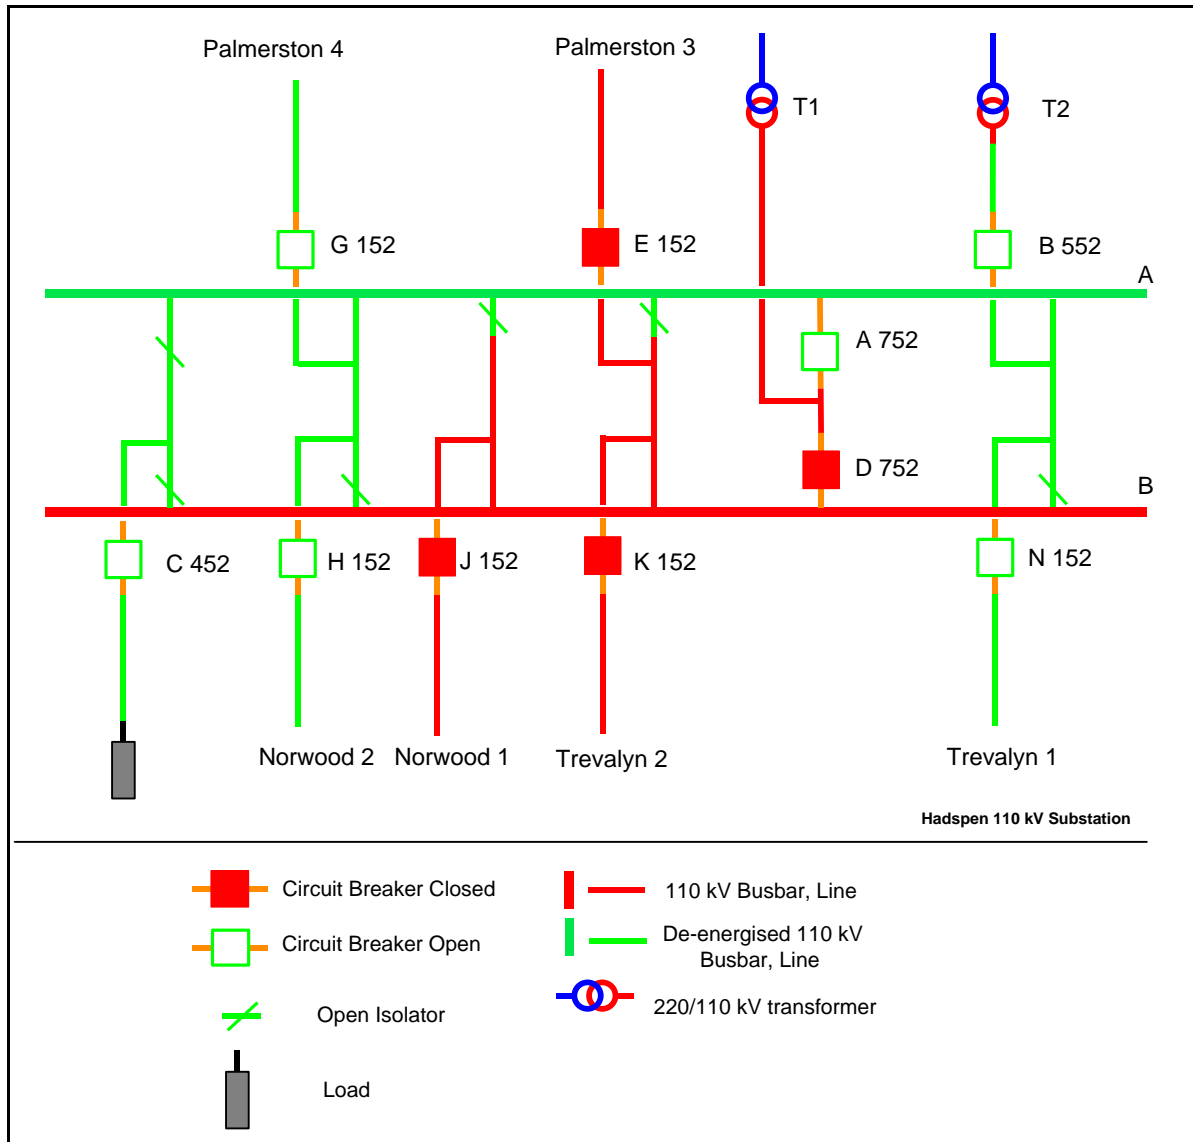
At 1338 hrs, the technicians attempted to initiate a test trip of 110 kV CB C452 at Hadspen from the Hadspen 110 kV Busbar protection panel. The trip signal was applied to the incorrect terminal on the protection panel which initiated the trip of the A 110 kV Busbar at Hadspen.

Figure 2 Status of the power system immediately after the incident

The Transend technicians had followed correct procedure in carrying the routine maintenance at Hadspen substation. The incident is attributed to a momentary lapse of attention when applying a trip signal to the appropriate terminal on the Hadspen 110 kV Busbar protection panel. The technicians involved were reminded to be vigilant when conducting tests to avoid a reoccurrence.
