# POWER SYSTEM OPERATING INCIDENT REPORT – TRIP OF SYDNEY WEST 132 KV B BUSBAR ON 28 MARCH 2012

PREPARED BY: System Capability

DATE: 26 July 2012

FINAL

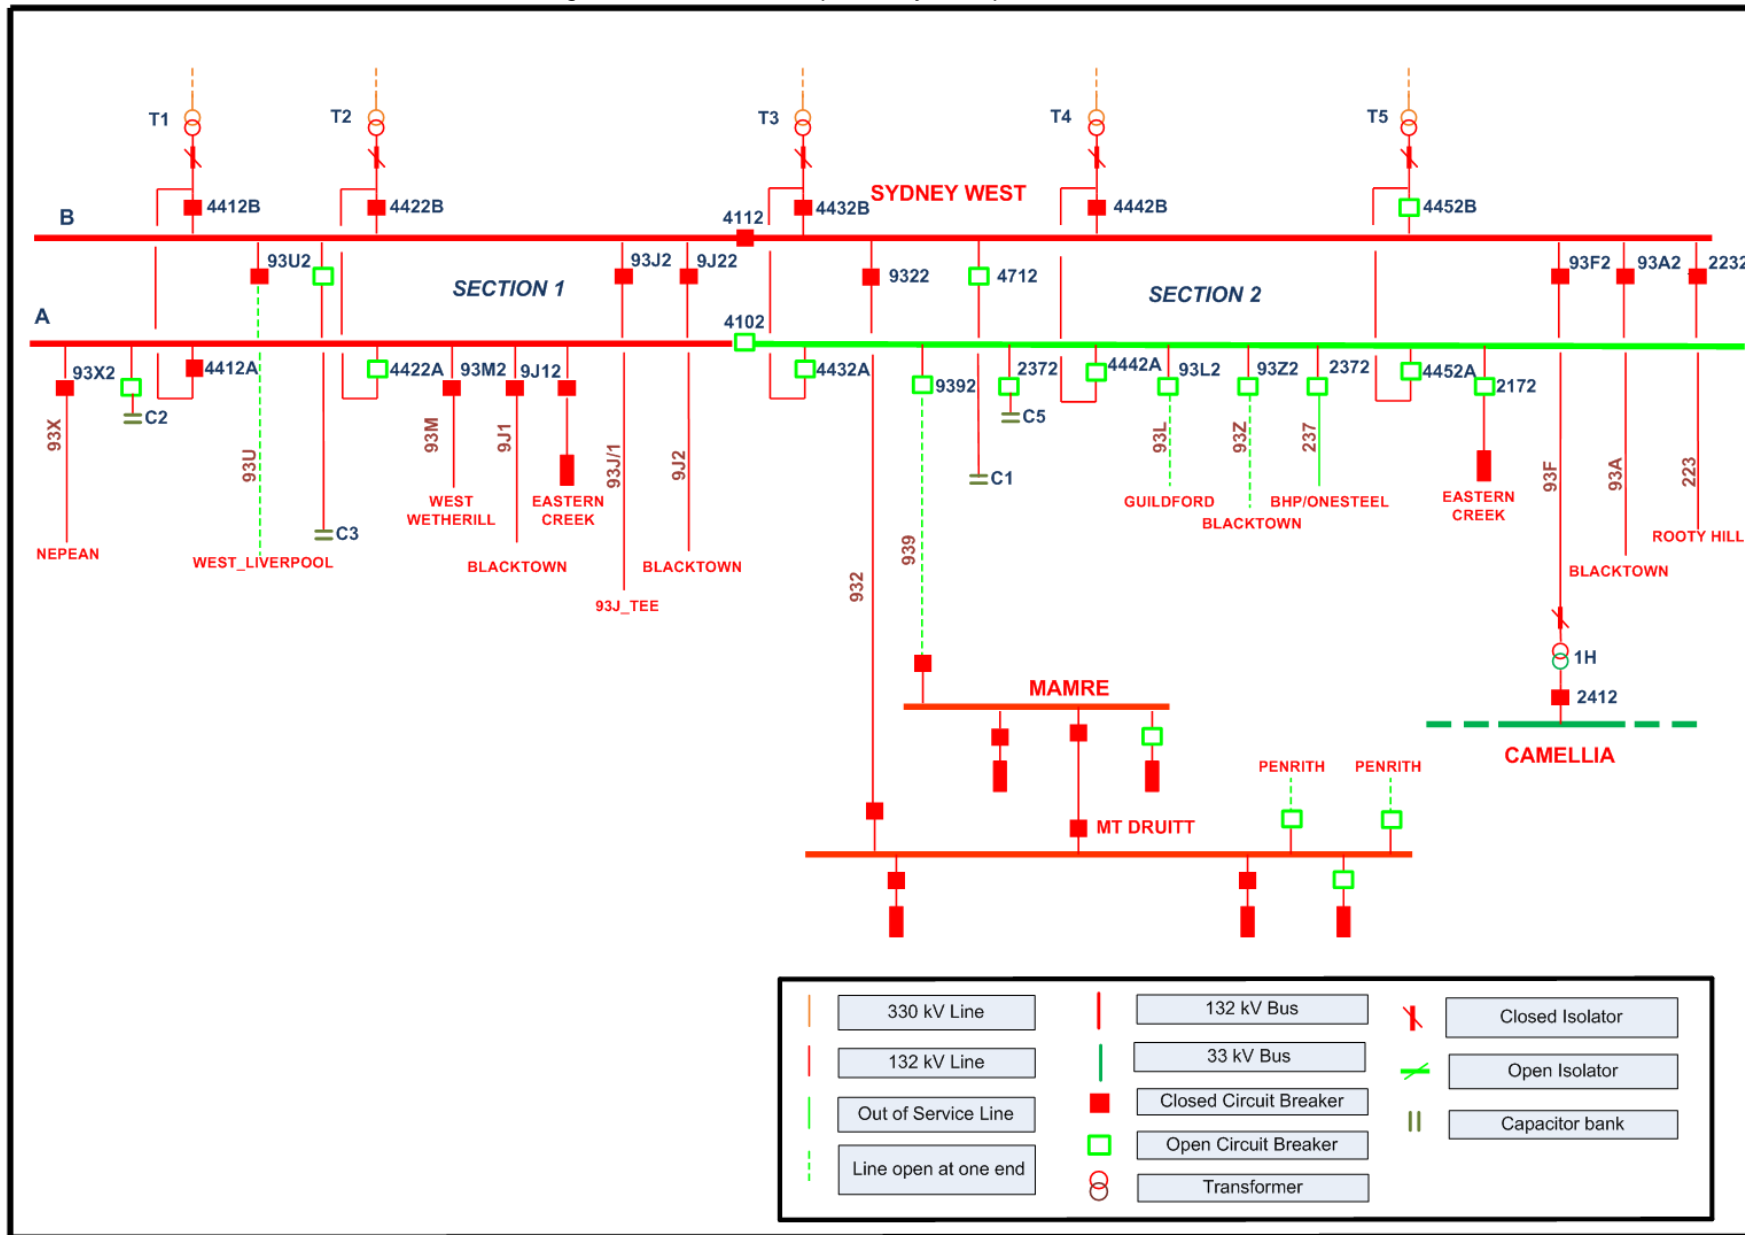
Figure 1 - Status of the power system prior to the incident

The status of the power system prior to the incident is shown in Figure 1. For clarity only equipment relevant to this incident has been included in the diagram.

Prior to the incident, section 2 of the Sydney West 132 kV A busbar was out of service for planned maintenance, off-loading the 939 Mamre, 93L Guildford, 93Z Blacktown, 237 BHP/Onesteel and 217 Eastern Creek 132 kV feeders and leaving the Mt Druitt and Mamre 132 kV substations being radially supplied.

The T5 330/132 kV transformer at Sydney West was also off-loaded.

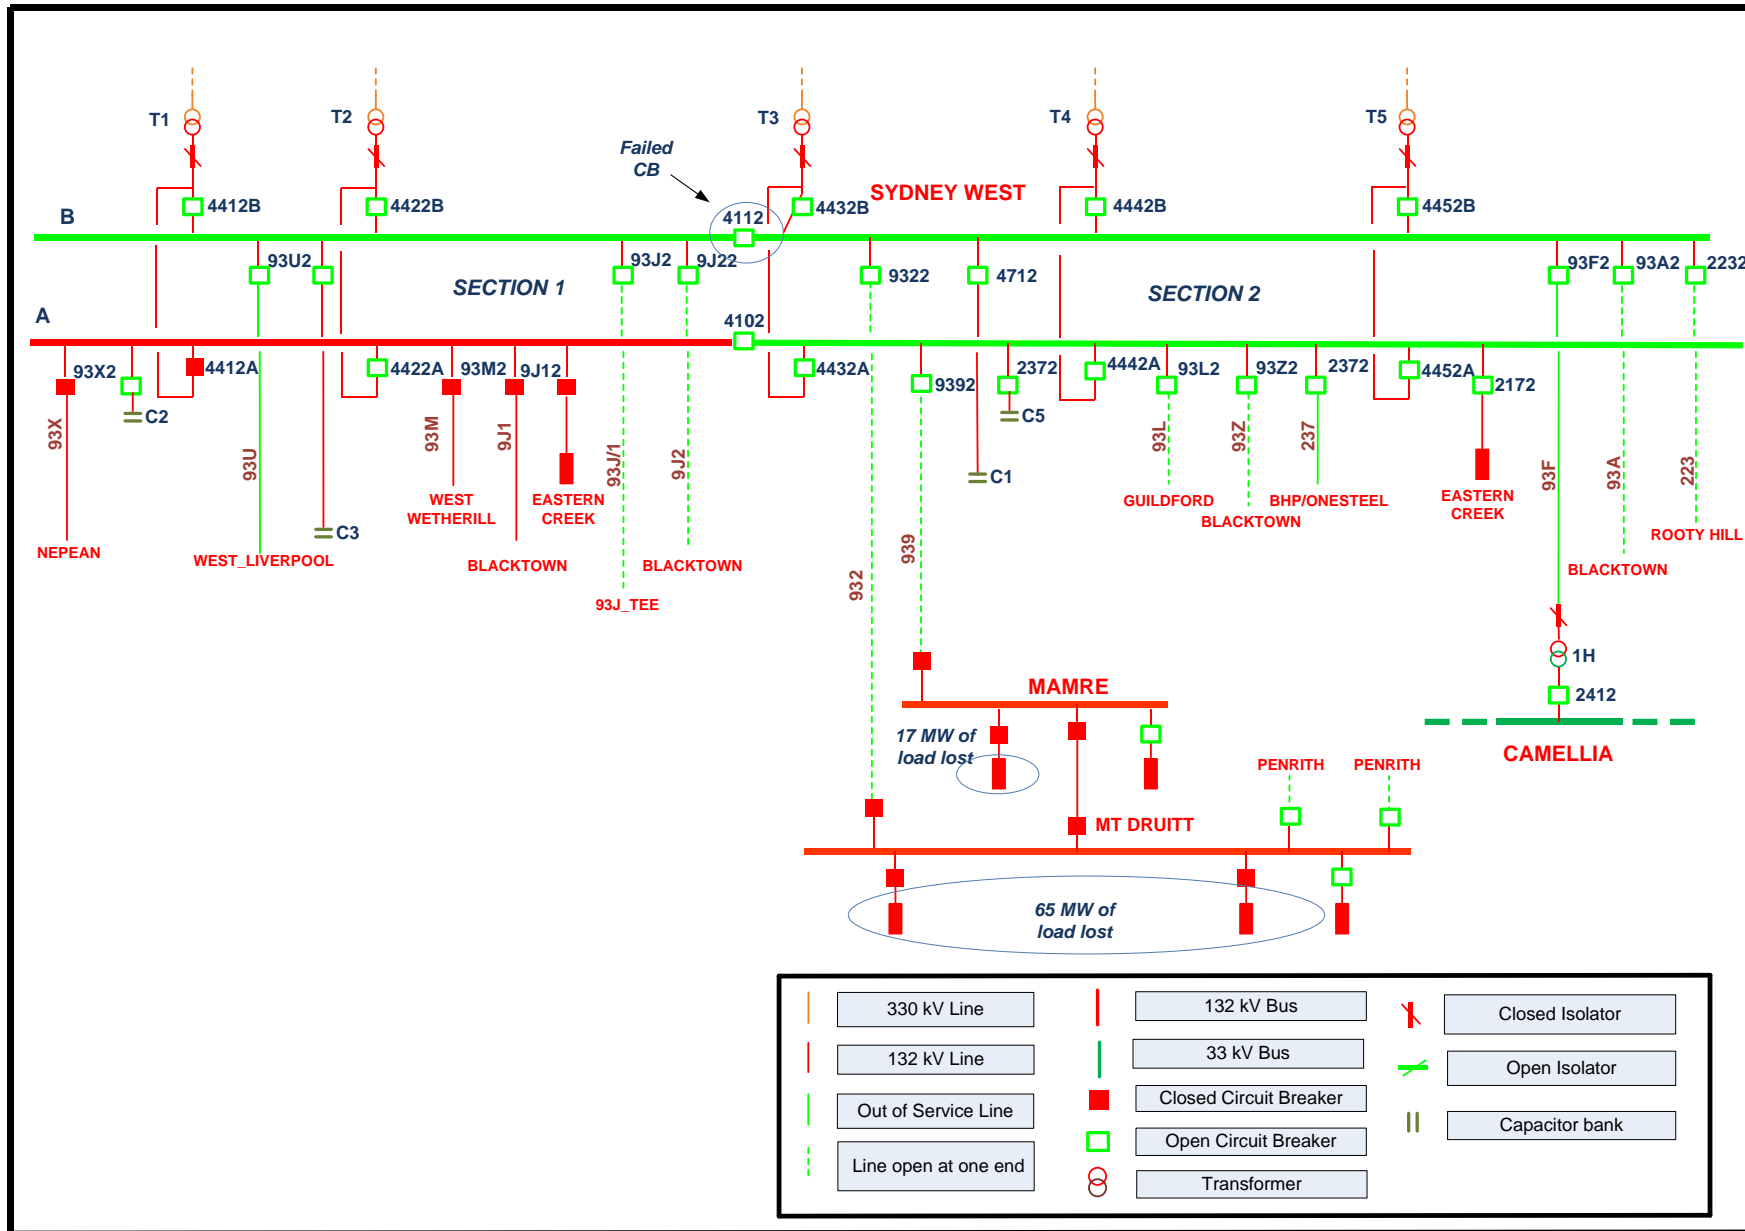
Figure 2 - Status of the power system immediately after the failure of the bus section CB 4112

At 1711 hrs on 28 March 2012, sections 1 and 2 of the 132kV B busbar at Sydney West tripped on operation of busbar protection following the explosive failure of the bus section CB 4112.

- disconnection of the Sydney West T1, T2, T3 and T4 330/132 kV transformers from the B busbar with only the T1 transformer remaining on load, supplying section 1 of the A busbar
- off-loading of the 93J/1 Wetherill Park tee Granville, 9J2 Blacktown, 93A Blacktown, 932 Mount Druitt, 93F Camellia and 223 Rooty Hill 132 kV feeders

Remote protection at Camellia 132 kV substation also operated to open CB 2412 at Camellia, disconnecting the 93F line.

Refer to Figure 2 for the status of the power system immediately after the incident.

Because the Mt Druitt and Mamre 132 kV substations were radially supplied prior to the incident, the busbar trip resulted in the interruption of approximately 80-90 MW of customer load supplied from those substations. A further reduction of approximately 70-80 MW of load was also observed, believed to have been caused by the operation of internal protection systems of customers.

- At 1720 hrs TransGrid closed the T3 transformer CB 4432A, returning section 2 of the A busbar to service ahead of schedule
- At 1721 hrs TransGrid closed CB 4442A, placing the T4 transformer on load
- At 1724 hrs the 132 kV A bus section CB 4102 was closed, allowing the T3 and T4 transformers to supply loads connected to A busbar section 1<sup>1</sup>
- At 1728 hrs CB 9392 was closed, returning the 939 Mamre 132 kV feeder to service and restoring supply to the Mt Druitt and Mamre substations
