POWER SYSTEM OPERATING INCIDENT REPORT – TRIP OF BERRI NO 1 66KV BUSBAR AND THE MONASH – MURRAYLINK 132KV LINE ON 27 NOVEMBER 2012.

PREPARED BY: System Performance and Commercial

DATE: 6 March 2013

FINAL

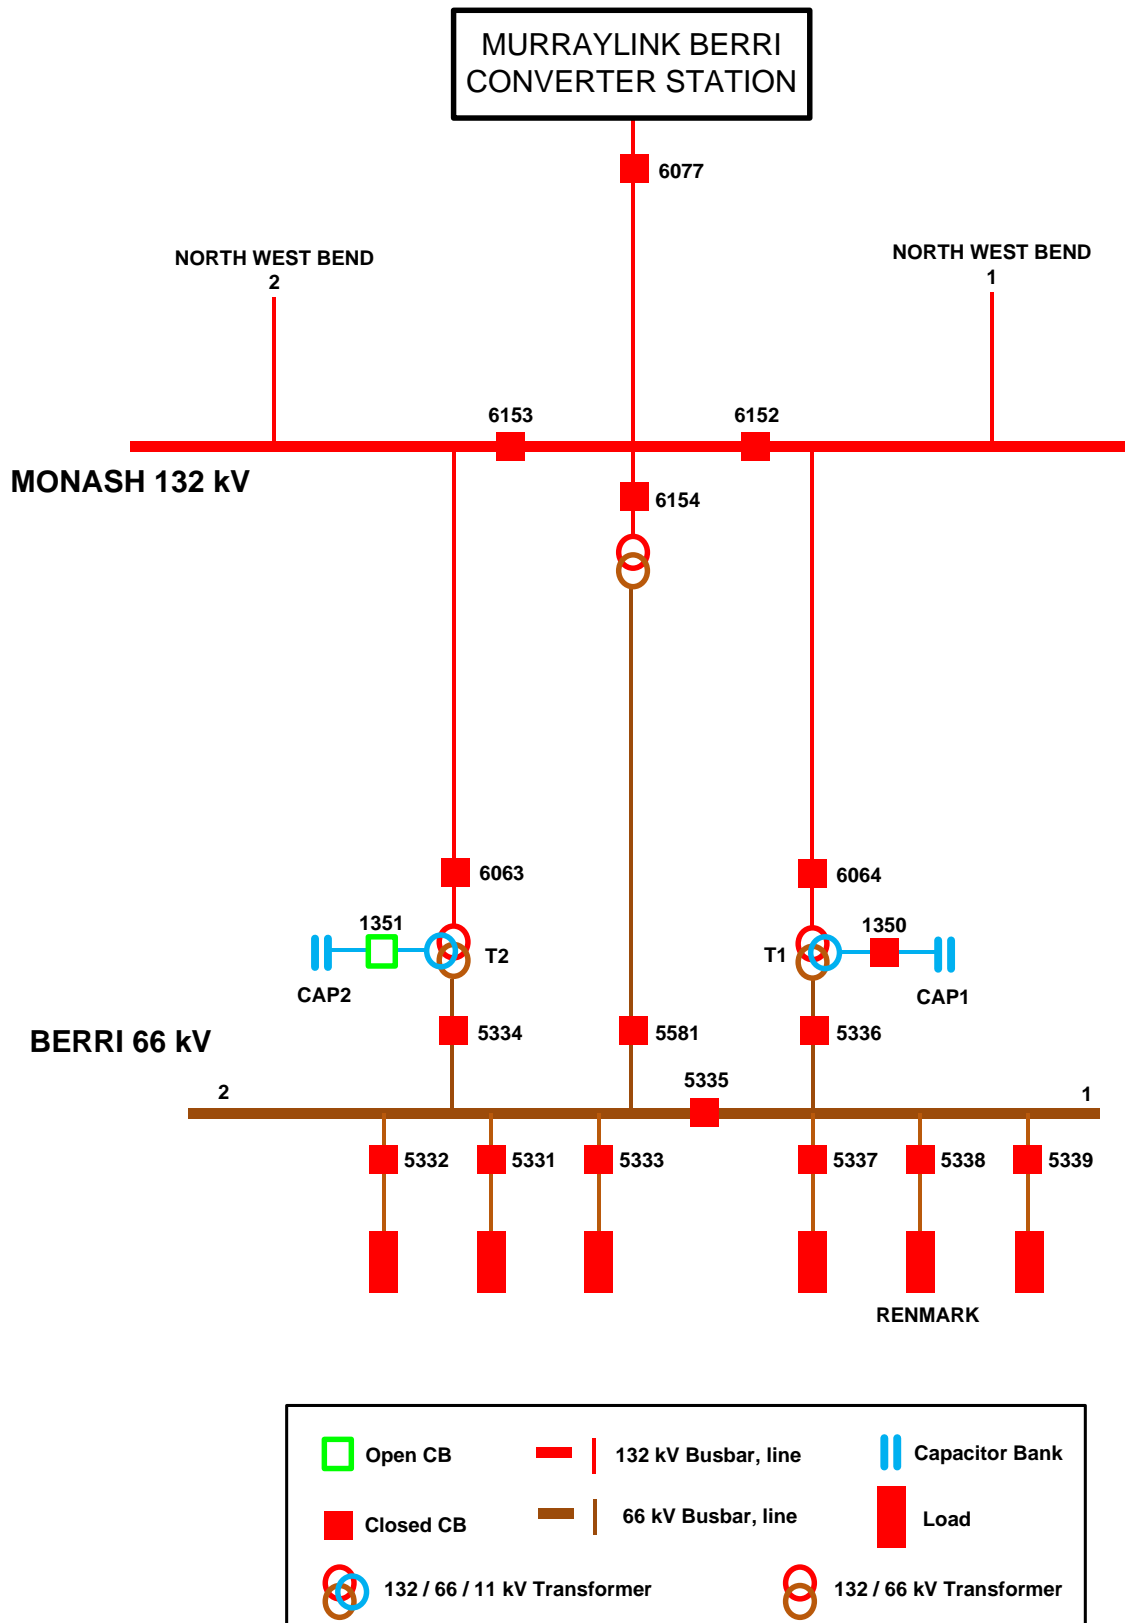
Figure 1 - Status of the power system prior to the incident

The status of the power system prior to the incident is shown in Figure 1.

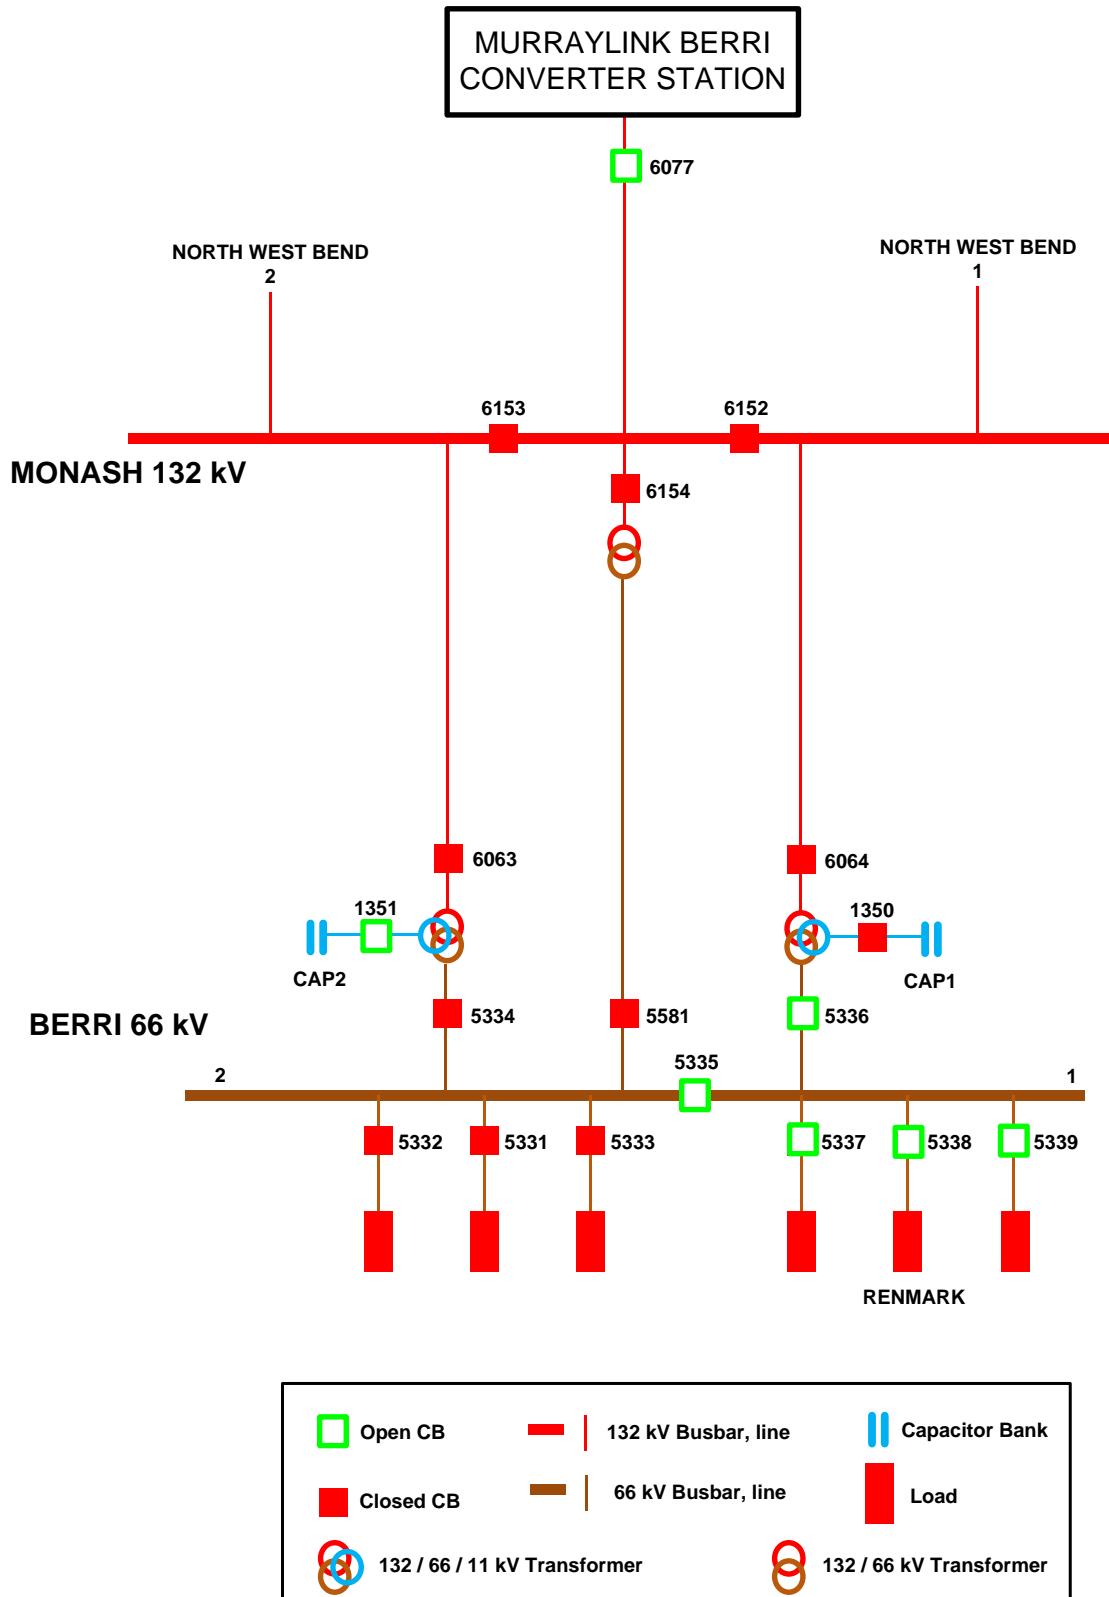
Figure 3 - Status of the power system immediately after the event

The status of the power system immediately after the event is shown in Figure 3.

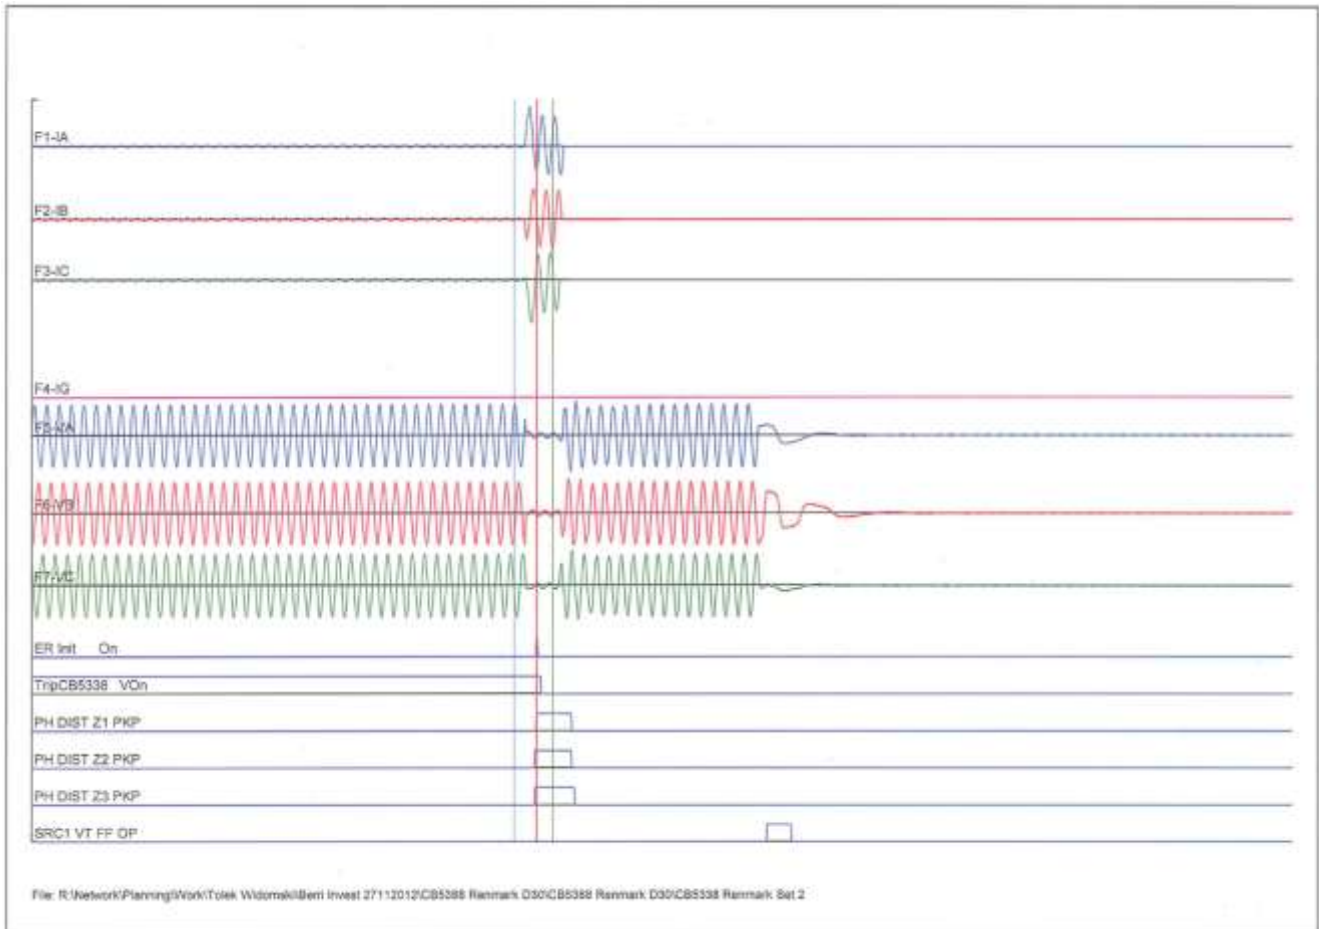
Figure 4 – Berri – Renmark 66 kV line – set 2 line protection (GE D30) oscillograph record

At the same time that the fault was detected, both sets of line protection issued a CBF initiate signal to the busbar zone 5 protection at Berri Substation. SA Power Networks has indicated that the secondary current of the CT supplying the CBF protection scheme did not subside in time due to residual magnetism in the CT and approximately 300 ms later the CBF condition for CB 5338 was declared by the busbar zone 5 protection at Berri Substation tripping the CBs 5335, 5336, 5337 and 5339.

Figure 4 below, shows the current and voltage waves on the Berri – Renmark 66 kV Transmission Line at the time of the event. The fault was effectively cleared by the action of the line protections causing the CB 5338 to open, but approximately 300 ms later the busbar was unnecessarily tripped by CBF protection.

Residual magnetism in a CT was identified as the causer of the maloperation of the CBF protection for the CB 5338 at Berri Substation. SA Power Network has implemented a temporary solution and will apply a permanent solution by July 2013.

SA Power Networks has informed that the problem with the CT has been temporarily addressed by adjusting the pickup level of the 66 kV CBF protection to consider any expected CT residual current following a close-in asymmetrical line fault. A permanent solution is planned by July 2013 consisting of the installation of additional wiring at the substation to allow for a selection of higher ratio CTs and thereby minimise the residual CT current problem.

SA Power Network should implement a permanent solution to the CT residual magnetism issue on the CT that supplies the CBF protection for the CB 5338 at Berri Substation. This solution is expected by July 2013 and SA Power Network should inform AEMO on completion.
