# POWER SYSTEM OPERATING INCIDENT REPORT – TRIPS OF YALLOURN W POWER STATION UNITS W1 AND W3 ON 14 NOVEMBER 2012

PREPARED BY: System Performance and Commercial

DATE: 7 March 2013

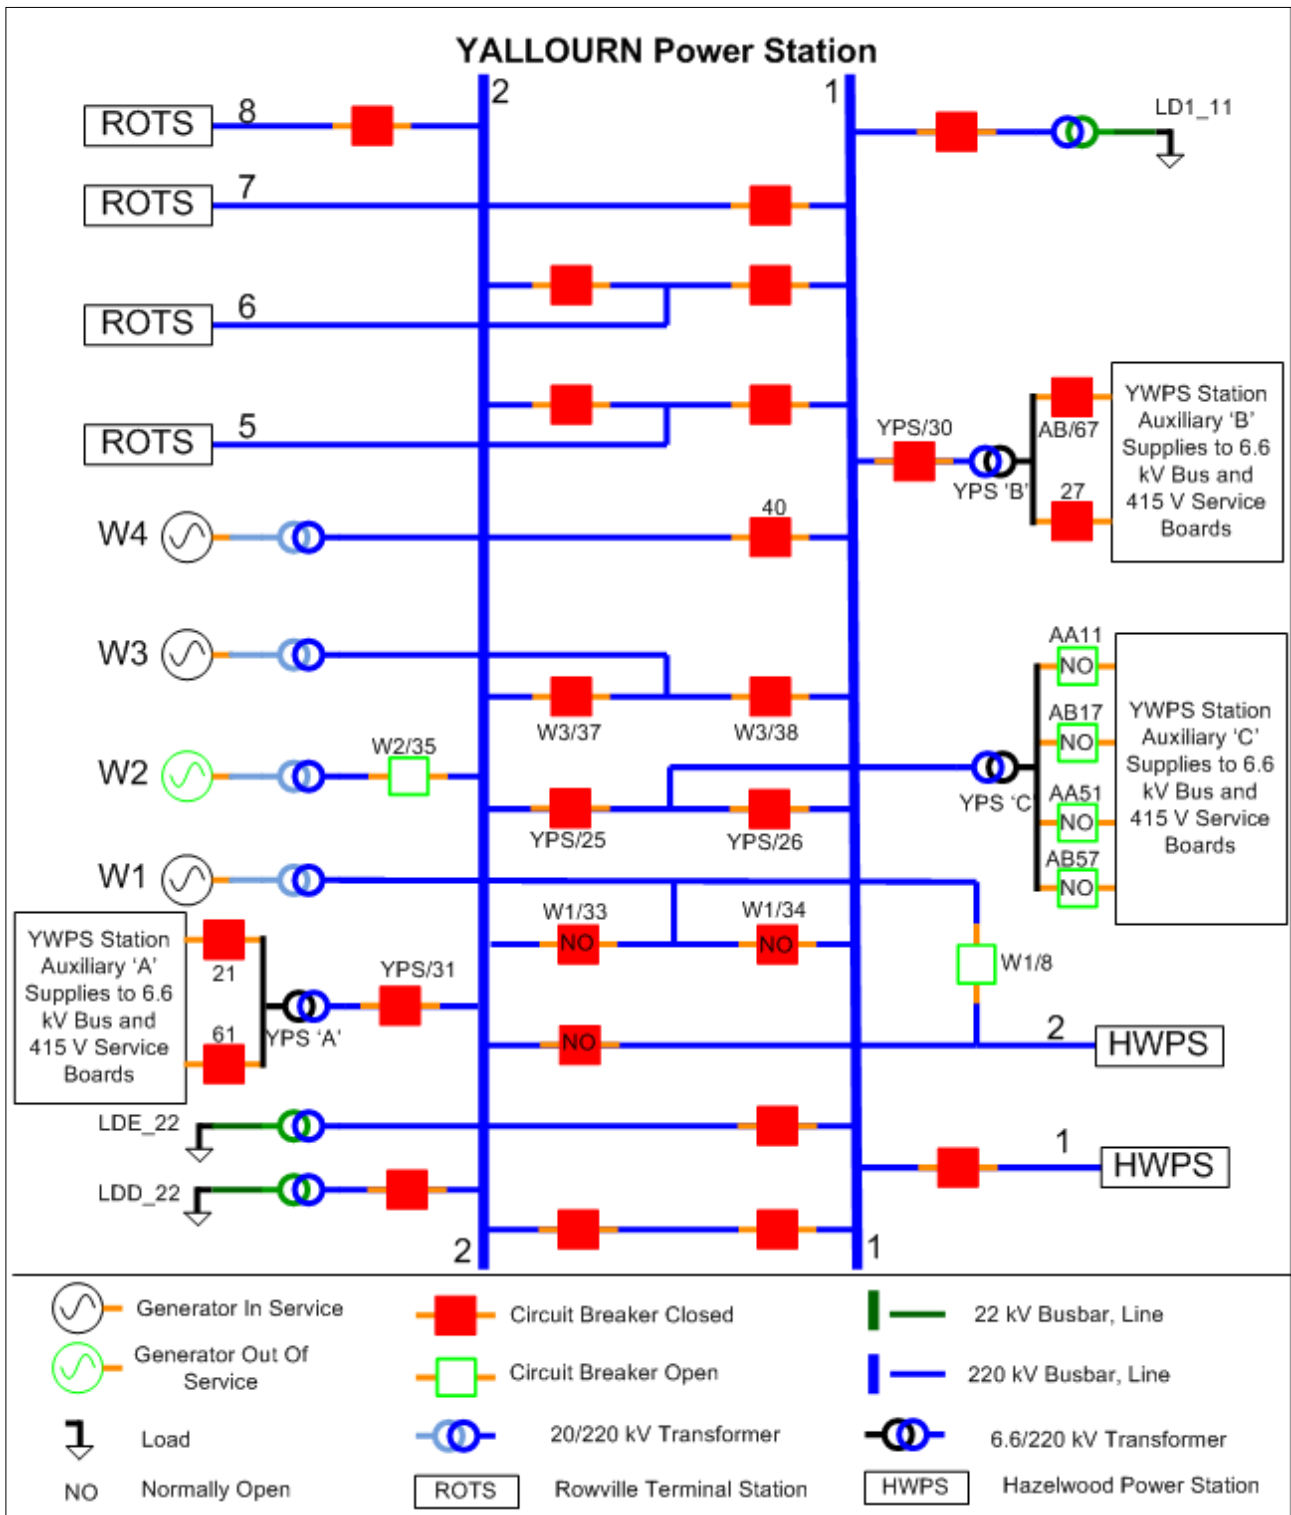
Figure 1 - Status of the power system prior to the incident

Prior to the incident, all equipment connected to the No. 1 and No. 2 220 kV Busbars at YPS was in service. YWPS unit W2 was offline as a result of planned outage and the other three YWPS units were in service generating a total output of approximately 950 MW.

The status of the power system prior to the incident is shown in Figure 1. For clarity only equipment relevant to this incident has been included in the diagram.

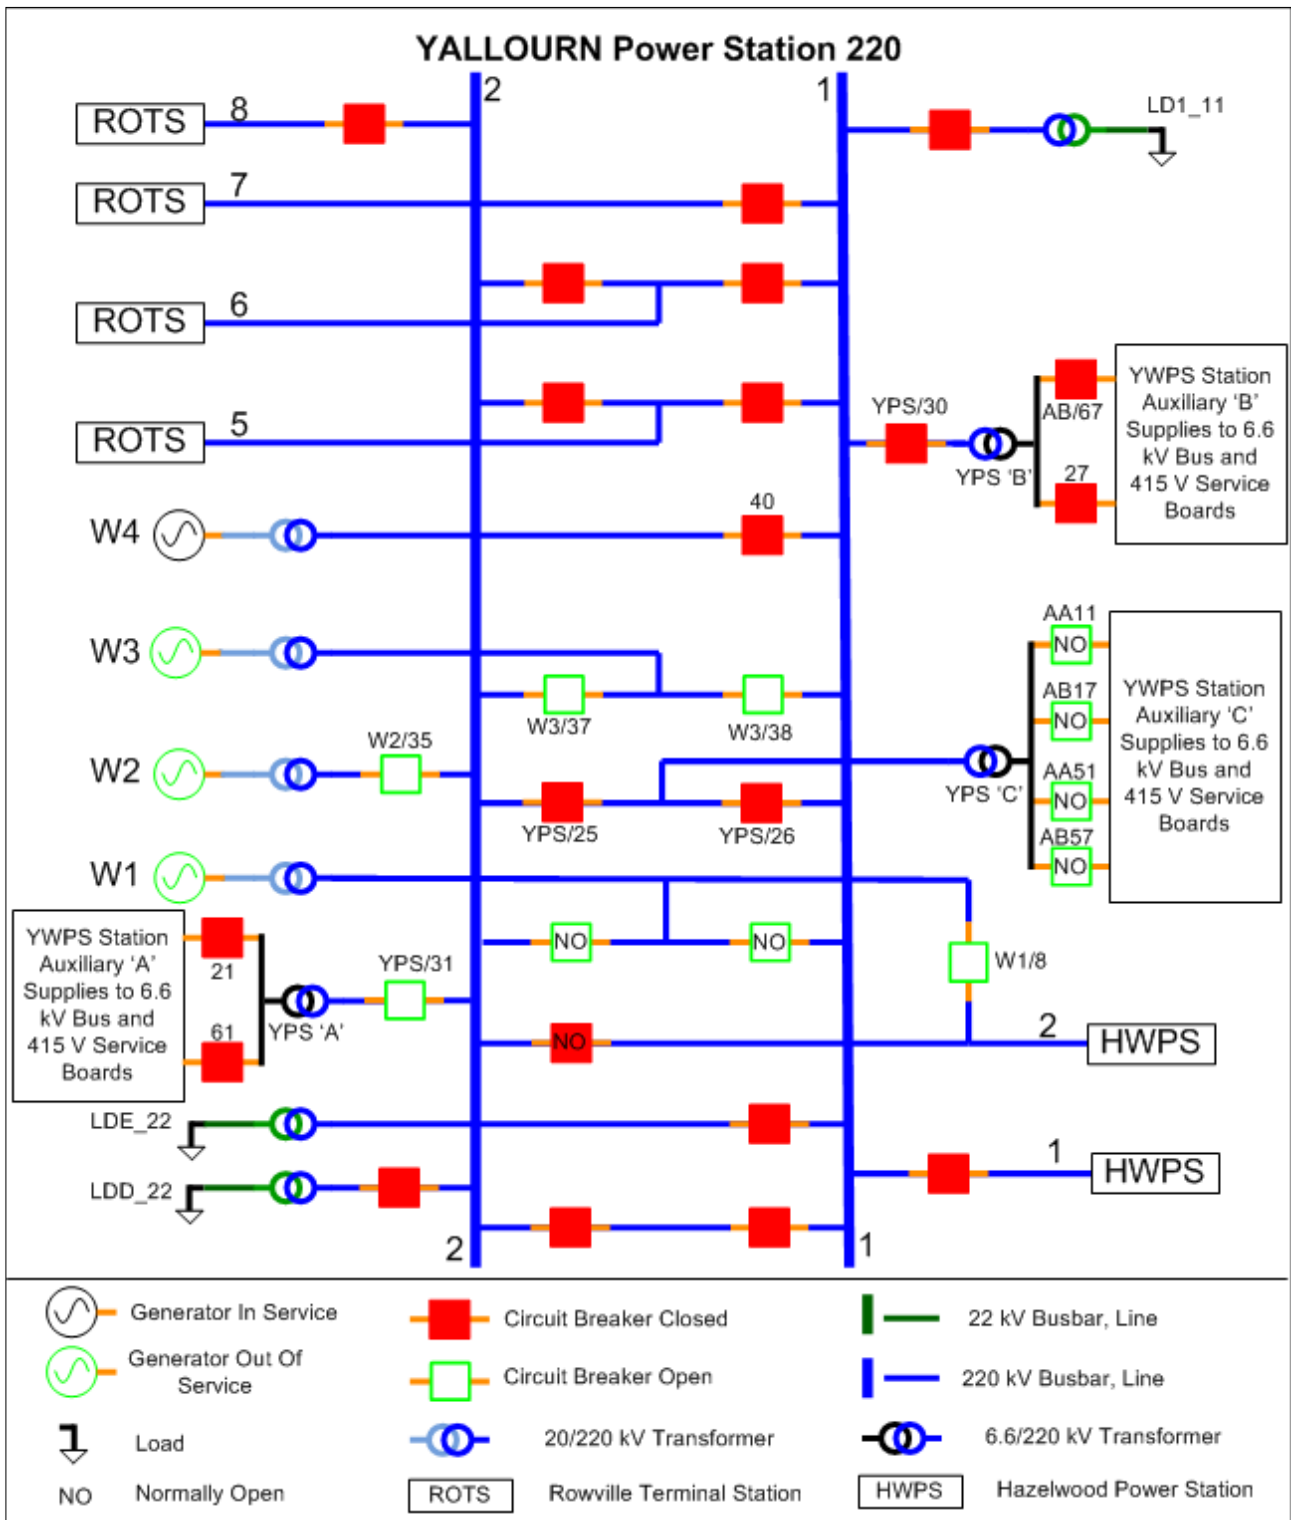
Figure 2 - Status of the power system immediately after the incident

The status of the power system immediately after the incident is shown in Figure 2 and Figure 3. At YWPS, unit W4 was the only unit remaining in service after the incident. Incorrect data was telemetered to AEMO indicating that YWPS unit W4 was operating at zero output following the incident. Two dispatch intervals were affected and the market impact was not significant.

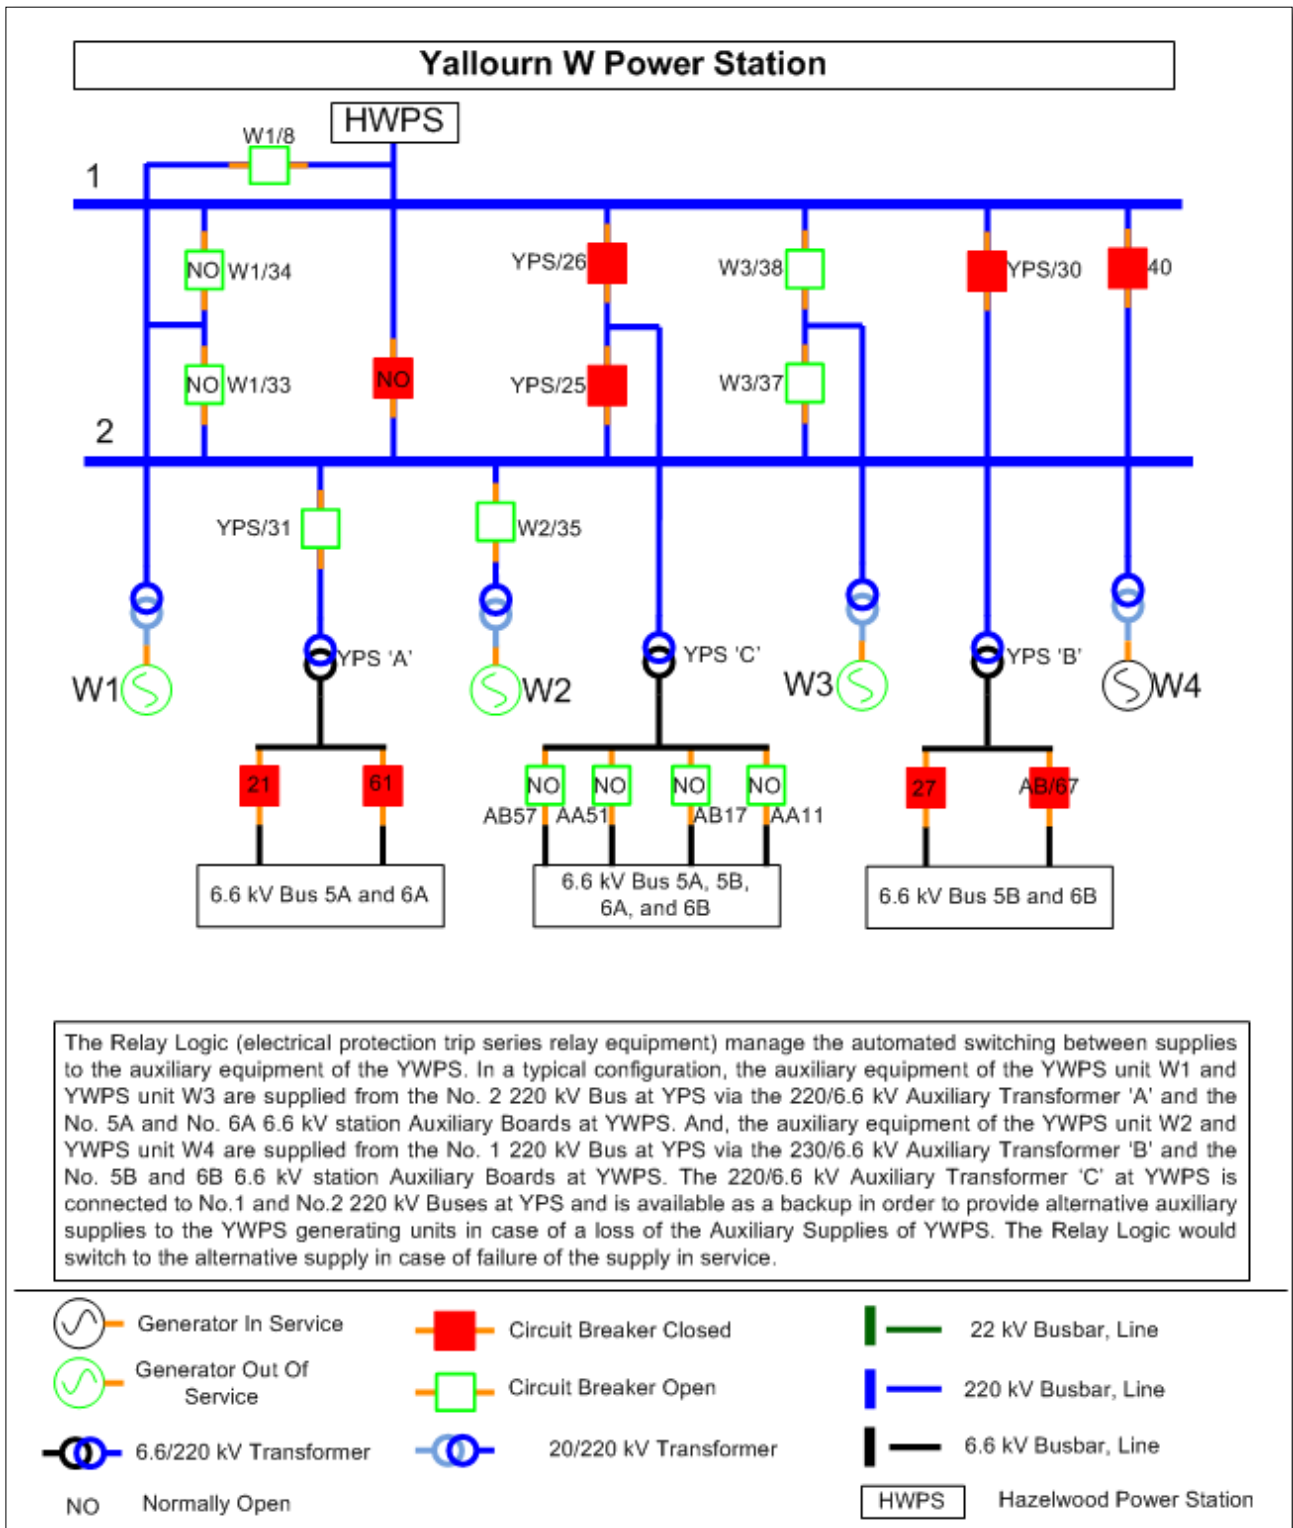
Figure 3: YWPS Auxiliary Supplies and the Distributed Control System

The key events that took place during the incident are summarised in Table 1 below. Auxiliary Transformer 'A' at YWPS was de-energised when the 220 kV CB YPS/31 at YPS (YPS switchyard end) opened due to a reason that was not identified at the time. The Auxiliary Transformer 'A' 6.6 kV CB 21 and CB 61 (YWPS station and unit board side) remained closed. This resulted in the interruption of auxiliary supplies to several station auxiliary boards and unit boards, however the

Relay Logic at YWPS did not initiate an automatic changeover to an alternate supply from the 220/6.6 kV Auxiliary Transformer 'C' at YWPS.

Unit W1 and unit W3 tripped due to interruption of the supplies to their auxiliary equipment. The Relay Logic is designed for an automatic changeover to alternate supplies for the auxiliary equipment from the 220/6.6 kV Auxiliary Transformer 'C' at YWPS. The Relay Logic automatic changeover to alternate supplies did not operate as it relies on the detection of an open status of the associated 6.6 kV CBs of the auxiliary transformers at YWPS (in this case, 6.6kV CBs 21 and 61 of V Auxiliary Transformer 'A' did not open).

Energy Australia intends to review the Distributed Control System (DCS) logic design with a view to include functionality to auto reclose from an alternate supply on loss of supply from an Auxiliary Transformer.

Energy Australia advised that a preliminary review of DCS design has been undertaken to allow the DCS to perform automated changeover of station auxiliary supplies when a transformer is de-energised and not tripped. Energy Australia is aiming to complete the review by the end of March 2013.
